CASE HISTORY

ECP HELICAL
TORQUE ANCHORS™

Tieback Anchors Repair Tilting Foundation Walls Denver, Colorado

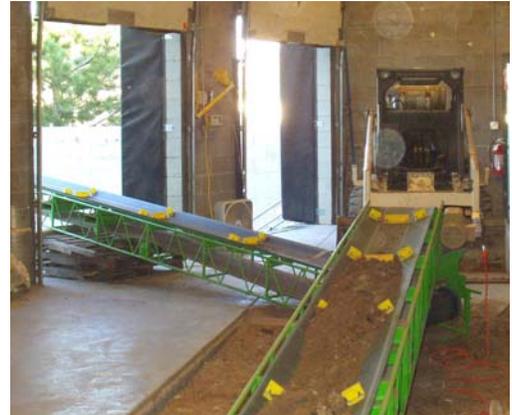
From the top: Soil removal was accomplished by conveyor as workers dug behind the stem walls. A helical tieback is installed at the specified angle.

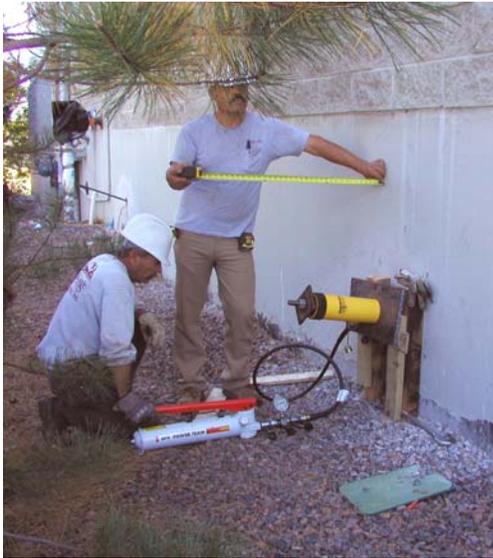
One technician applies a hydraulic force against the wall while the other holds a tape measure. A third technician, not visible, monitors the amount of wall restoration.

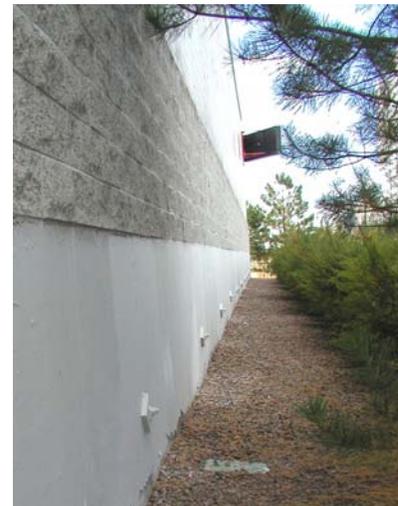
Finally, here is a view of the restored wall. The small wall plates are the only evidence of the work.
