# CASE HISTORY

## ECP HELICAL TORQUE ANCHORS™

### Tieback Anchors Repair Tilting Foundation Walls Denver, Colorado

| Project Summary | |
|---|---|
| Project: | Rotated Wall Repairs, Denver, Colorado |

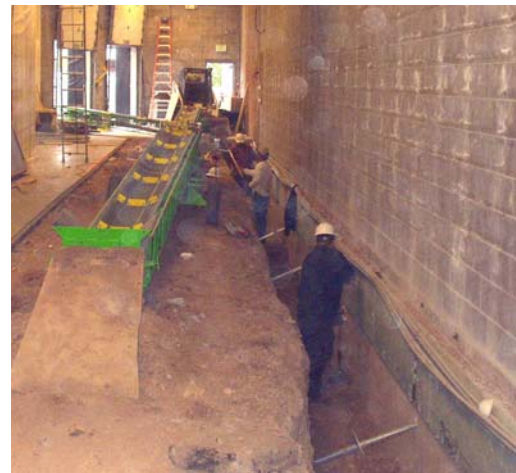
From the top: Soil removal was accomplished by conveyor as workers dug behind the stem walls. A helical tieback is installed at the specified angle.

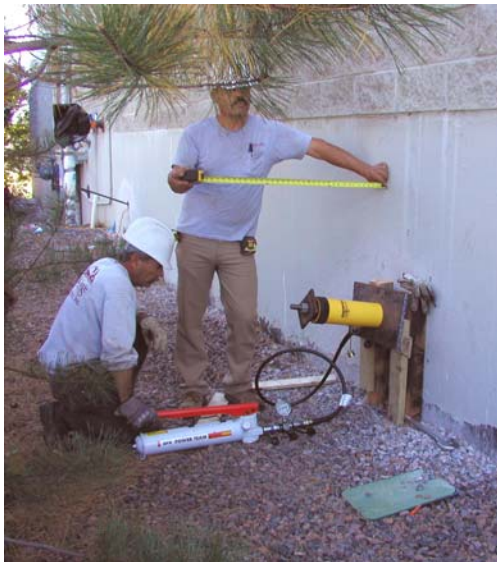
One technician applies a hydraulic force against the wall while the other holds a tape measure. A third technician, not visible, monitors the amount of wall restoration.

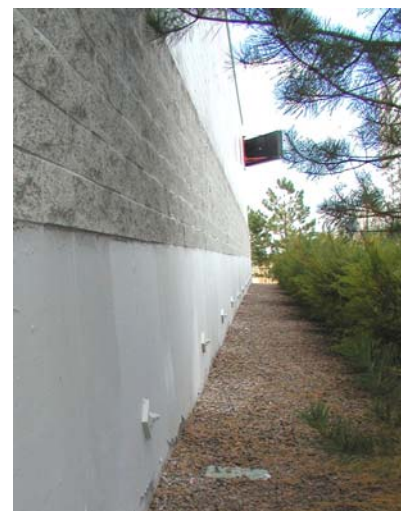
Finally, here is a view of the restored wall. The small wall plates are the only evidence of the work.
