## The First Law of Foundation Stability: Buildings Built on

Land Fill will Settle

Jackson County, Florida

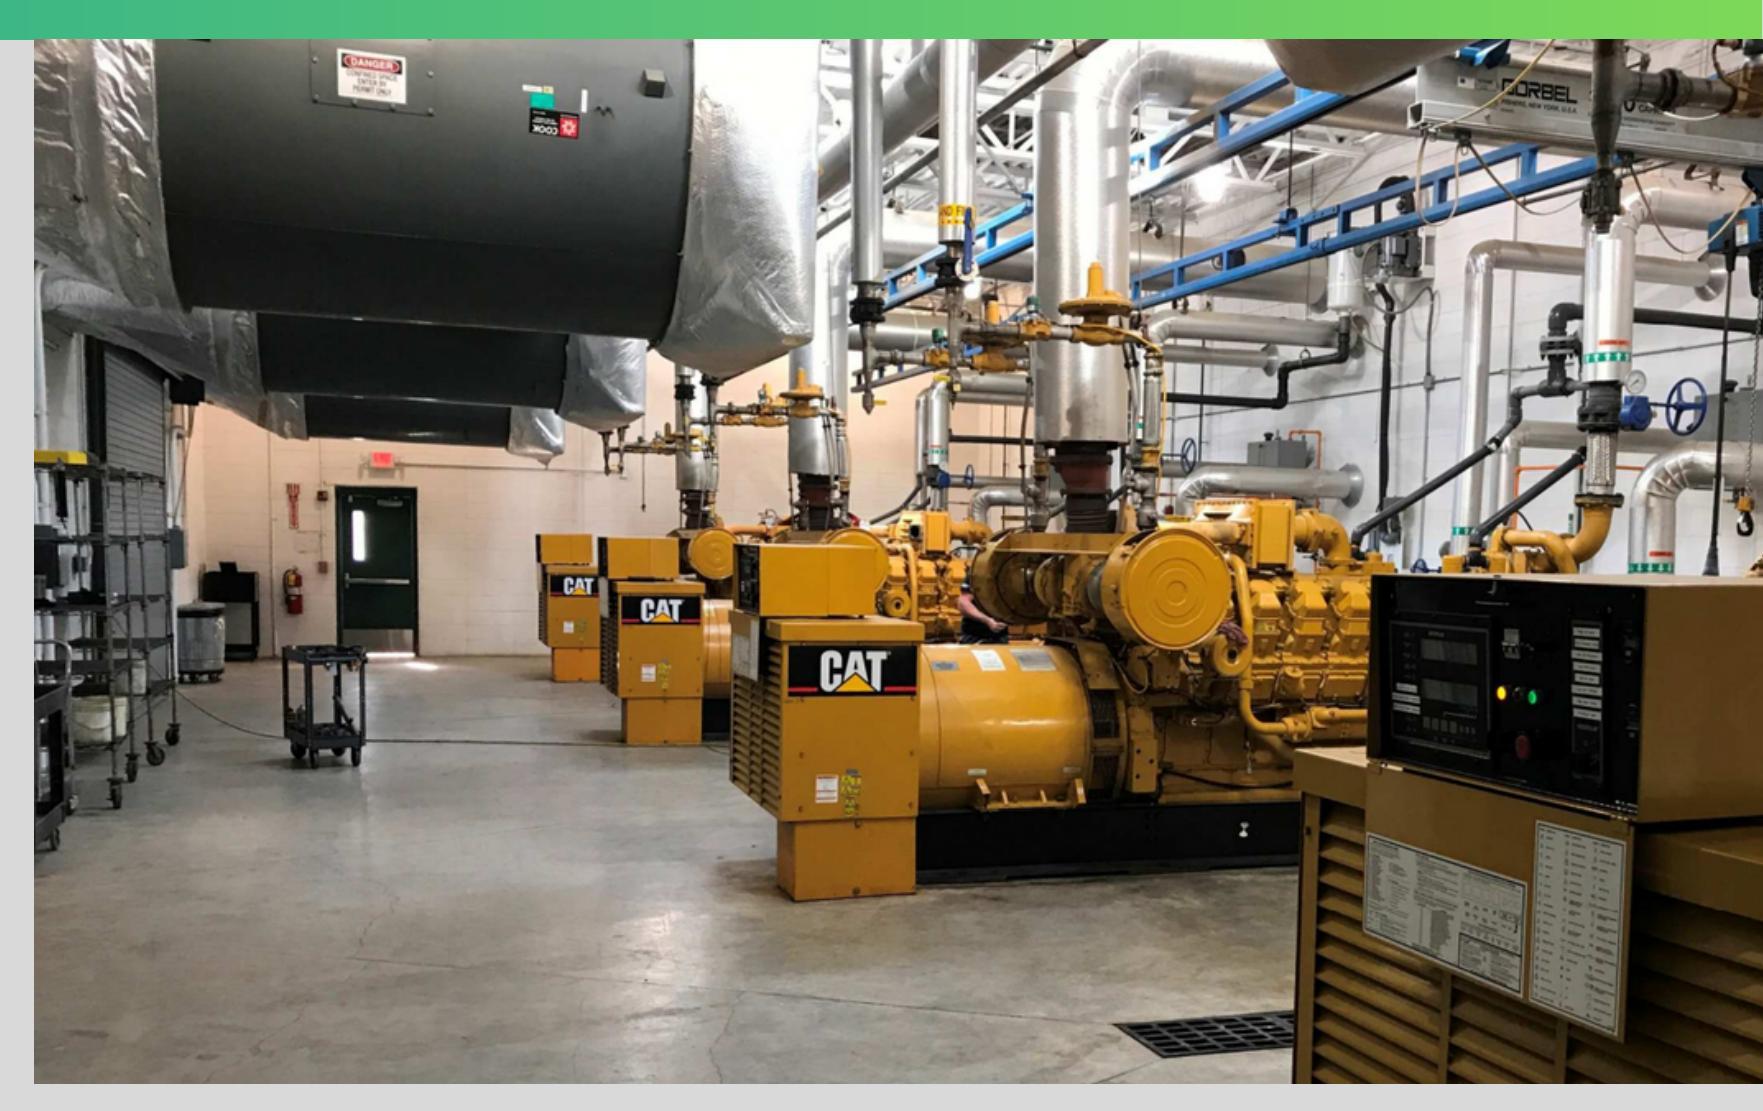
Google Earth historical aerial imagery showed the building straddles the west edge of a closed landfill cell. The original building plans have a detail for the over excavation of the unsuitable land fill materials. Evidence shows that this specification was skipped by the original contractor. The existing building shows signs of foundation movements and instability. These appeared as separations between the wall and floor slab, stairstep fractures and vertical cracks in the masonry work and differential movement with cracks in the floor slab. The east wall of the building showed lateral movement toward the east along with wall rotation causing several roof joists to pull away from the west wall bearing plates.

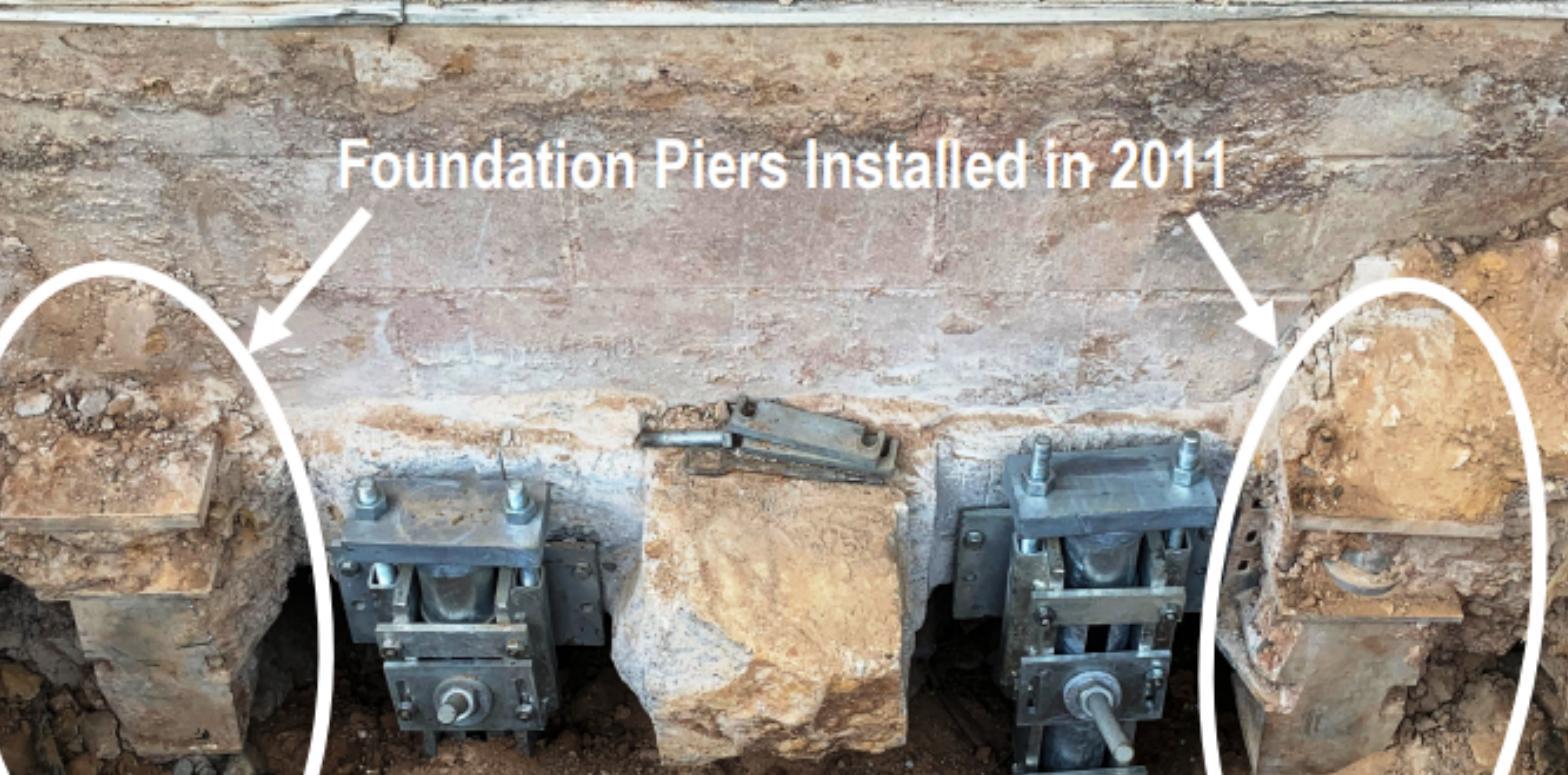
Photos show 2 previously installed push piers, filthy perched water flowing from below the structure and a huge pile of decaying garbage removed at a pier location.

In 2011 a local competing foundation repair company installed 75 push piers under parts of the east wall and floor slab on the south half of the building. There were areas of the concrete slab showing evidence where previous foundation work had been installed. Patches were visible on the interior and exterior masonry and on the slab. No foundation repairs were made on the north end of the building. The plant manager stated that after the previous foundation underpinning and repair was complete, some parts of the building were better than before and some parts were worse. The building continued to move both in the area of previous foundation work and in other portions of the building. The owner hired Larry M.

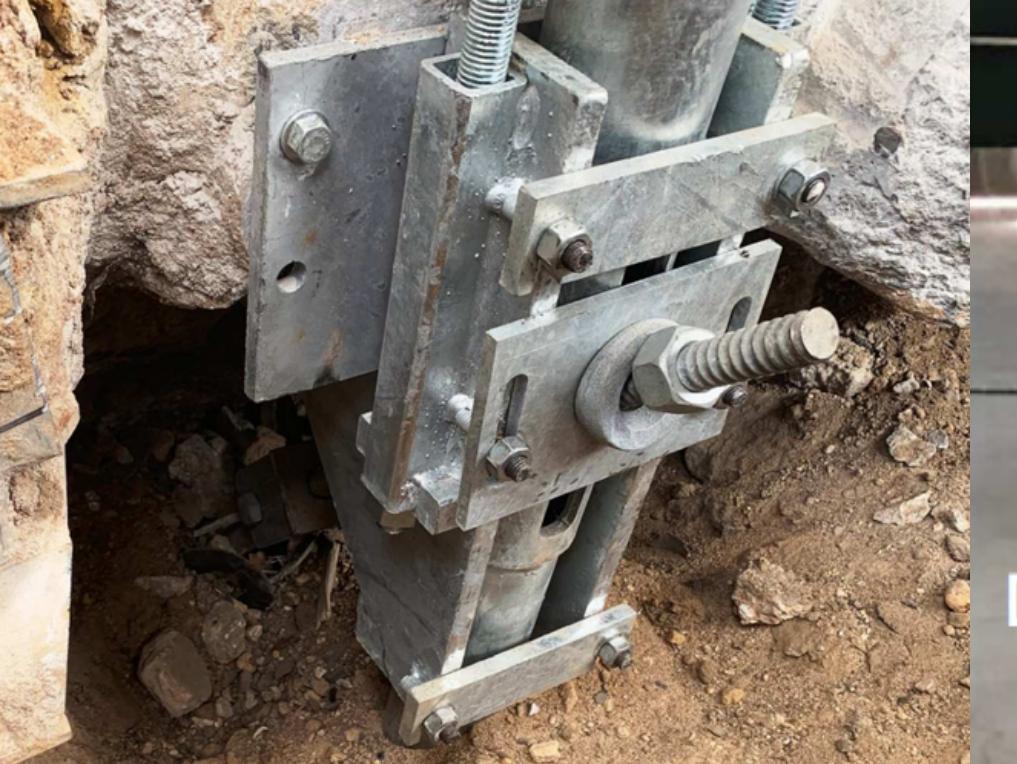
Differential Foor Settlement

Installing

Tieback

Anchor

The remediation procedure was designed to vertically and laterally stabilize the foundation of the structure. Recovering the lost floor elevation and vertically stabilizing it was accomplished by installing ECP Steel Piers that provide end bearing resistance against a verified and proof loaded tested stratum deep below the surface.

The lateral movement of the concrete footings required ECP Tieback Anchors attached to the ECP steel piers. There was also need for 20 slab piers to support, lift and stabilize the settlement and slab misalignments. At the locations of differential slab movement, the defects were corrected using ECP Torque Anchor compression piles connected to slab brackets. Steel angle supports were installed at the ends of 34 roof trusses to provide load bearing. Foundation Professionals of Florida had to overcome several obstacles to complete the project. Many massive concrete bollard foundations were encountered and had to be removed to gain access for the installation machinery. The original underpinning placement plan had to be modified several times due to conflicts with the 75 previously installed piers from 2011. There were serious amounts of garbage and debris excavated from under the structure. Even though over-excavation of areas with land fill were specified originally, the building contractor failed to remove the debris and replace it with control fill. The existence of sub-surface garbage, liquids, and major debris caused major time delays. Over excavated foundations under canopy support were encountered and some footings were larger than specified on plans causing extra time and work to remove and replace.
