# Helical Piles Support Interior Walls and Structural Slab

Central Decatur School Renovation

Leon, IA

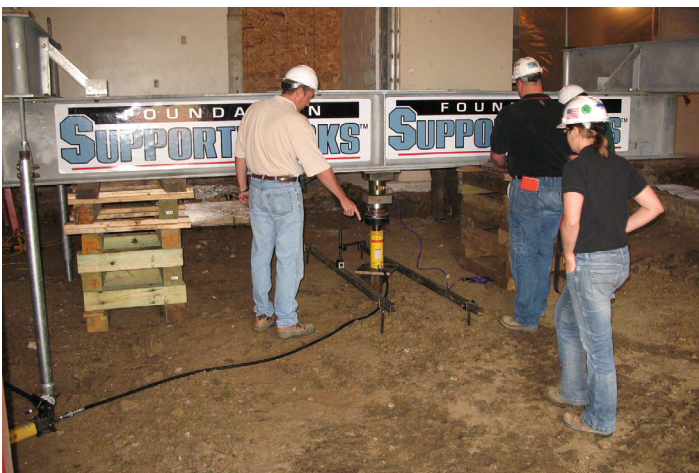
Load test set up prior to installation of production piles

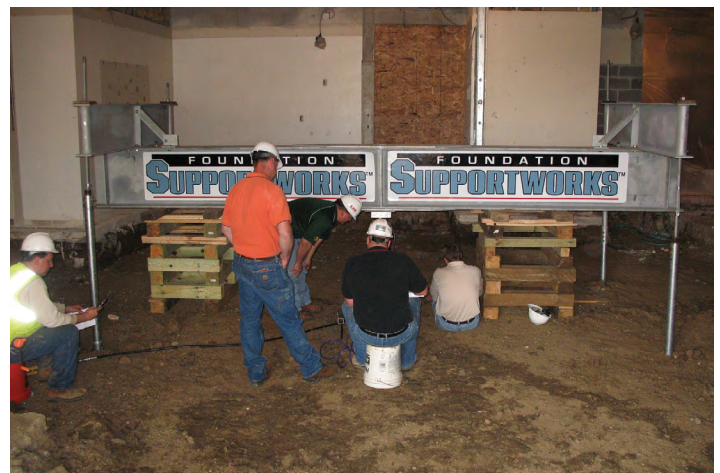
Load test completed and design capacities confirmed

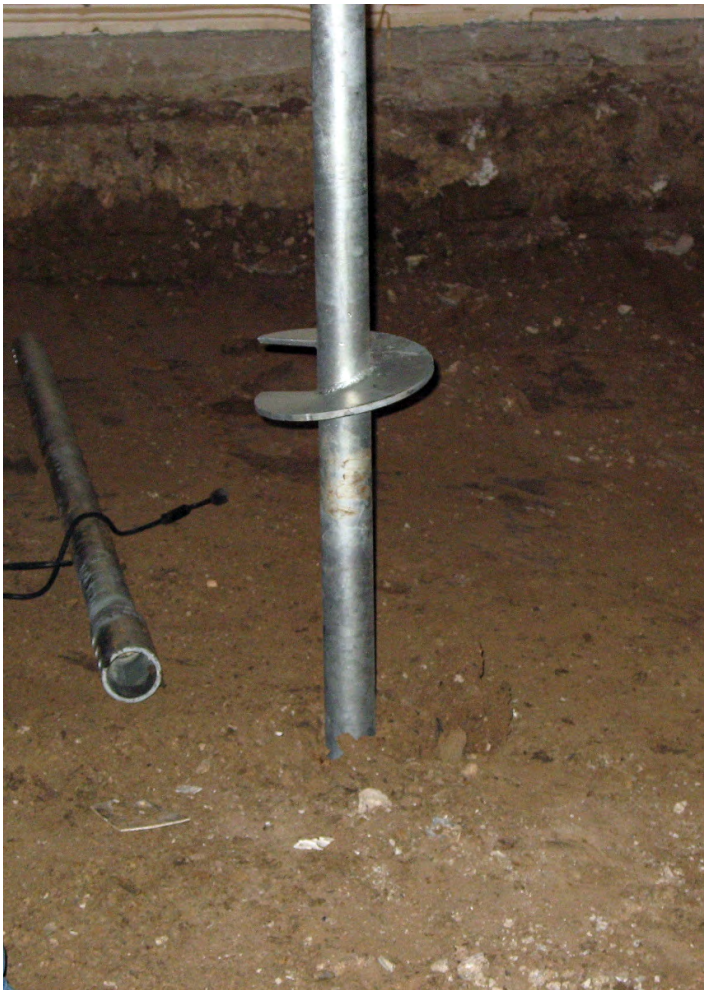
Advancing lead section through hard, dry to damp fill soil

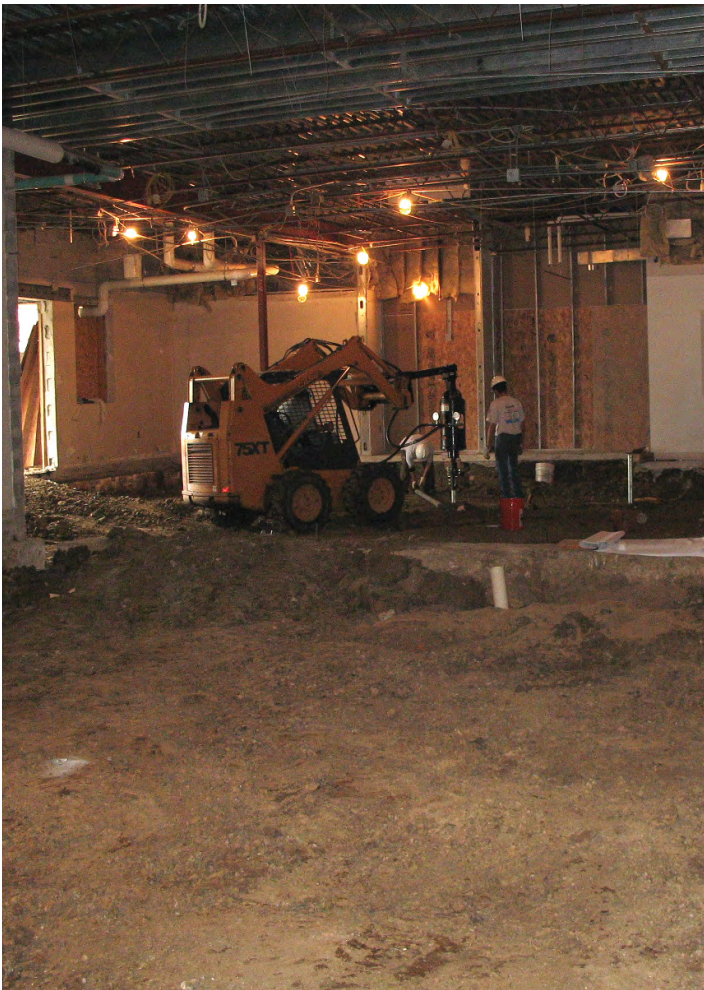
Piles are installed in limited access areas within the building using small construction equipment
