2015 CASE STUDY

Type: Residential | Issue: AL201501

Drilled Concrete Piers Fail, Steel Piles Provide Sure Footing

THREE-STORY PORCH RECOVERY

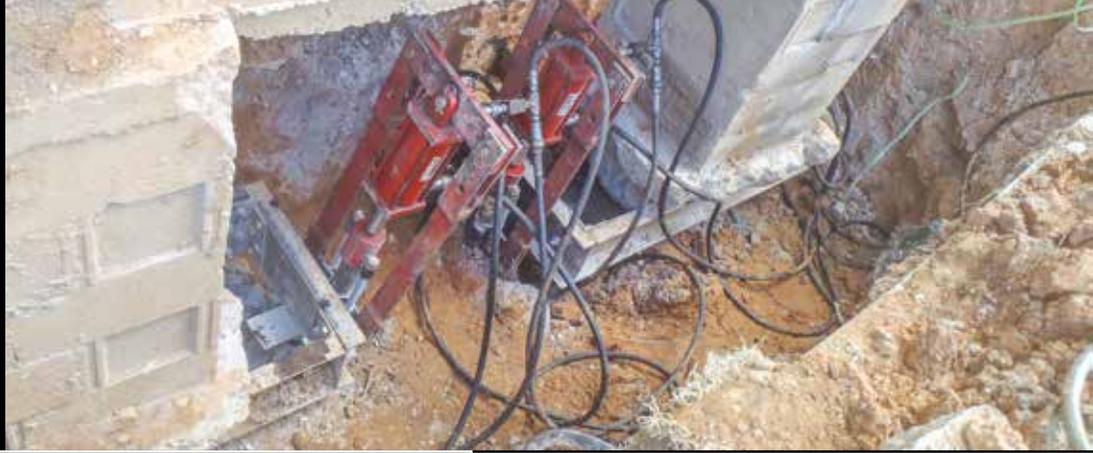
The home was built on imported soil and rested on drilled, concrete piers as structural support for its bearing foundation. While the home itself remained on solid ground, the three-story rear porch was beginning to settle and separate from the main dwelling. Over time, cracks formed in the exterior bricks, and the floor of the upper two stories grew uneven. Engineers and inspectors assumed that the rear porch was built on standard, near-

surface footings rather than drilled concrete pilings as with the rest of the home. This less strong and less stable solution quickly settled, causing visible damage to the rear exterior porch.

The professionals at Alabama Ram Jack designed a new solution while not incurring a substantial increase in cost. Ram Jack engineers designed a steel frame to fit around each of the drilled concrete piers. The three steel frames would be supported by two helical piles each, providing the three-story porch with the structural stability it needs to remain stable and safe while preventing further damage.

After the successful installation of the steel frames and helical piles, the drilled concrete piers were cut so the structure would be entirely supported by the new steel frames and piles. The structure was lifted 1 in. to achieve maximum practical recovery.
