# CASESTUDY

9 UNIT HILLSIDE CONDO  
COMPLEX NEEDS FOUNDATION  
STABILIZATION

# CONDOS OVERLOOKING SAN CLEMENTE COAST STABILIZED W/ HELICAL PILES AND TIEBACKS

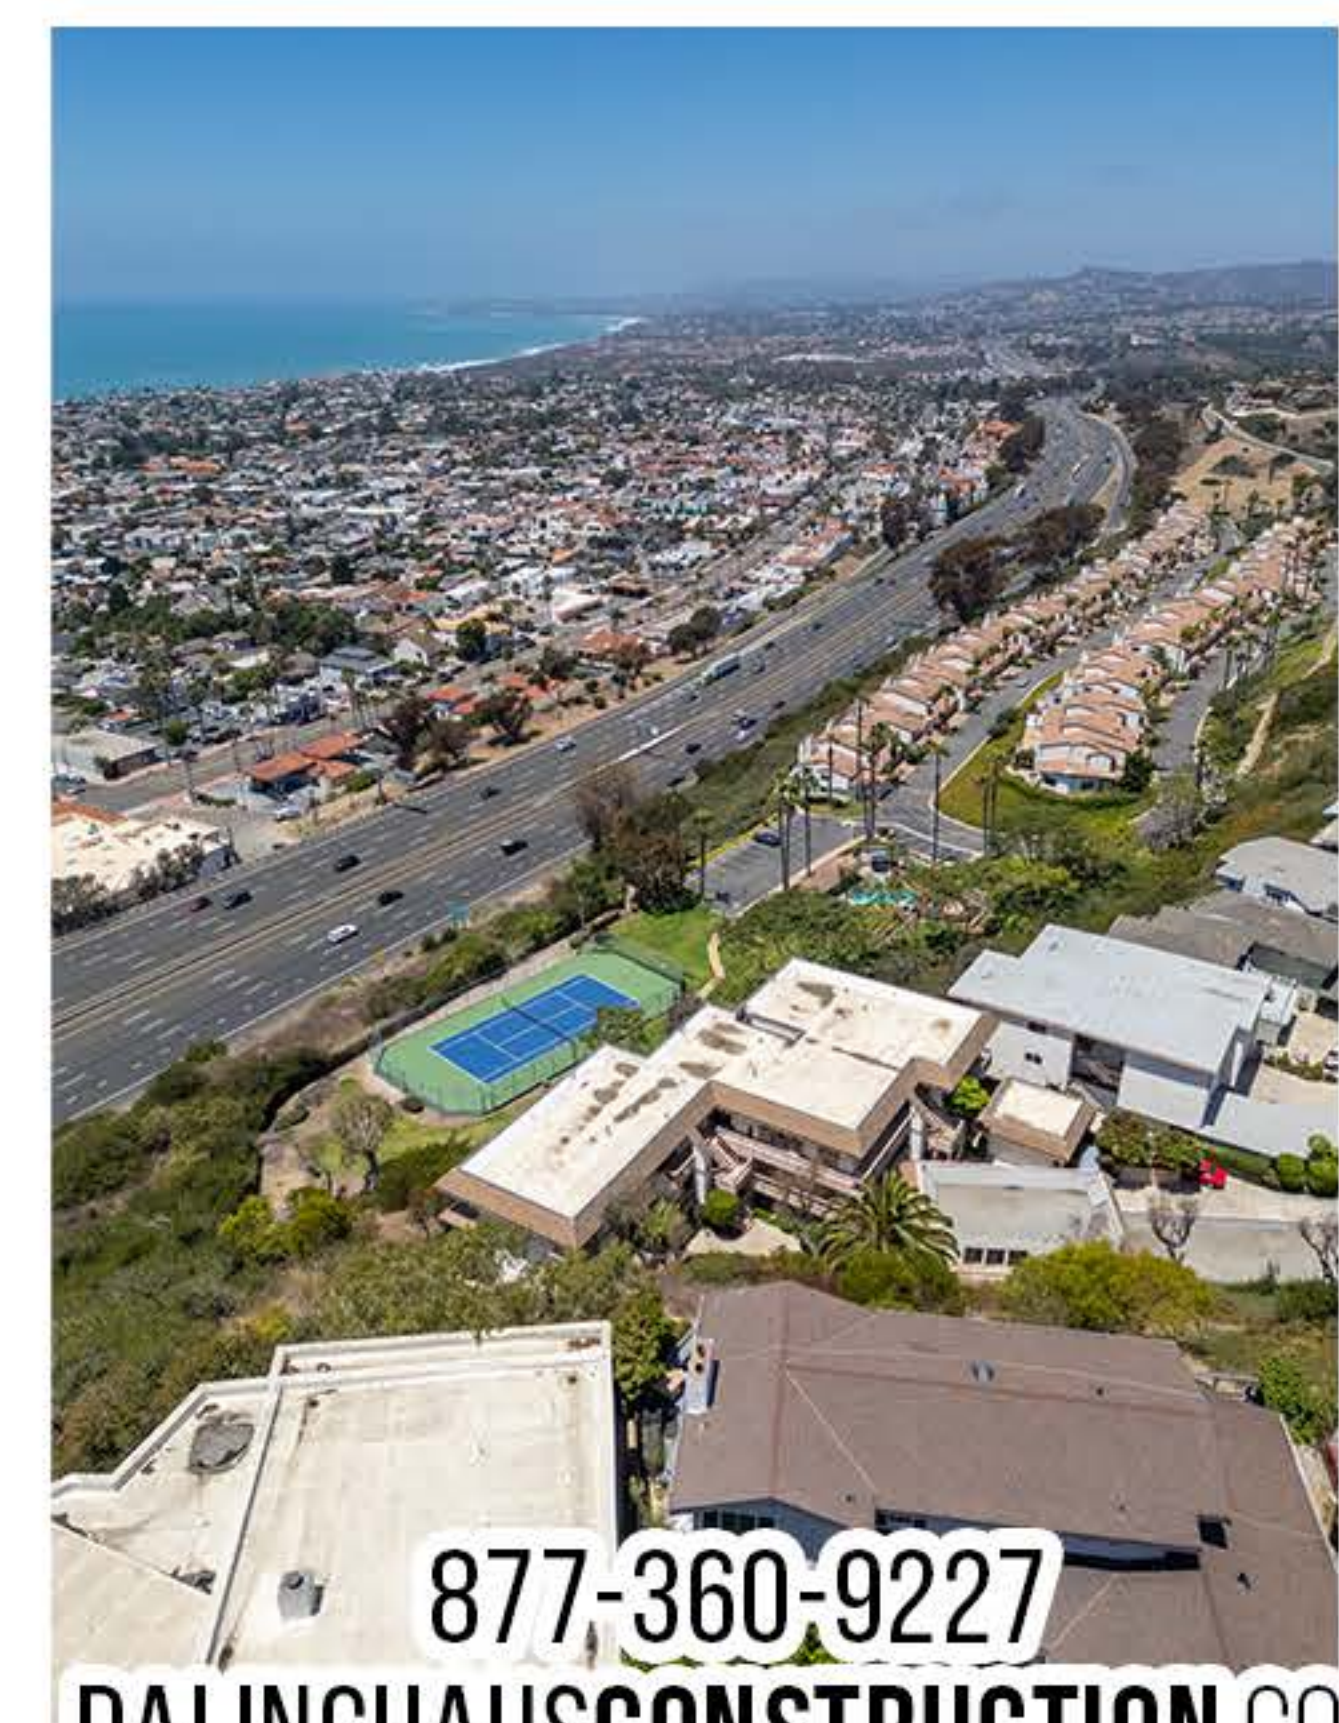
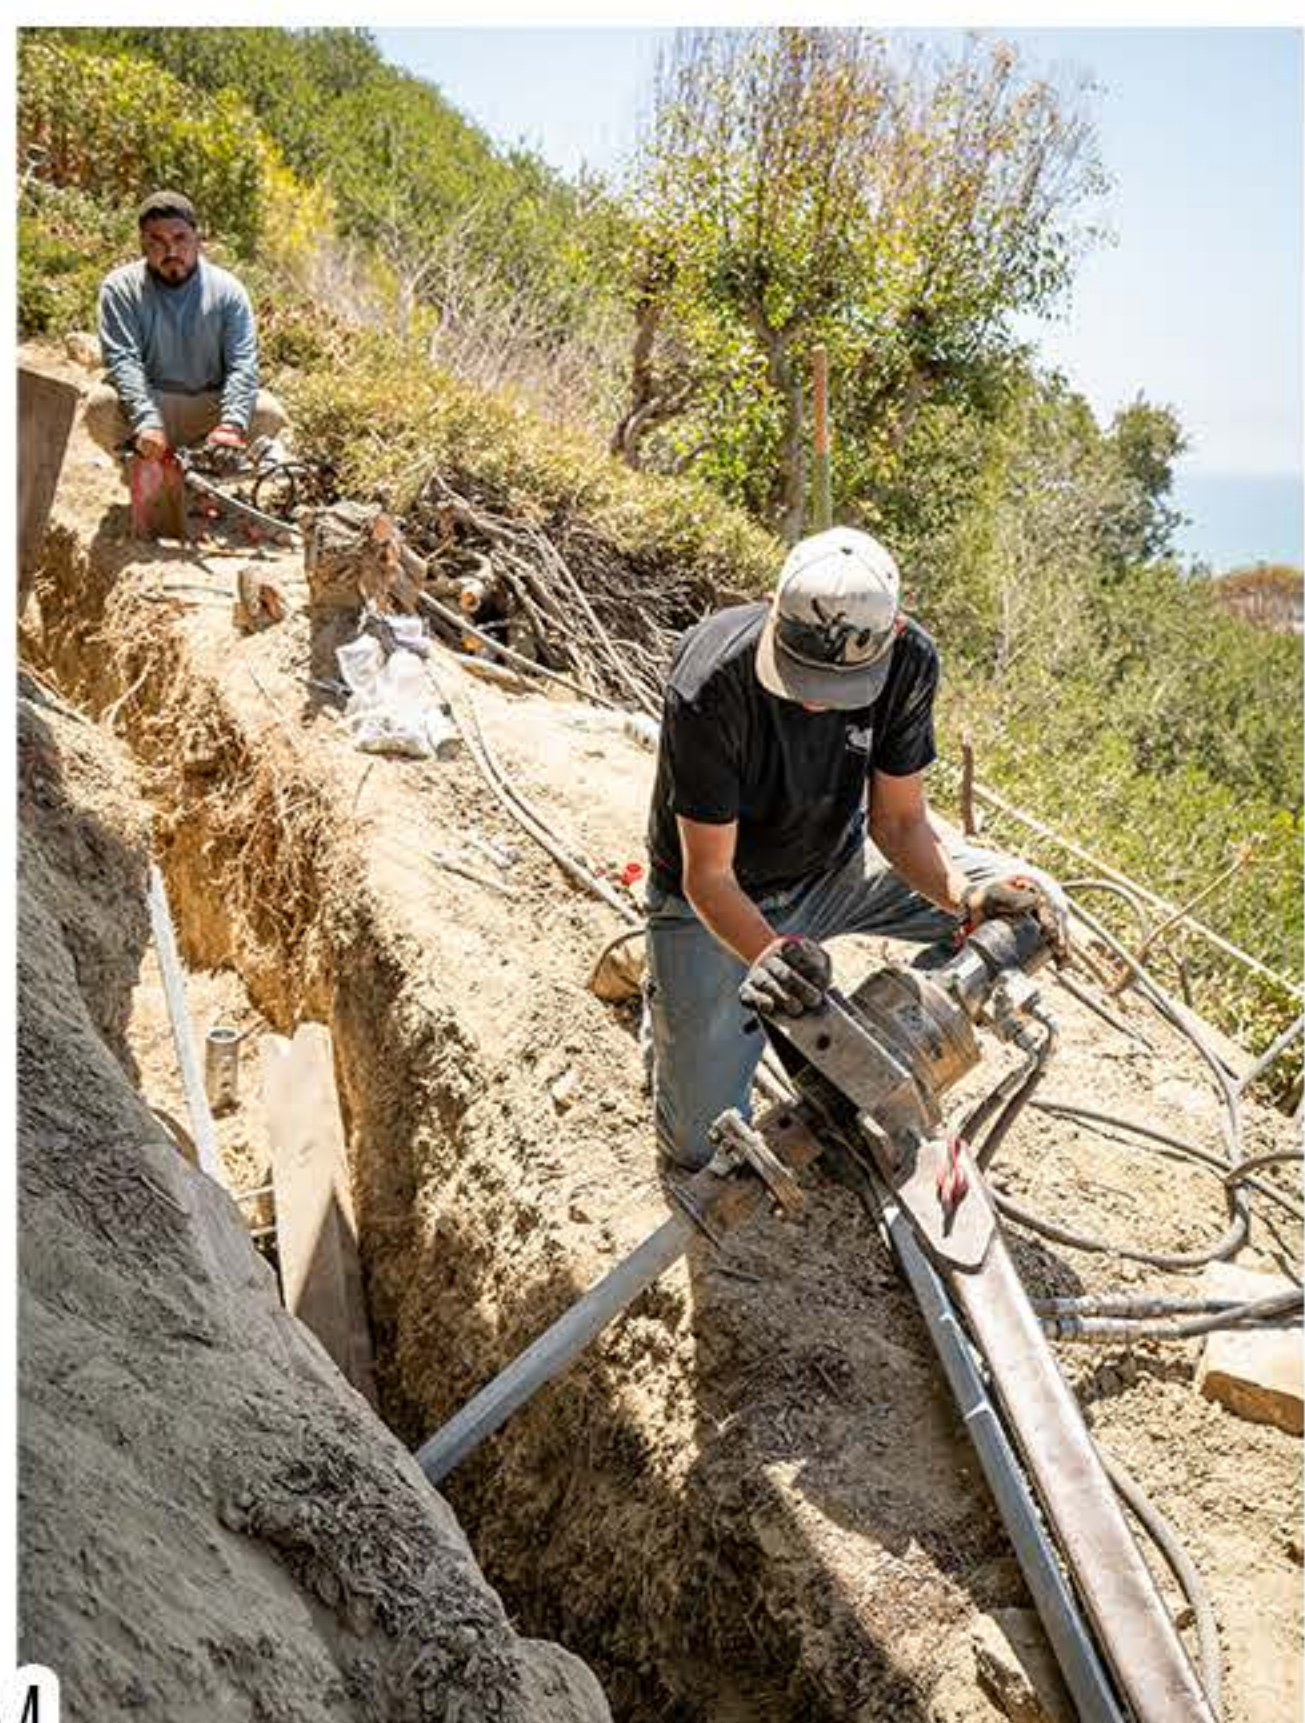
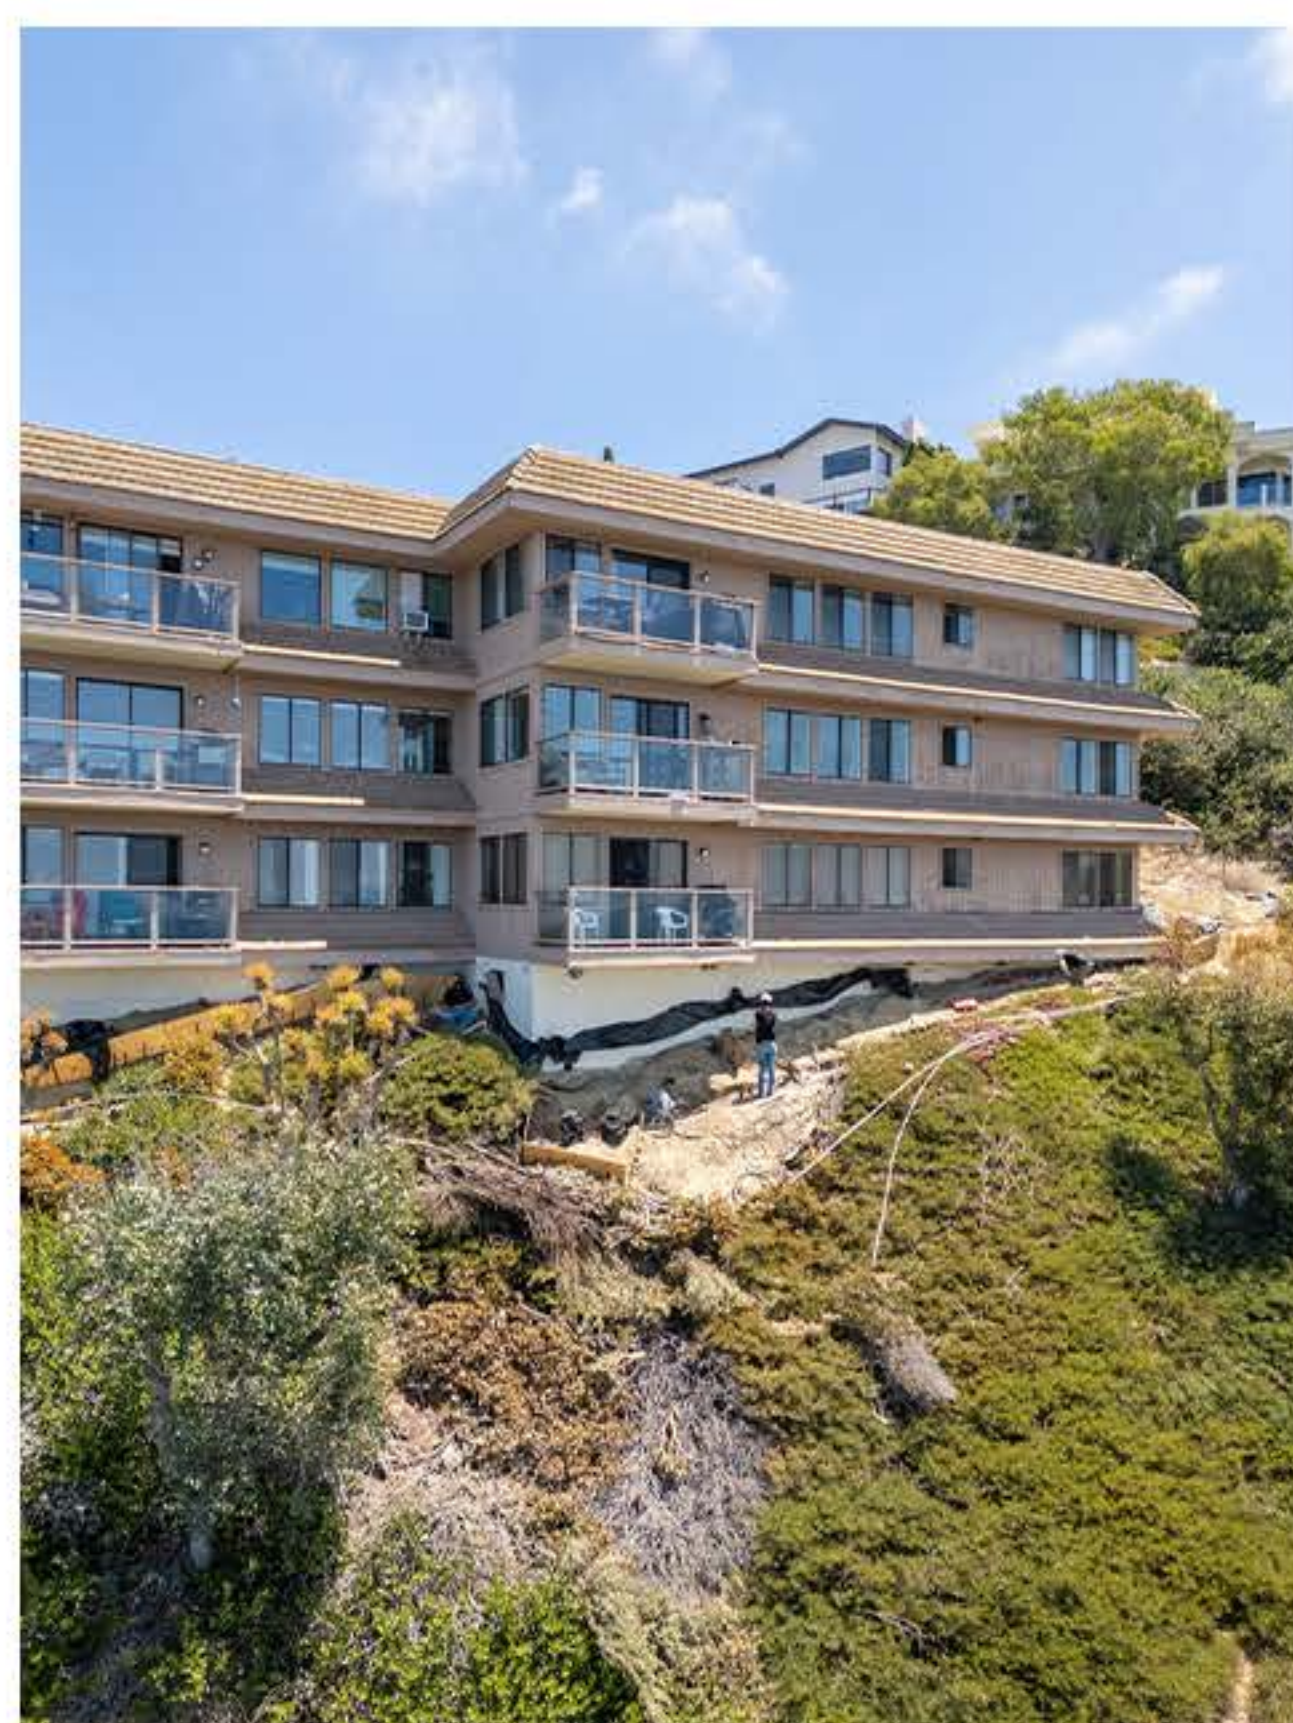
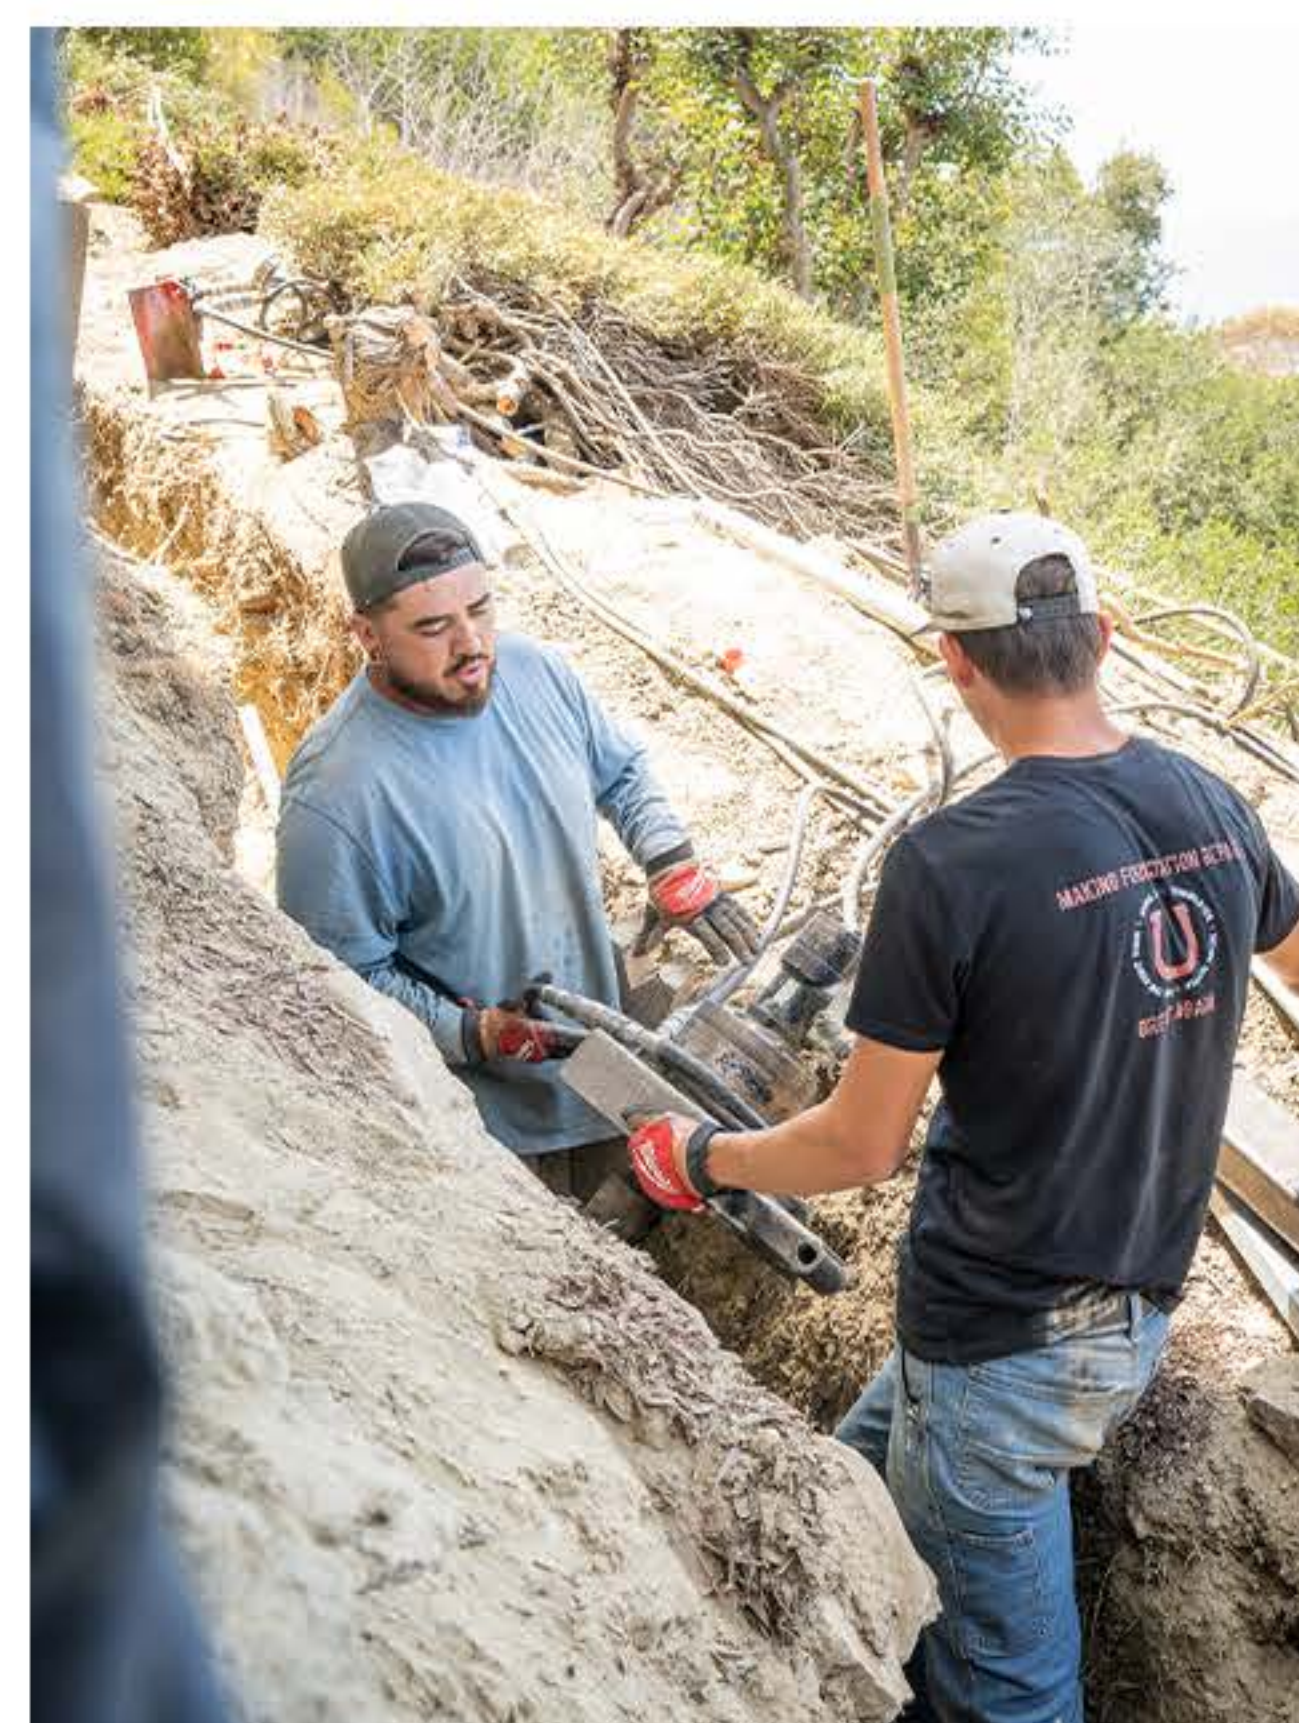
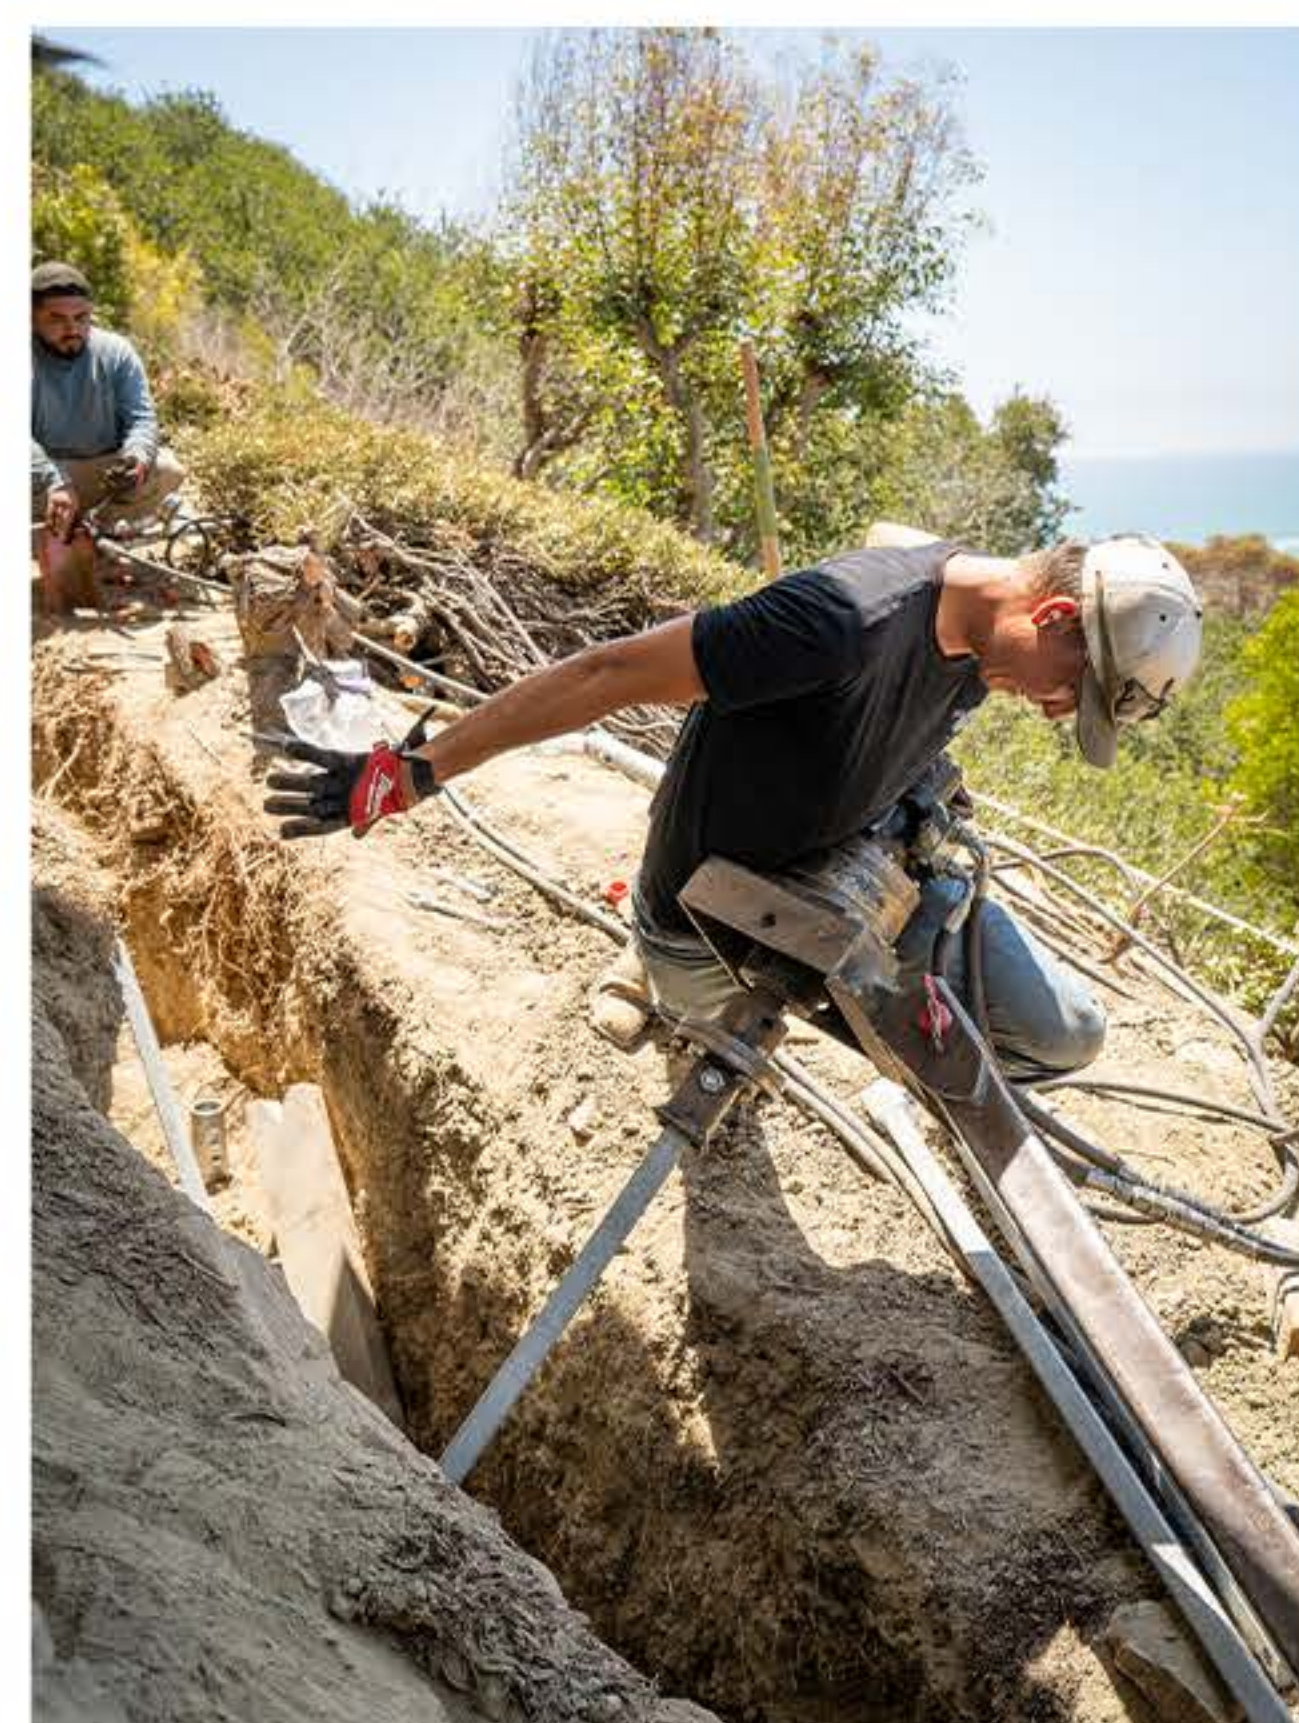
Ryan and his crew made quick work of the helical pile installations using their handheld equipment due to access on the slope. On average the helical piles were driven to about 20 feet below grade while the tiebacks found depth at about 26 feet on average. During the lift the crew was able to recover roughly one and a half of the two inches of settlement in the area that had settled.
