8 HELICAL PILES AND 3 HELICAL TIEBACK ANCHORS STABILIZE CA MOUNTAIN HOME FIND MORE CASE STUDIES AT: DALINGHAUSCONSTRUCTION.COM

SETTLING FOUNDATION FOUND ON HOME DURING ESCROW, STABILIZED WITH HELICAL PILES

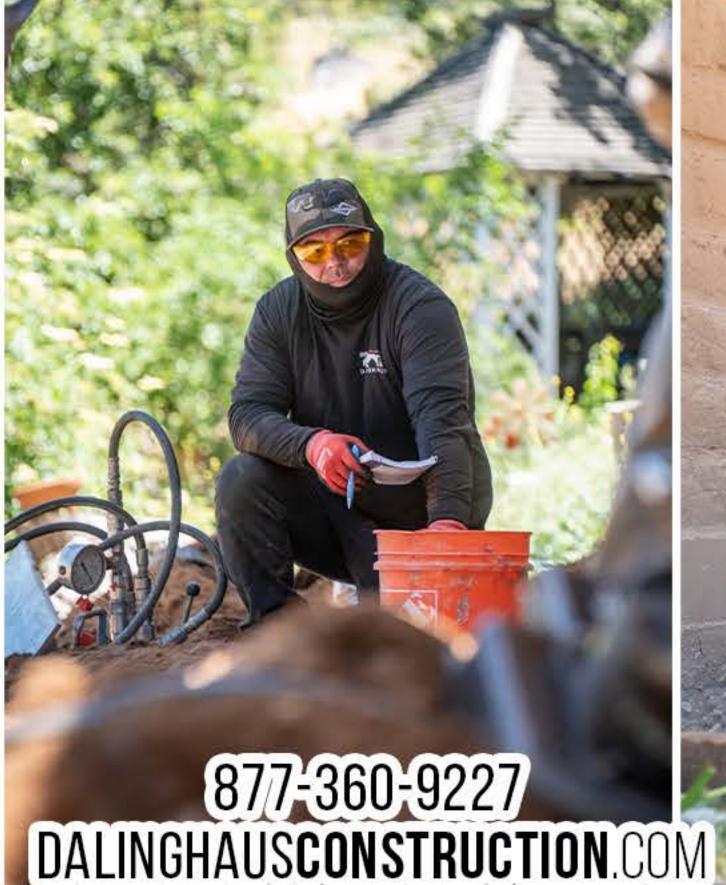
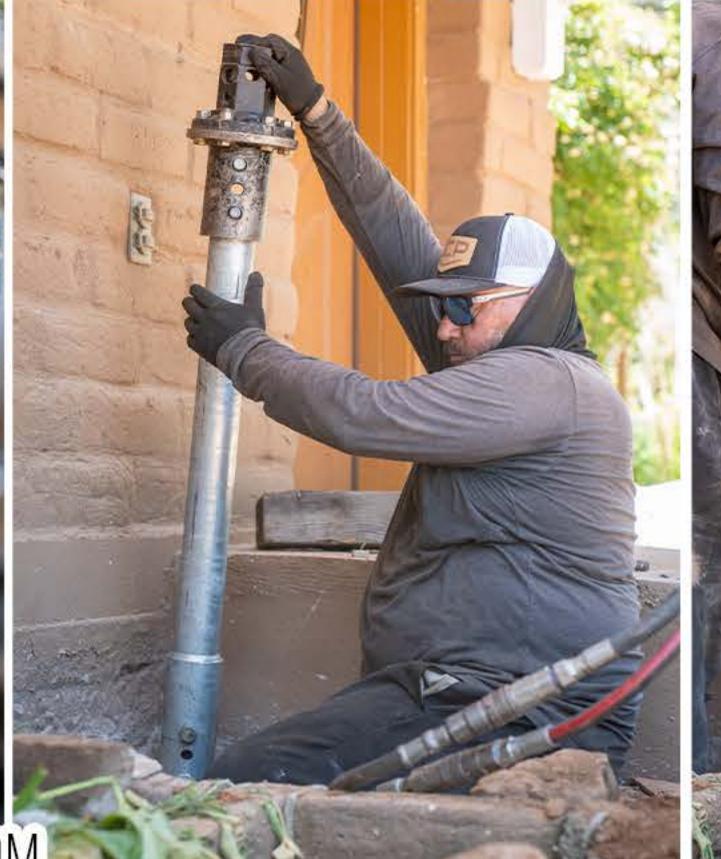
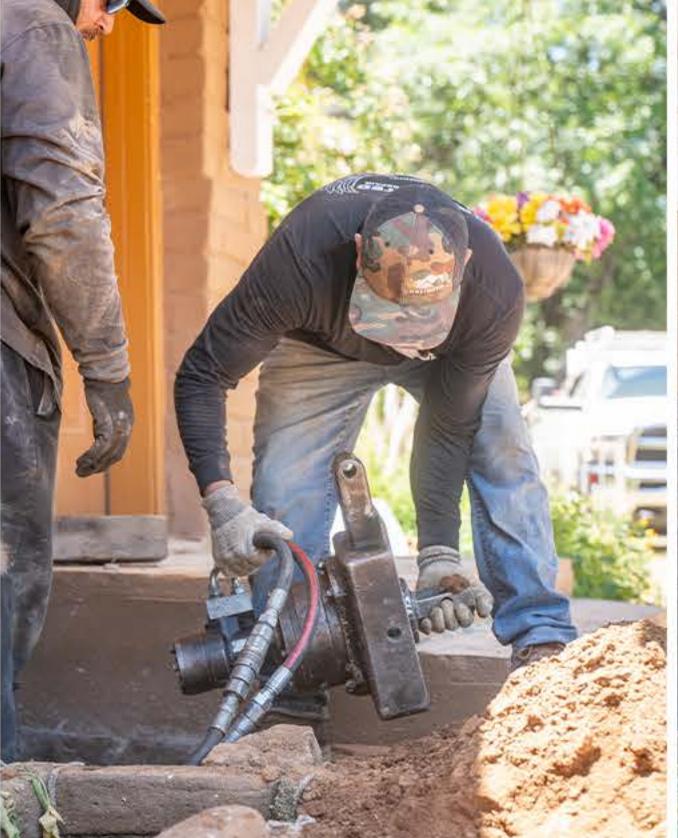
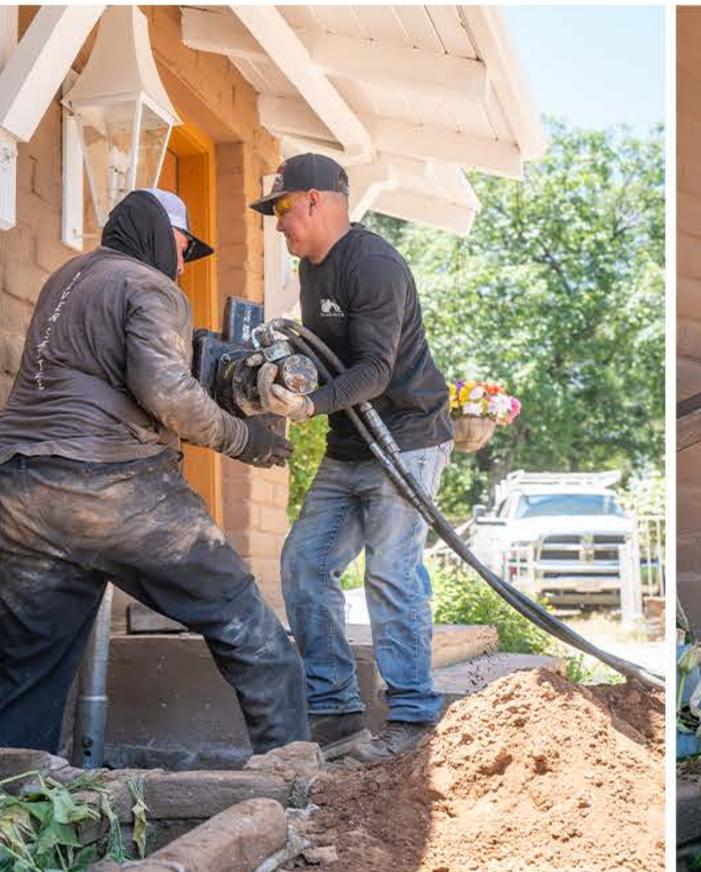
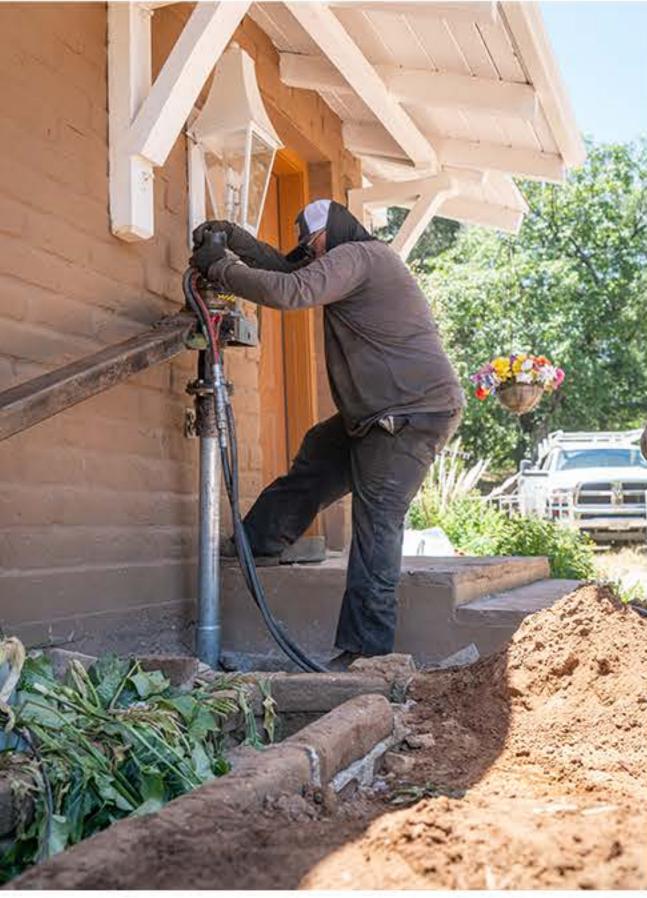
Mark performed the initial inspection and found all the cracks that were noted in the general inspection report. After drawing a scaled diagram of the home Mark used his Ziplevel altimeter to take floor elevation measurements. He measured varied degrees of settlement throughout the house, but the corner of the home where the second story was located measured the worst at 1.2 inches in relative change in a very short distance. He also found several slab cracks.

The repair plan would consist of 8 vertical helical piles and 3 tieback anchors to stabilize the home and prevent continued settlement in the future as well as address lateral movement concerns down the hillside the home sits on. The project foreman, Joe, and his crew made quick work of the project and performed all of the excavations and installations by hand. After the helicals piles were completed the addressed the slab cracks with carbon fiber staples.
