# CASESTUDY JUNE 2023

# HELICAL PILES STABILIZE SETTLING HOME IN LA HABRA THAT MEASURED OVER 10 INCHES OF SETTLEMENT

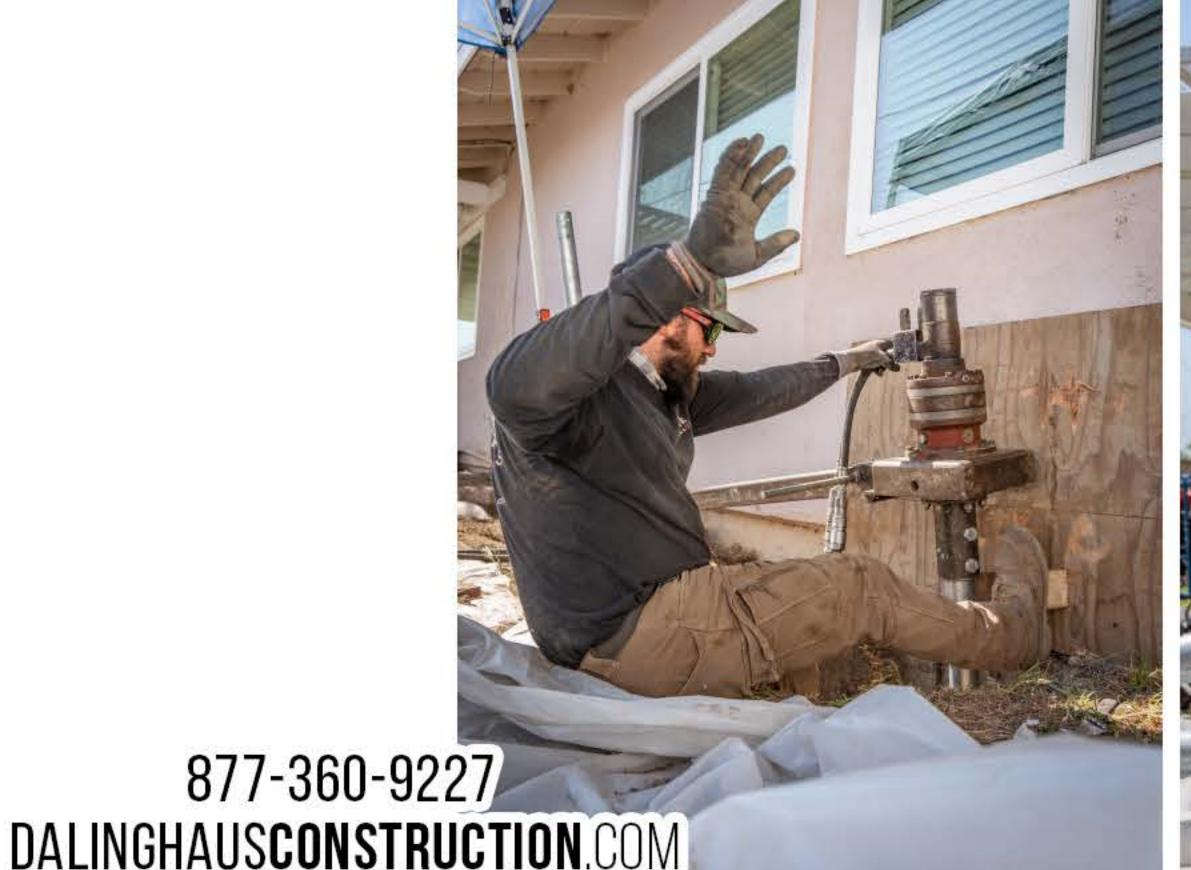
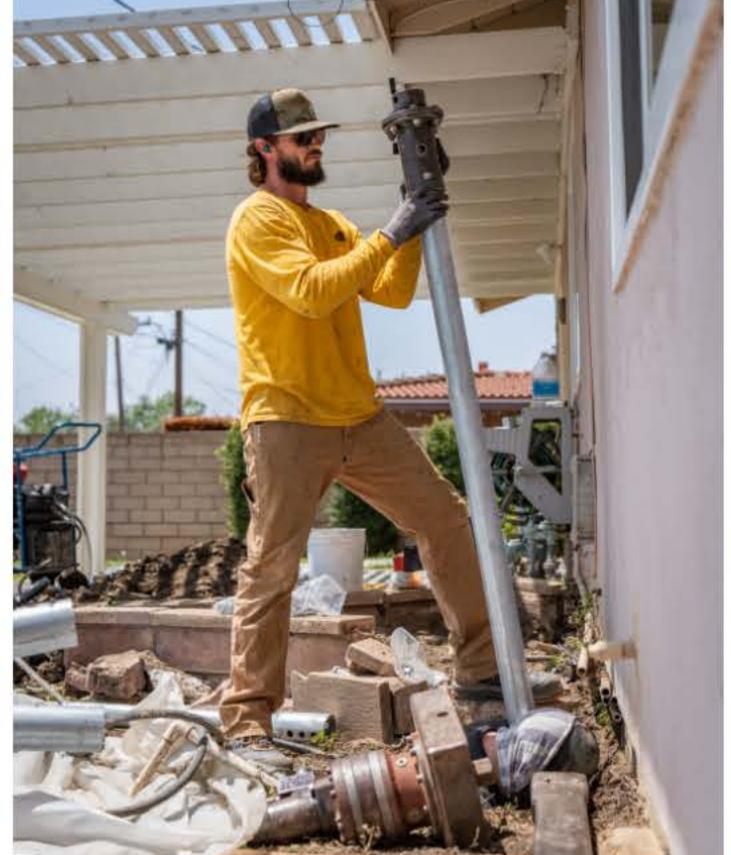
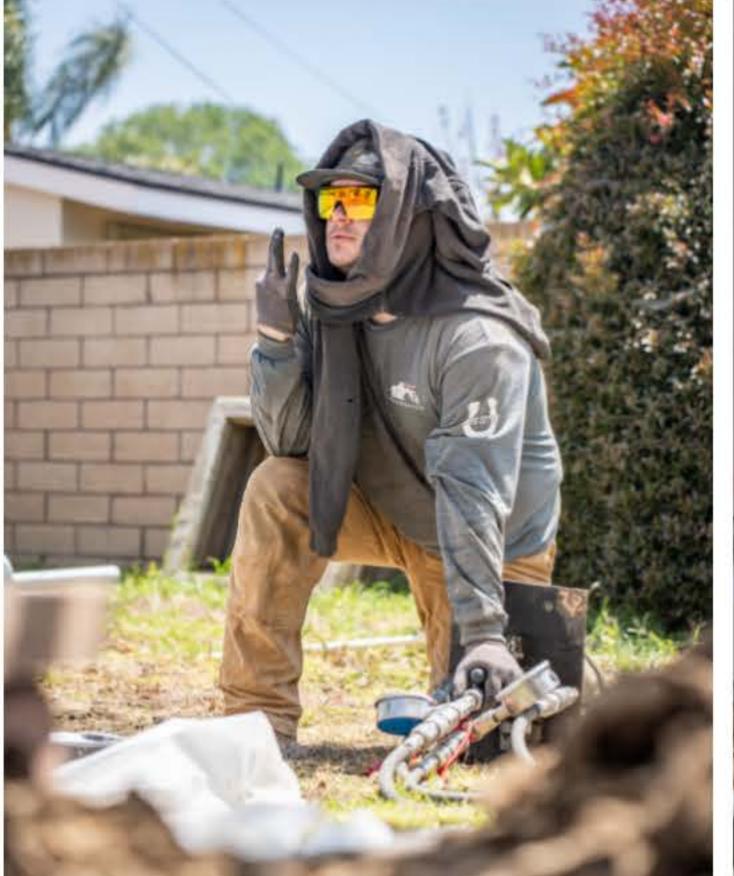
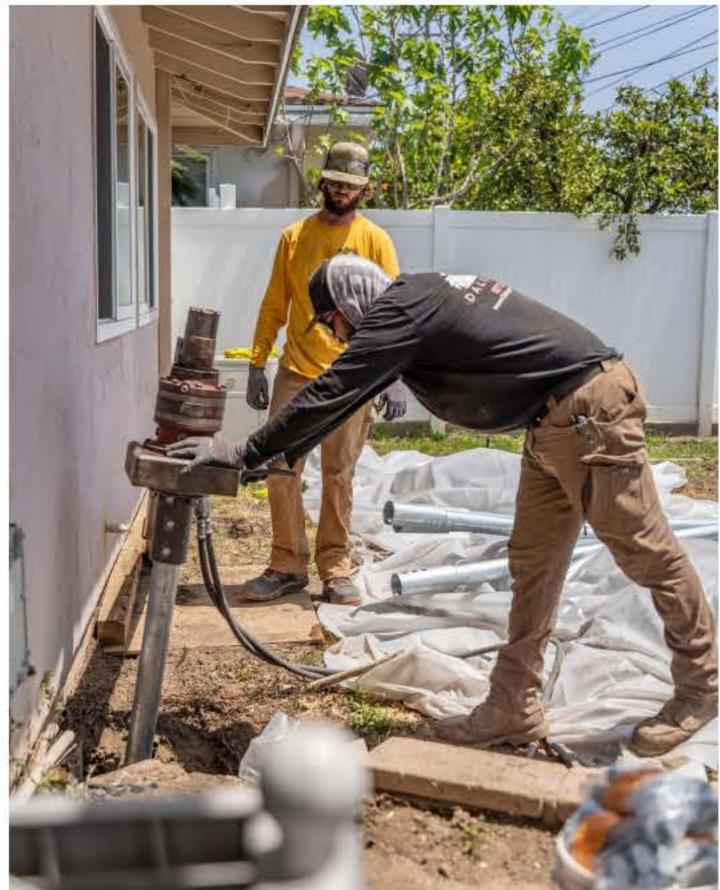
With limited access around the home the crew excavated pier locations, prepped footings, and began installing helical piles with hand equipment. The first pile found competent, load-bearing soils at almost 30 feet and it was pretty consistent for the remaining helical piles. After all of the piles were installed the crew cut and capped each pile and secured them to the home's footing. They were then able to lift the home and recover about 8 inches of the settlement.
