CASESTUDY

3 HELICAL PILES TO
STABILIZES SETTLING
SAN CLEMENTE, CA
HILLSIDE HOME

SETTLING TOWNHOUSE FOUNDATION STABILIZED WITH HELICAL PILES

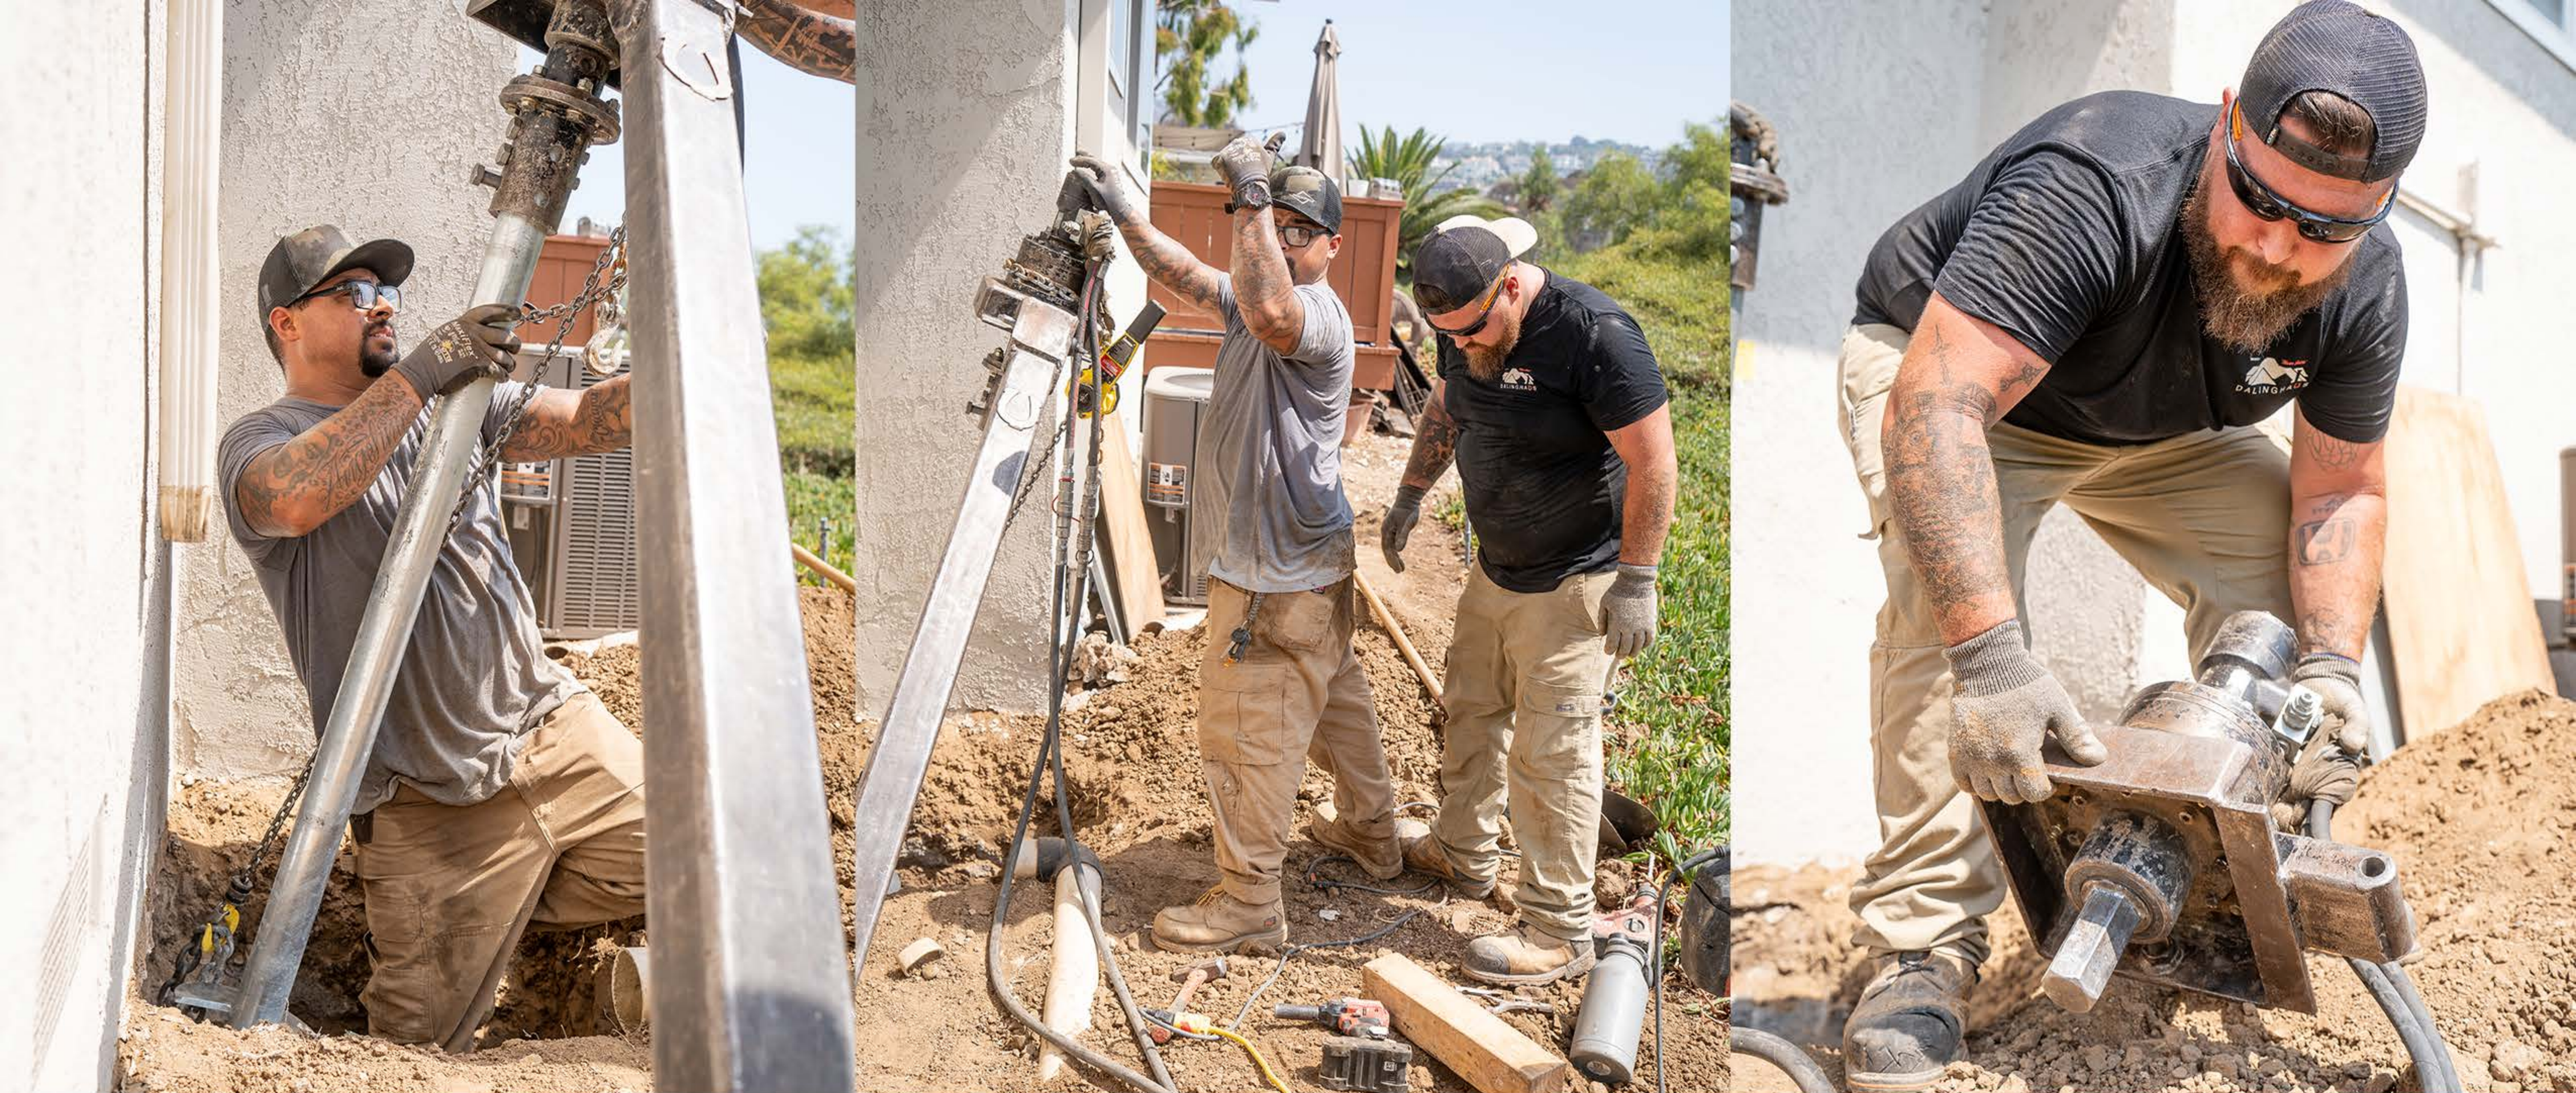
A San Clemente homeowner called our team out for a second time after noticing several cracks on the backside of there both on the inside and outside. A few years prior our team made some crawlspace repairs to the front side of the home by installing several new girder beams as well as smart jacks to provide support to the home's foundation. The home seemed to be in good health otherwise, but at some point in time the drainage and irrigation systems had changed on the backside of the home located near a pretty big slope. This led to about an inch and a half of settlement in that area.

Phil Laney helped design the original repair plan so it only made sense to send him back out to reinspect the property to figure out what was going on. Much to his surprise he measured some settlement on the back side of the home and took a look at the backyard, or lack thereof. He designed a small repair plan consisting of 3 helical piles to stabilize only the area affected, helping to save the homeowner costs.

Ben, Ben, and Isaac made quick work of the project and were able to get in and out in just a day or two. They found competent, load-bearing soils at depths of about 30 feet below the bottom of the footing. Due to space and access constraints the three helical piles were installed with hand equipment.
