MAR 2023

19 HELICAL PILES & 10 TIEBACKS
STABILIZE AND LIFT HILLSIDE
HOME IN CHINO HILLS, CA

HELICAL PILES & TIEBACKS SAVE RECENTLY PURCHASED HILLSIDE HOME THAT HAD SETTLED & MOVED Laterally

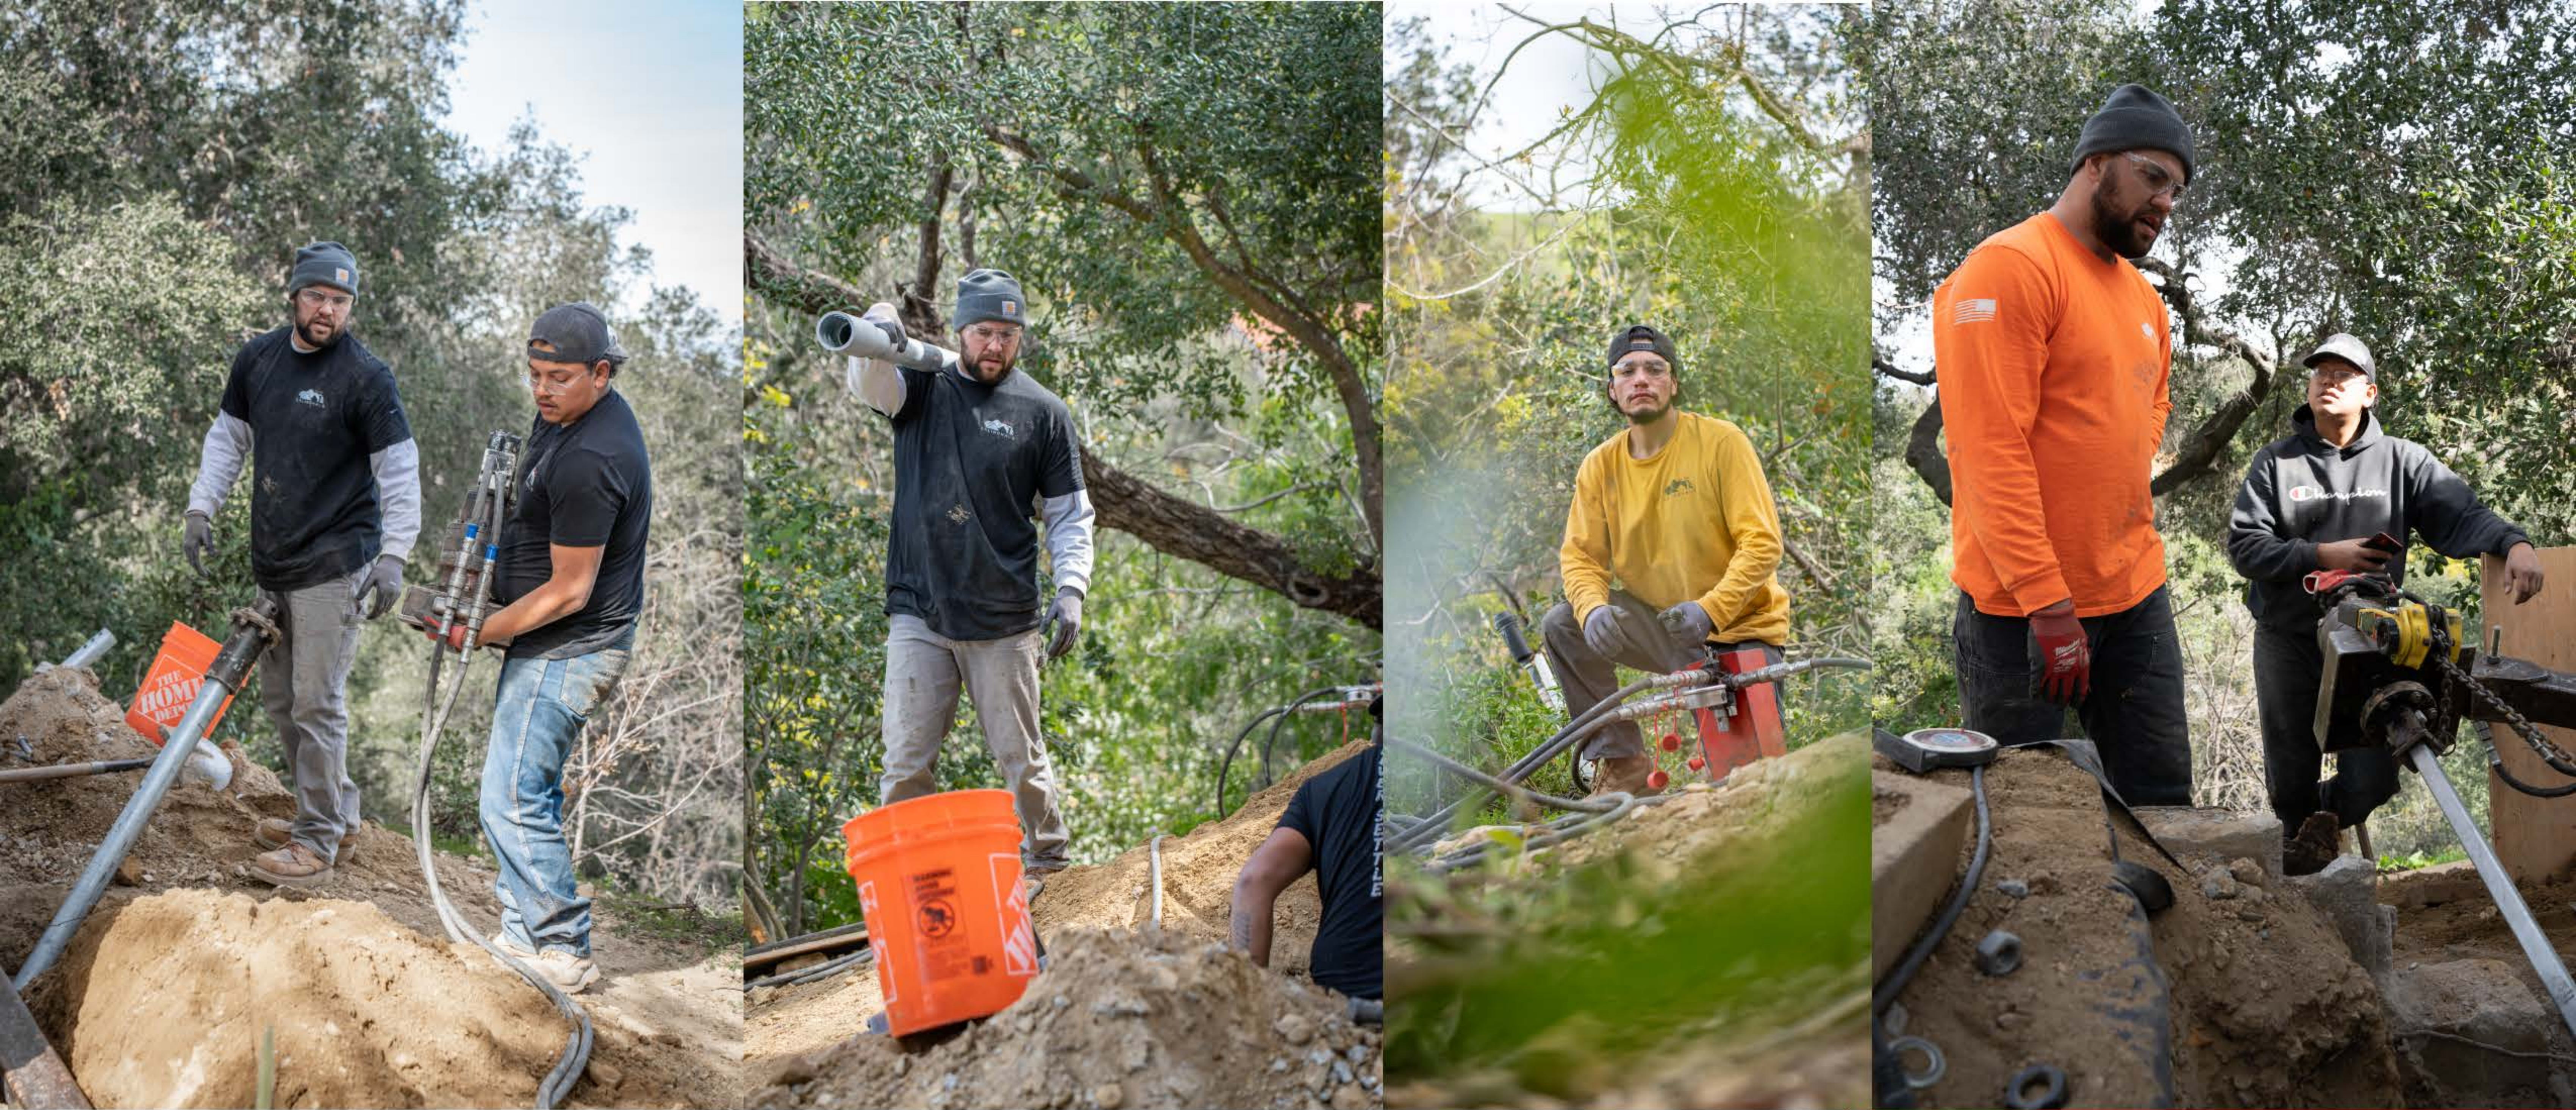
After recently purchasing a beautiful hillside home in a secluded area of Chino Hills, this homeowner was concerned with the cracks appearing through out his home's drywall and stucco. The cracks were especially noticeable along the area of the home that was closed to the hillside. Being an engineer, he understood that some cracking would be natural as the organic materials making up his home would expand and contract... but these cracks, to him, were showing signs that the home was moving towards the slope it sits atop.

After performing his initial evaluation our Inspection Specialist, Tom, found that there was as much as 2.7 inches of settlement along just about the entire back side of the home closest to the slope. During the evaluation he also noticed signs of lateral movement with the deck and backyard pulling away from the home.

Tom worked with Engineering Services & Design of SoCal to design a repair plan consisting of 19 helical piles as well as 10 tiebacks to stabilize the home and attempt to recover some of the settlement that had taken place.

The tiebacks would address lateral movement, while the helical piles would address the settling or downward movement that was measured. Our crew began by installing the helical piles down to competent soils, which were found between 14 and 18 feet beneath the soil's surface. Due to accessibility limitations the crew dug and installed the helicals all with handheld equipment and wrapped up the project in about 6 days!
