EagleLIFT Installs (25) Helical Piles for a Foundation Augmentation & Seismic Upgrade Project for a Structure in El Segundo, CA

Fall 2016

Project Name & Location:	777 Aviation Way Structure - El Segundo, CA
Project Date:	Fall 2016
Project Type:	Helical Pile Foundation to Support New Staircases
Helical Pile Installation Contractor:	EagleLIFT, Inc. , Rancho Cucamonga, CA
General Contractor:	WL Butler , Irvine, CA - www.wbutler.com
Geotechnical Engineer:	Geotechnologies, Inc. - Glendale, CA - www.geoteq.com
Structural Engineer:	Greg Riley, P.E. - Valencia, CA - www.structuralconsulting.com
Helical Piles Specifications:	(25) 2.00" RCS Lead Sections with 8",10",12" Helix Bearing Plates; 4.50" Extension with 14" Helix Bearing Plate; 4.50 Extensions; New Construction Brackets - All Galvanized
Soils & Embedment Depth:	Fill, Sand, Clay; 25' Average Install Depth
Project Timeline:	(7) Days
Helical Pile Manufacturer:	MacLean Power Civil Products Group, Fort Mill, SC

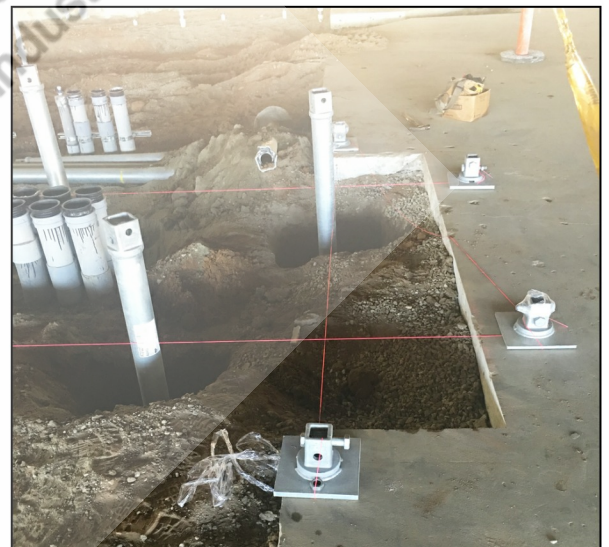
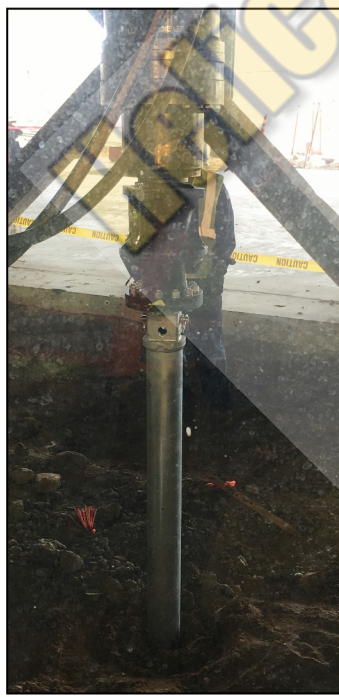
The helical piles consisted of a 2.00" RCS lead section with 8",10",12",14" helix bearing plates. Following the lead section were 4.50" round shaft sections used to reach the 25 ft. average install depth.

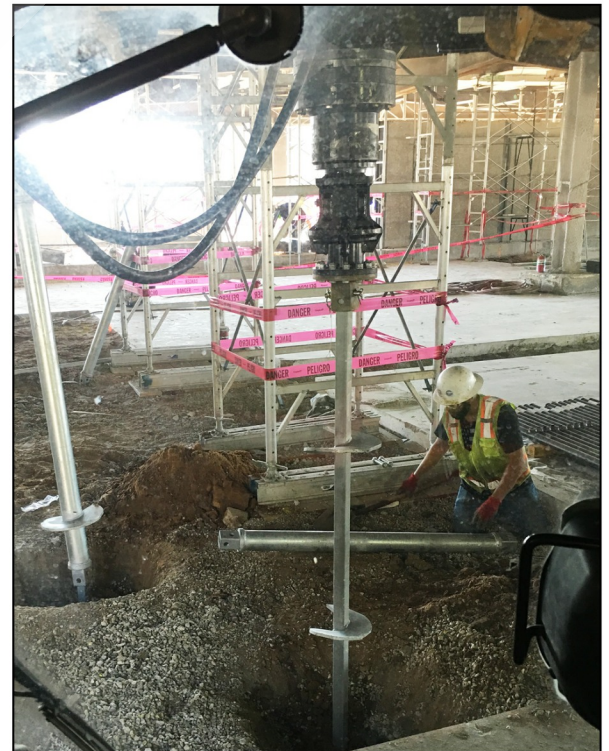
The very low head clearance provided challenges for the crews as did some newly installed underground utilities. An open basement around two of the column pad areas required crews to wear fall protection gear during the installation.

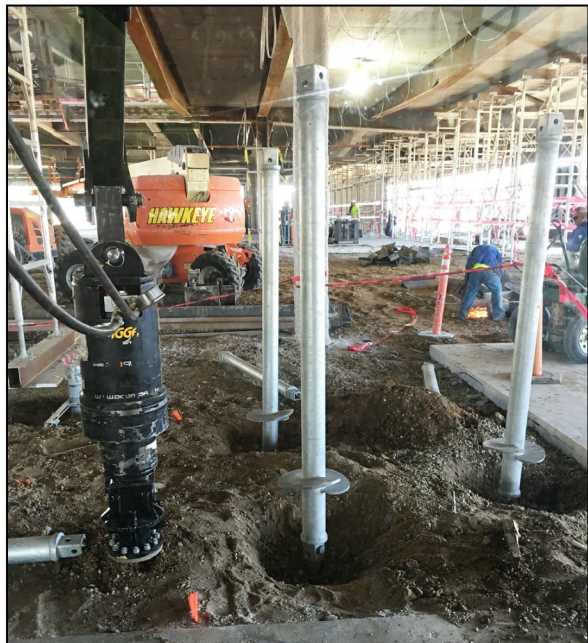
A tension test was successfully completed to 2x the design load of 150 kips. The install work was tedious and time consuming with having to deal with so many variables, but the project was successfully completed in (7) days.
