Installer: Ram Jack Foundation Repair · Jacksonville, FL · 904.380.8488

SITUATION

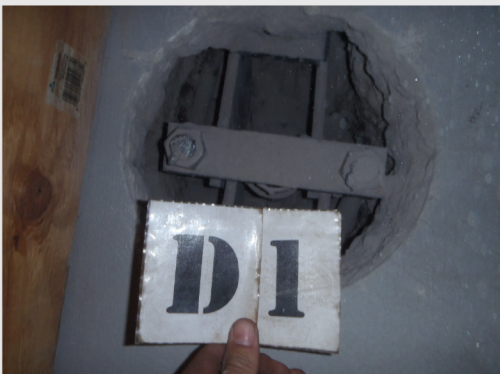
One of the most common signs of foundation failure is doors that will not close, and Corey-Kerlin Funeral Homes and Crematory of Jacksonville, Florida had an especially important door to fix. Ram Jack Foundation Repair was contacted by Corey-Kerlin to resolve severe settling in the crematory cooler at their Northside location. Time was of the essence for a sensitive project such as this one, and Ram Jack has specialty brackets that can lift & support settling slabs like this.
