**ONE HELICAL PILE TO
STABILIZE PATIO OF
PHOENIX HOME**

RECENTLY RENOVATED PHOENIX HOME SHOWS SIGNS OF SETTLEMENT AROUND BACK PATIO

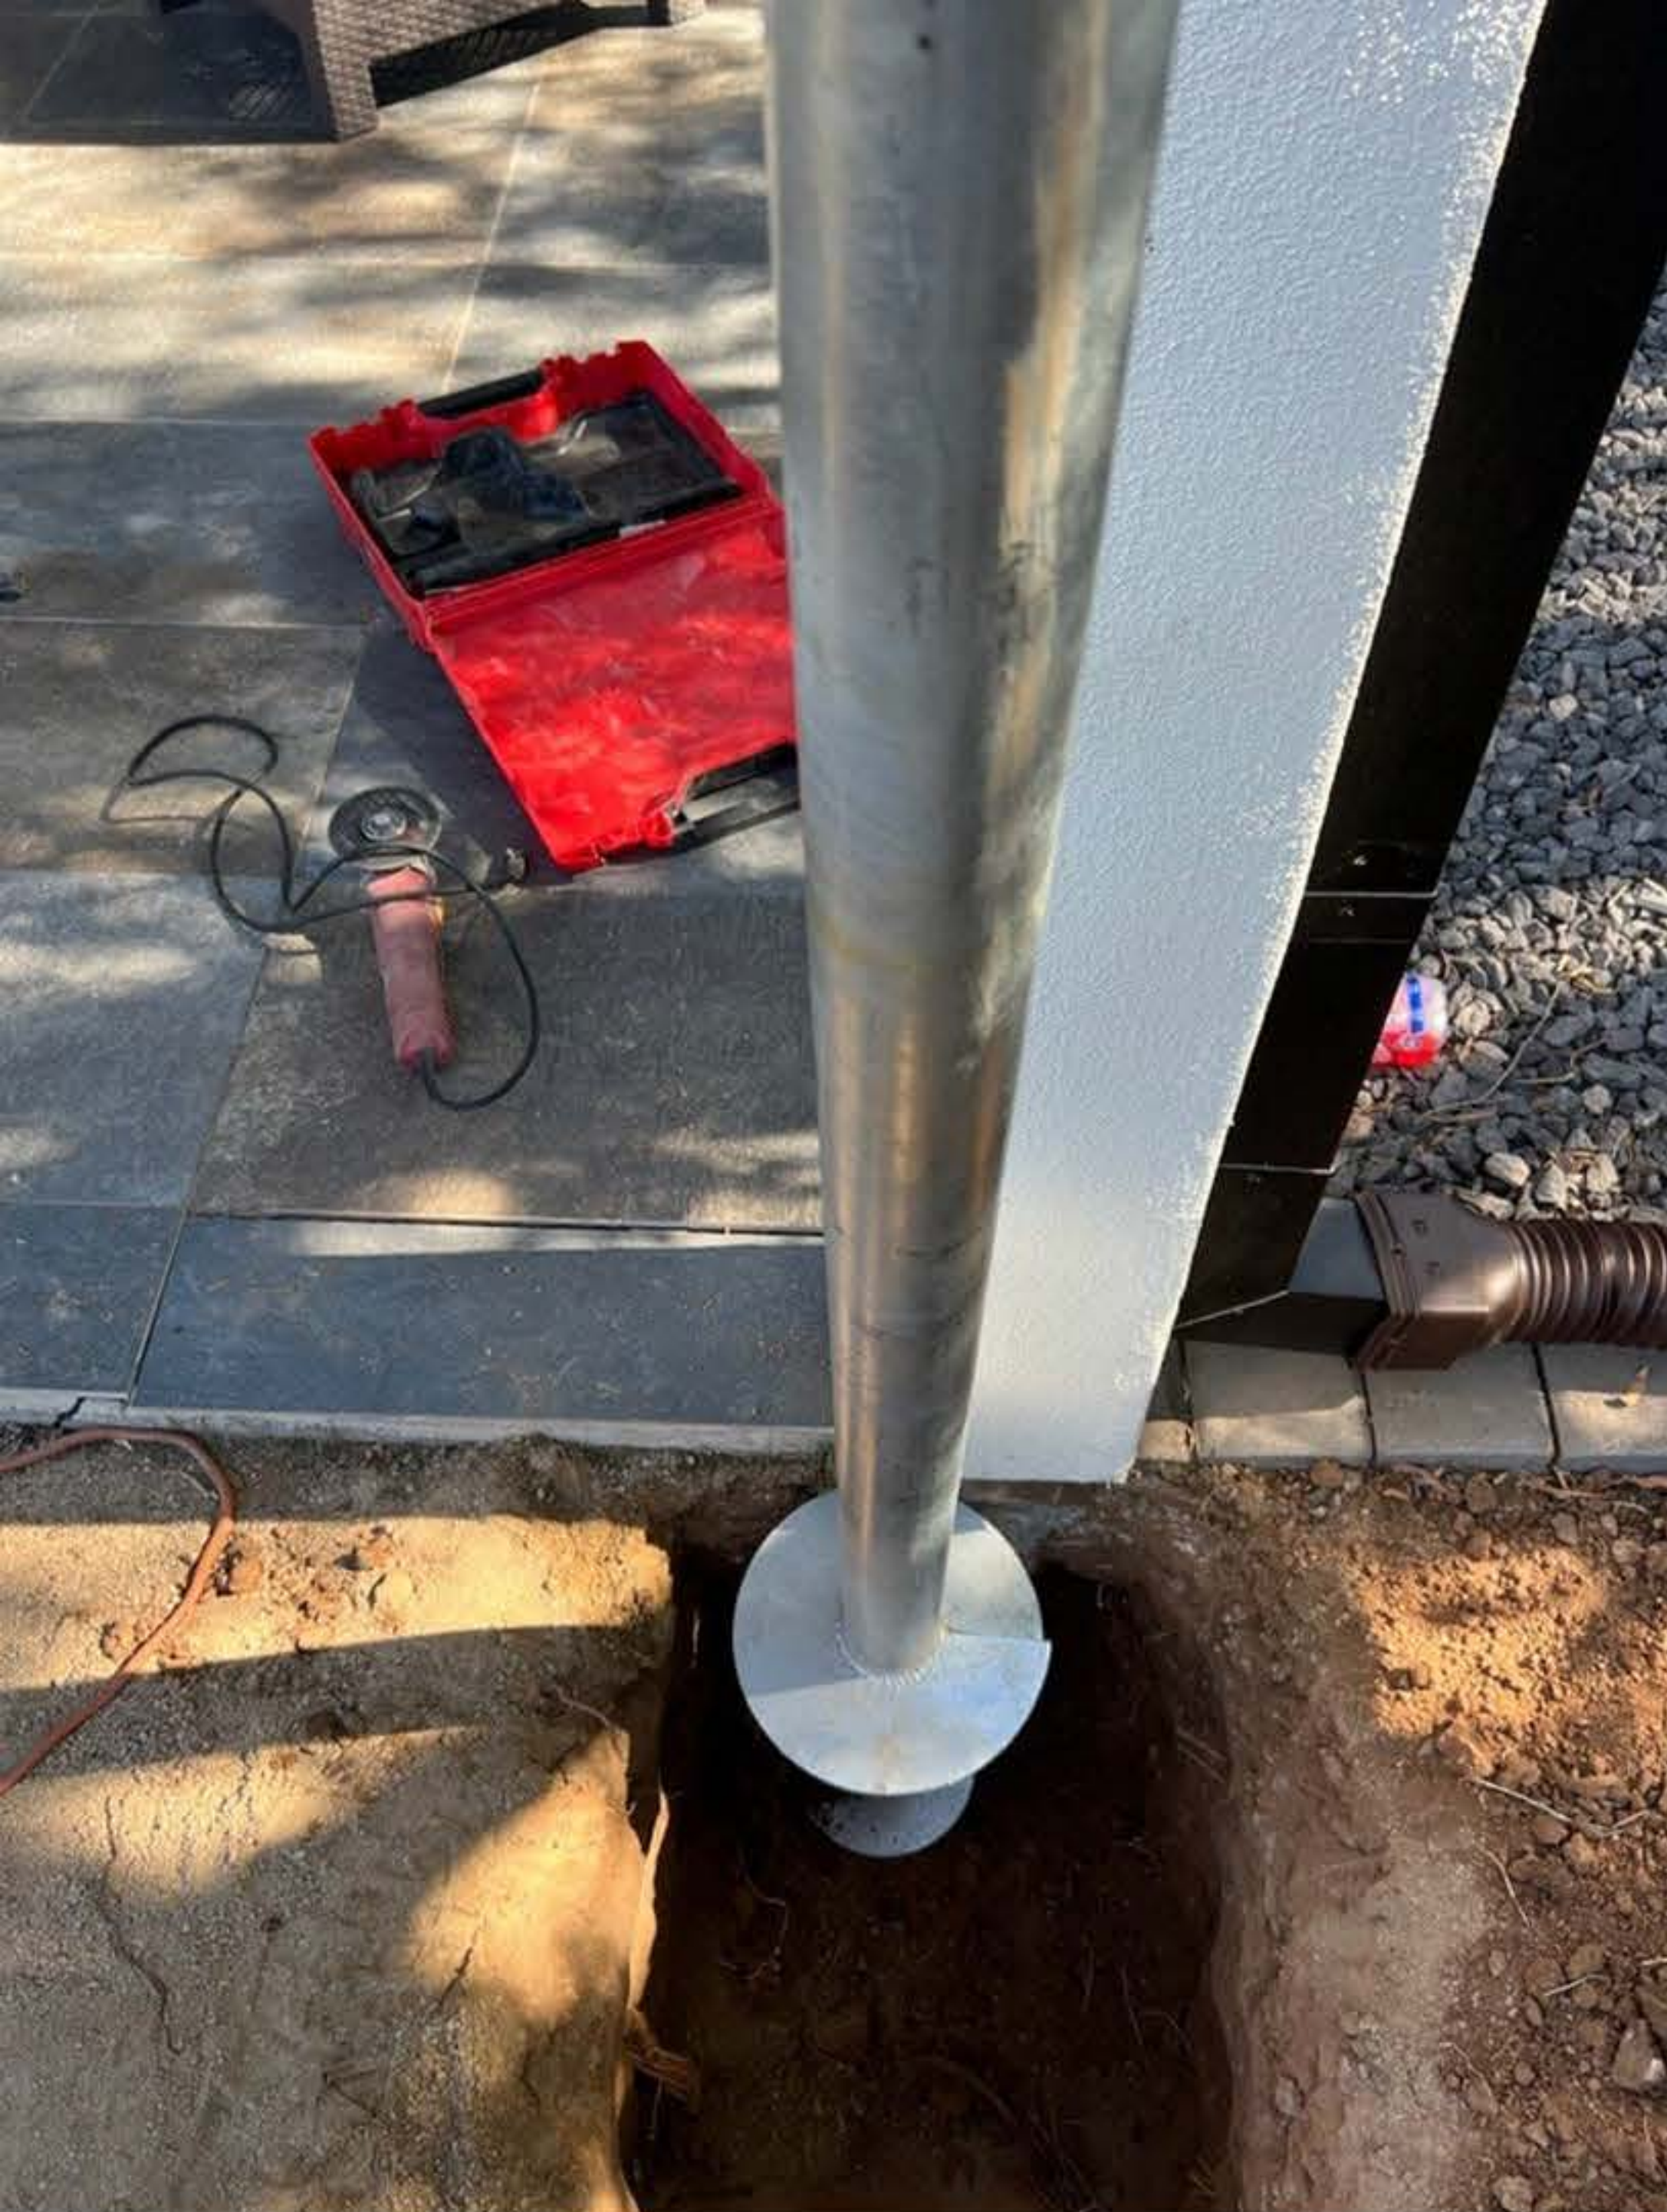
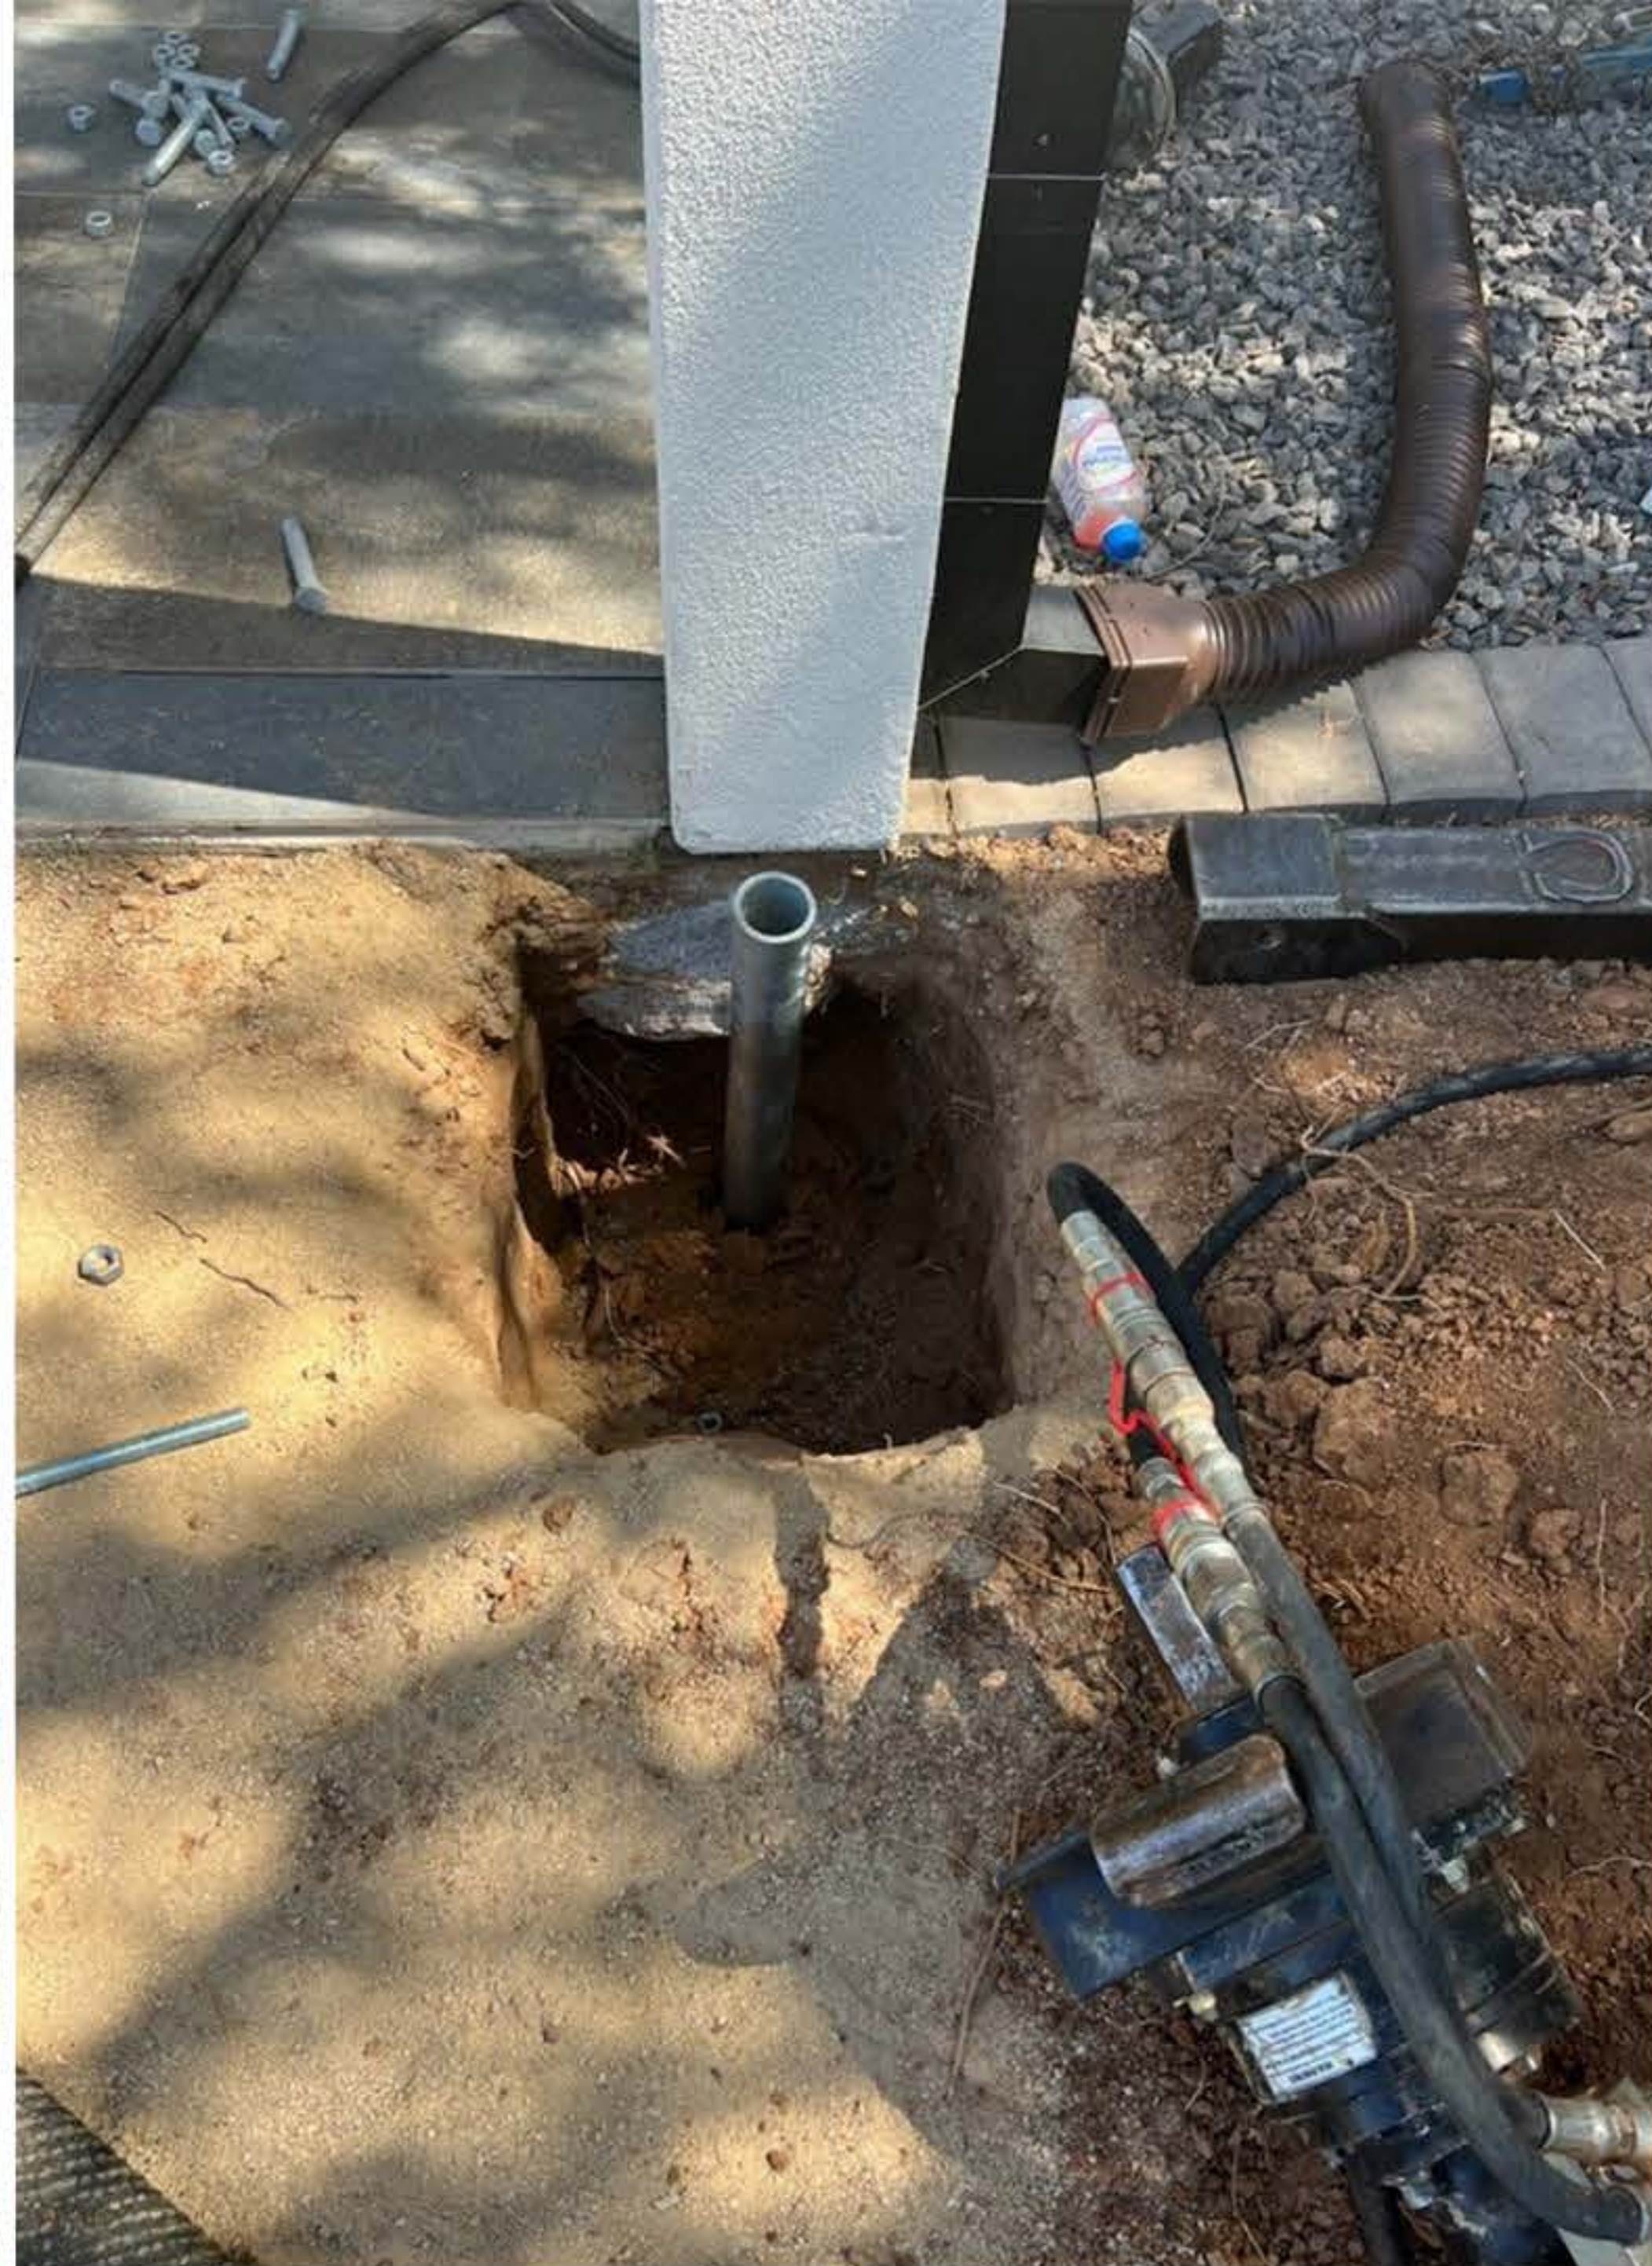
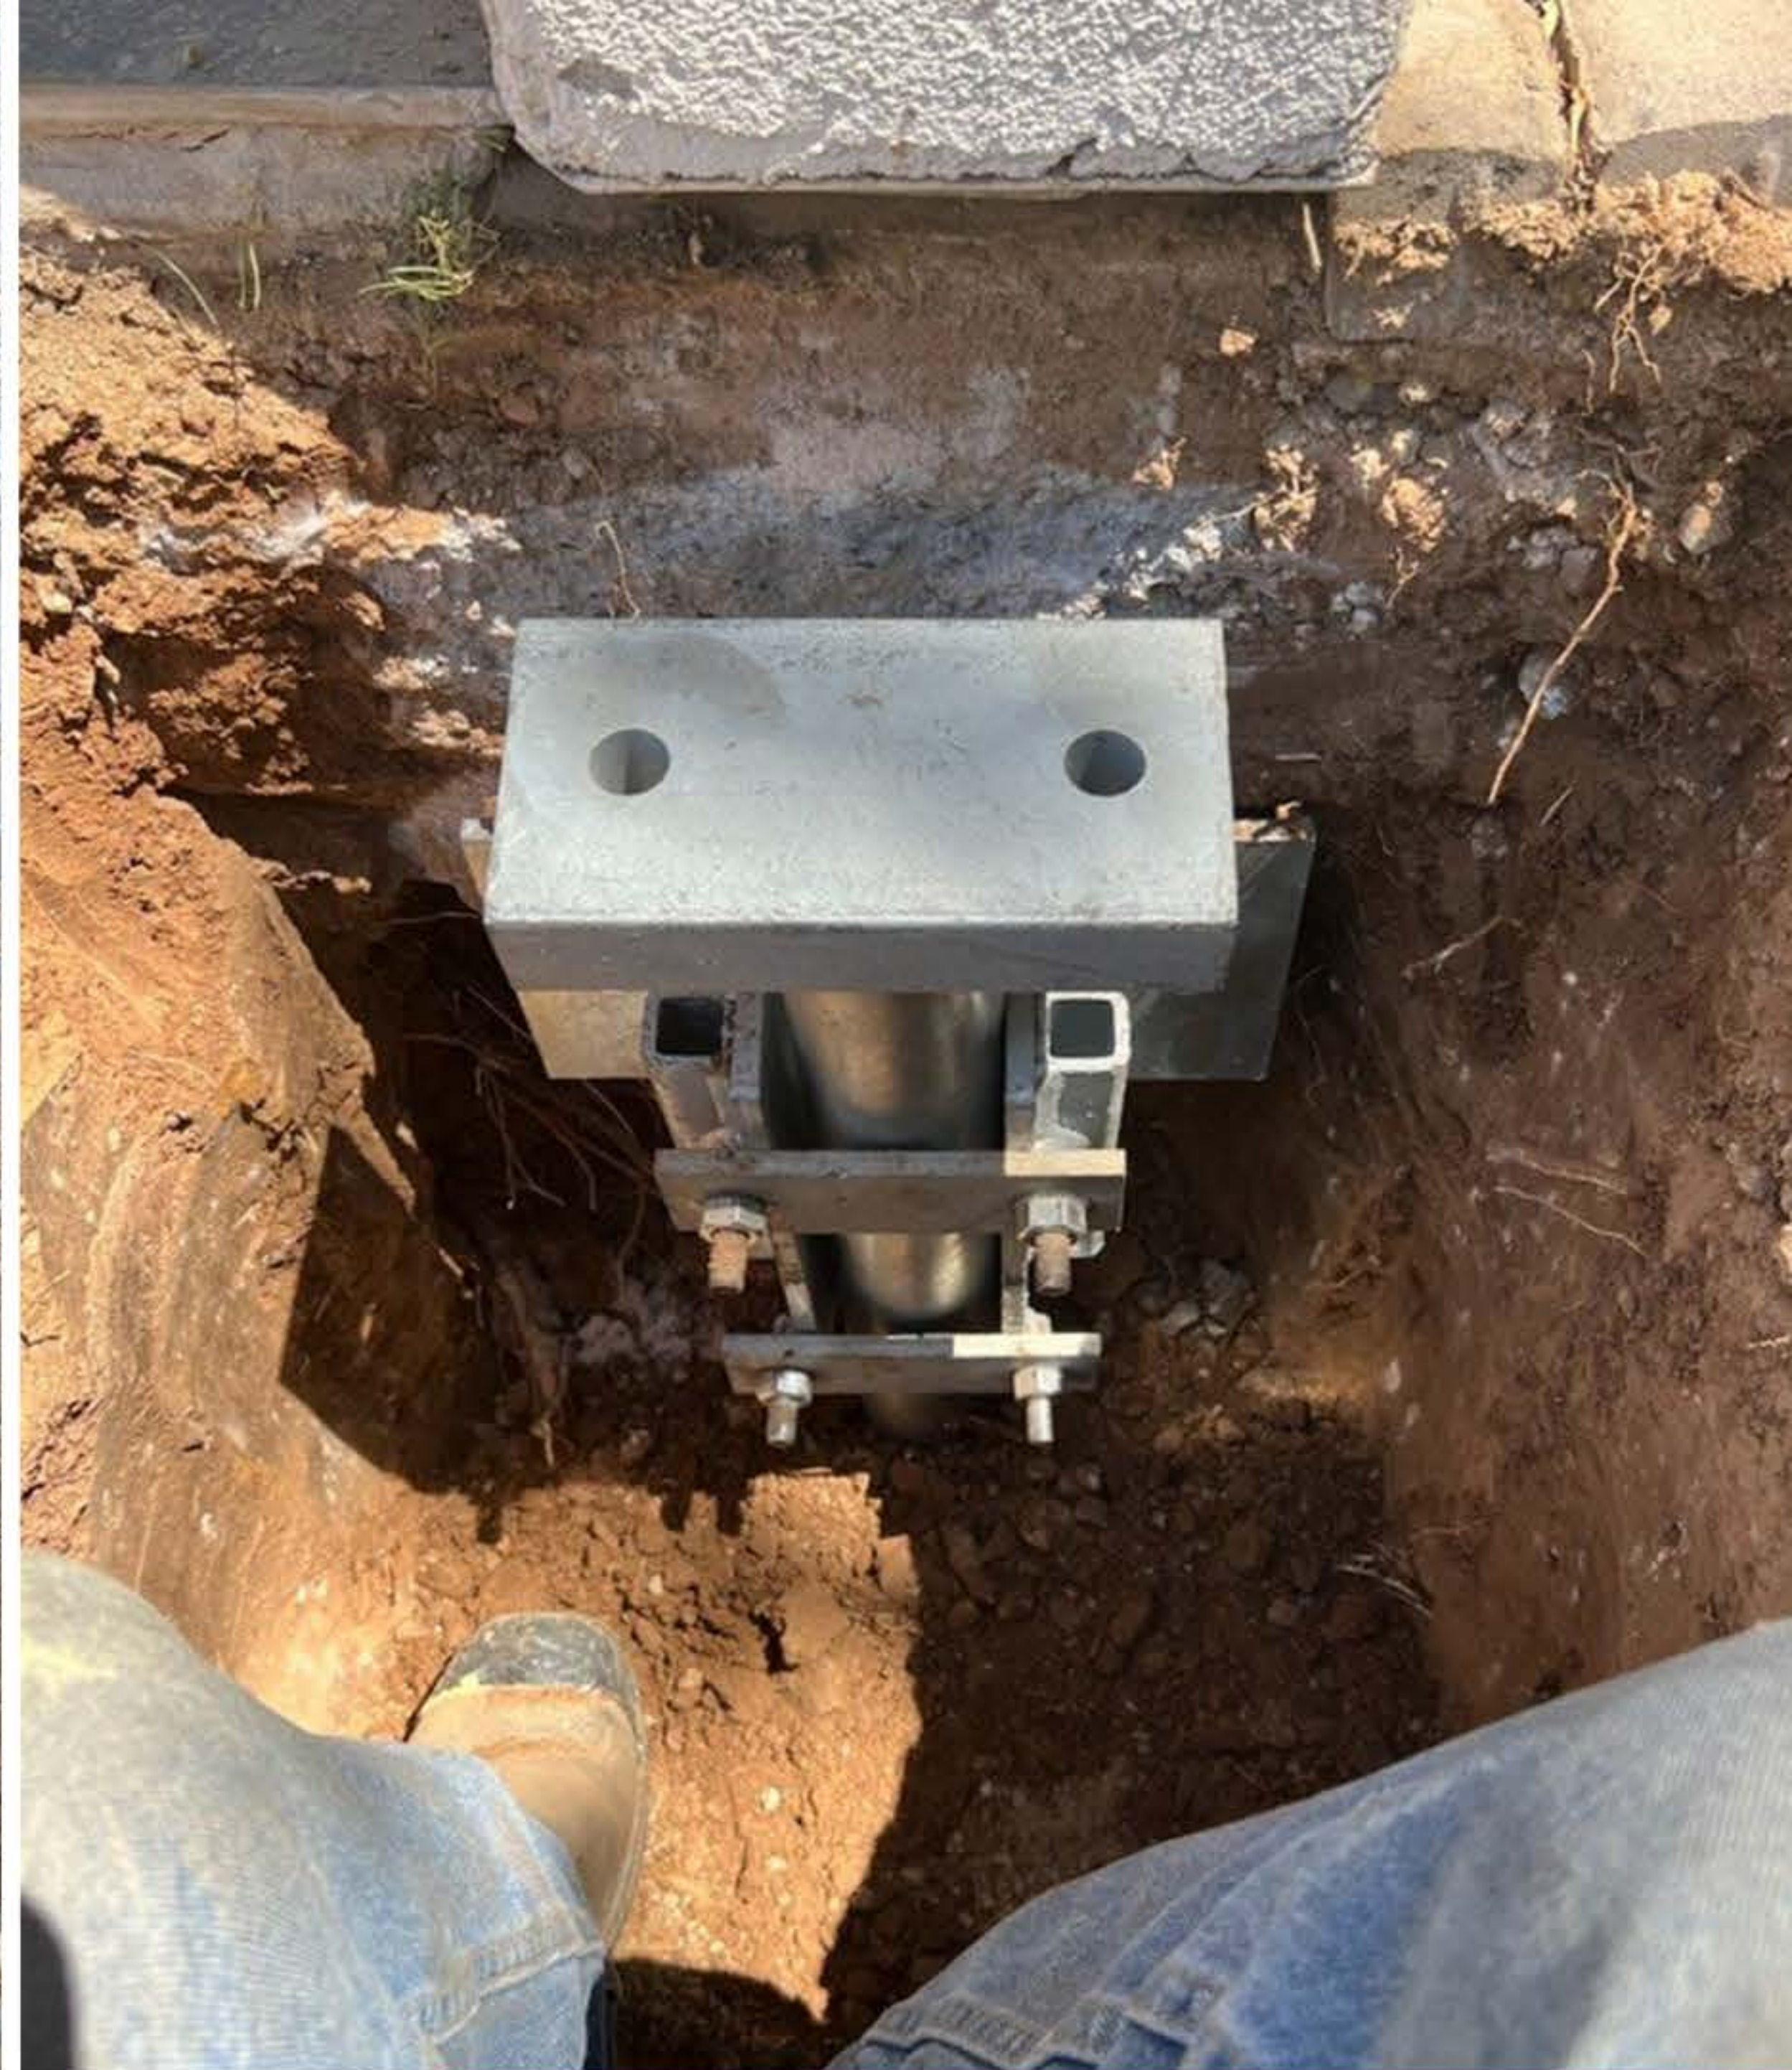
After battling cracks in their patio, gaps between their foundation and footing, and drywall cracks a Phoenix, AZ homeowner wanted to find an actual solution to their problems that would fix them once and for all. After calling our team to schedule a foundation evaluation they were setup with our specialist, Bryan Wooldridge, to take some measurements and figure out what was causing the problems they were seeing around their home.

Following a visual inspection of the interior and exterior of the home Bryan began taking measurements which included floor elevation measurements. Luckily for the homeowner, their home's foundation was in great shape and didn't seem to be settling or heaving, but a column on the corner of their patio in the backyard was in fact settling which was causing the cracks seen throughout that area of the home. He was able to design a repair plan consisting of a single helical pile to stabilize the column and even attempt to lift it to recover some of the settlement.

In a matter of hours the crew was able to excavate the soils, expose the footing beneath the small column, drive the helical pile down to competent soils, attach the bracket to the footing, and lift the column to recover the settlement. During the lift many of the drywall cracks closed up and the homeowner would need to make repairs to those cracks one final time!
