**34 HELICAL PILES  
STABILIZE A SETTLING  
FORT MOHAVE, AZ HOME**

# FORT MOHAVE, AZ HOMEOWNER CALLS DALINGHAUS CONSTRUCTION TO STABILIZE SINKING FOUNDATION

## PROJECT BACKGROUND

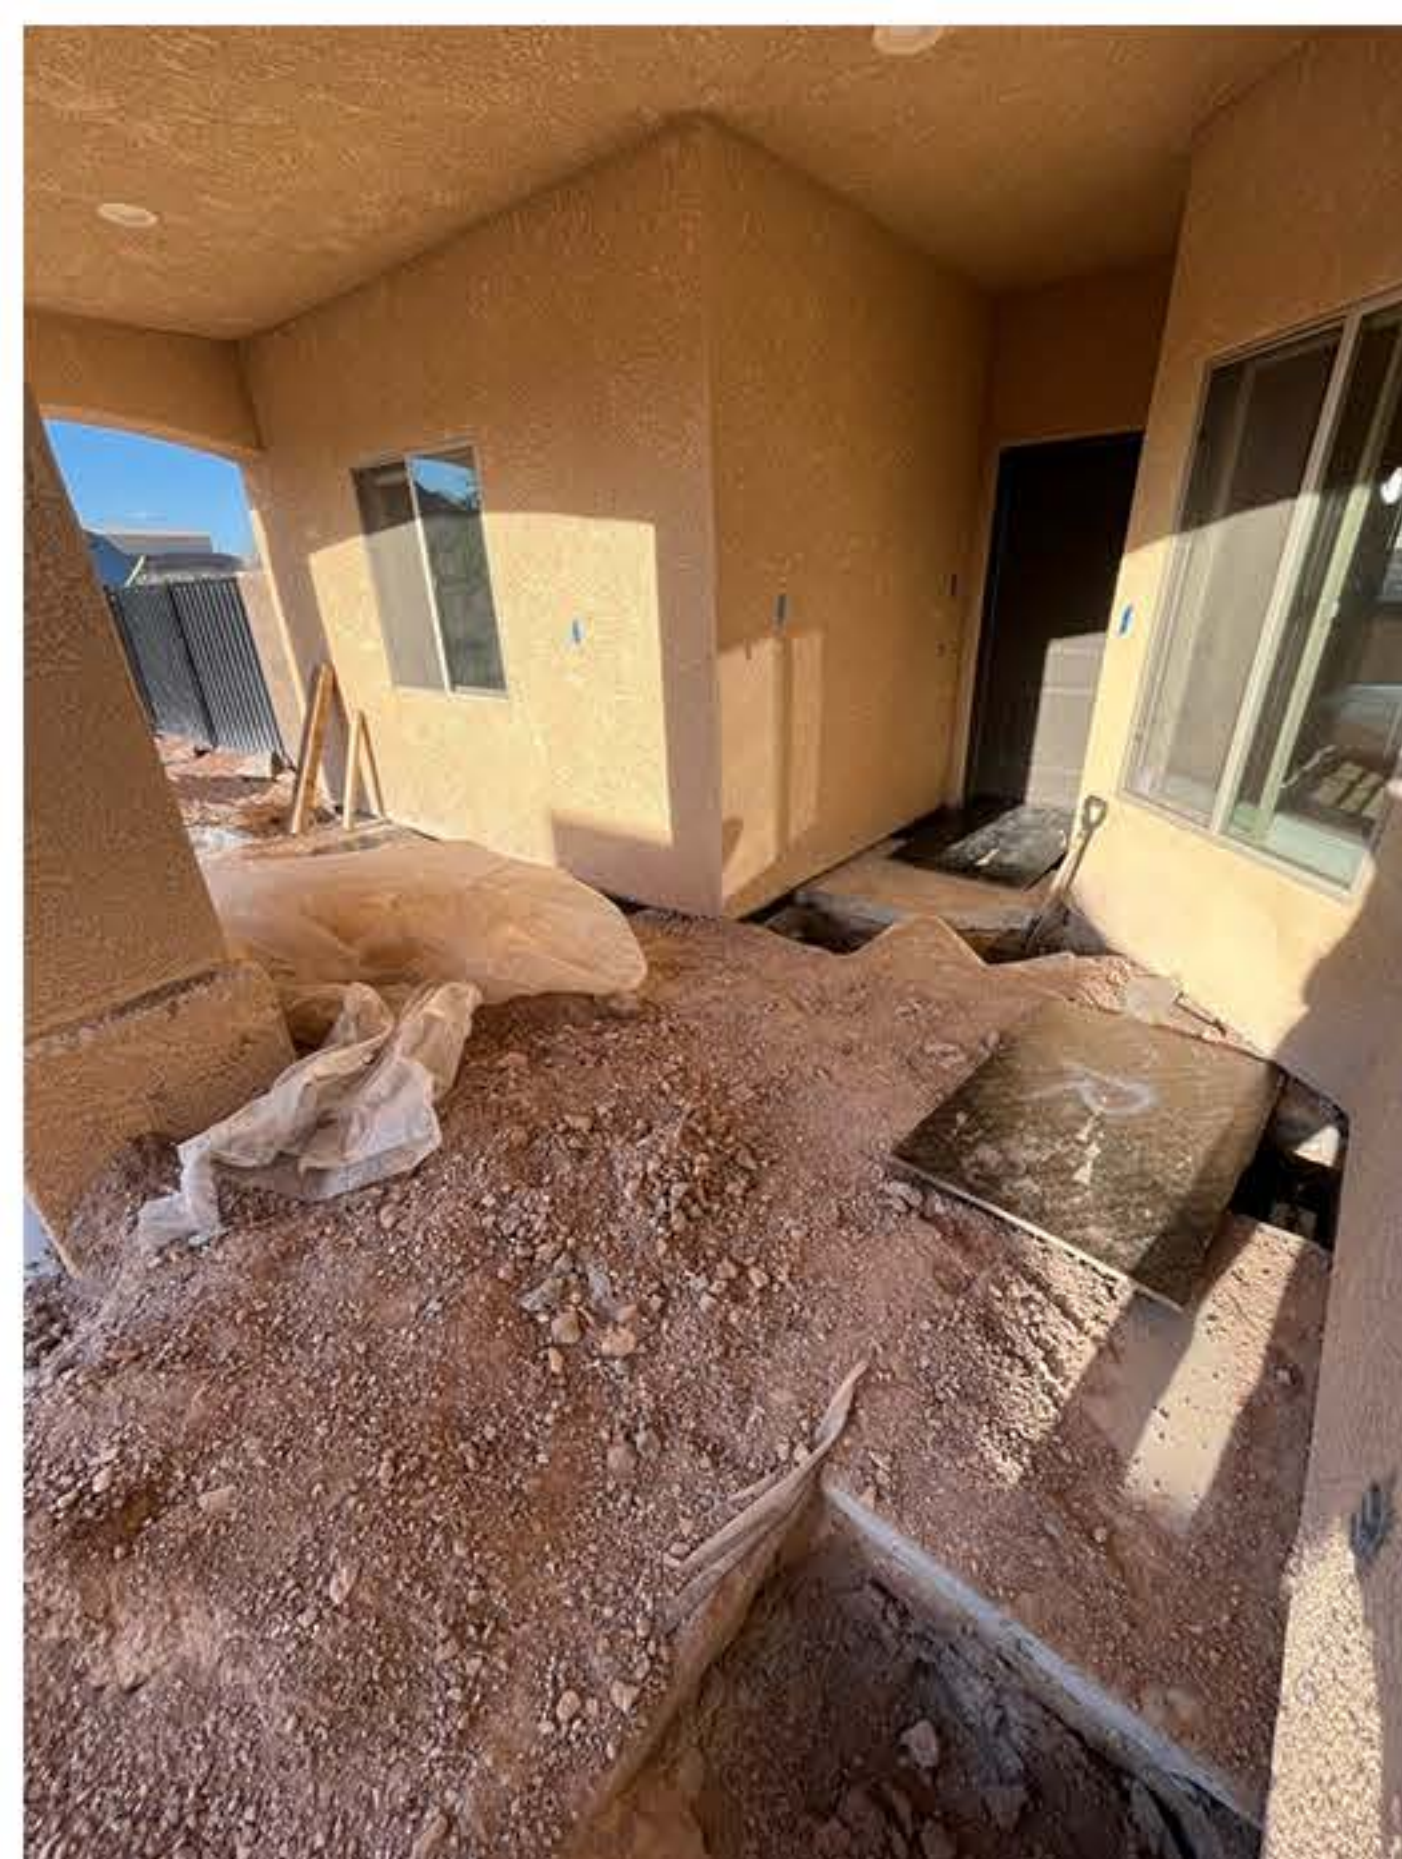
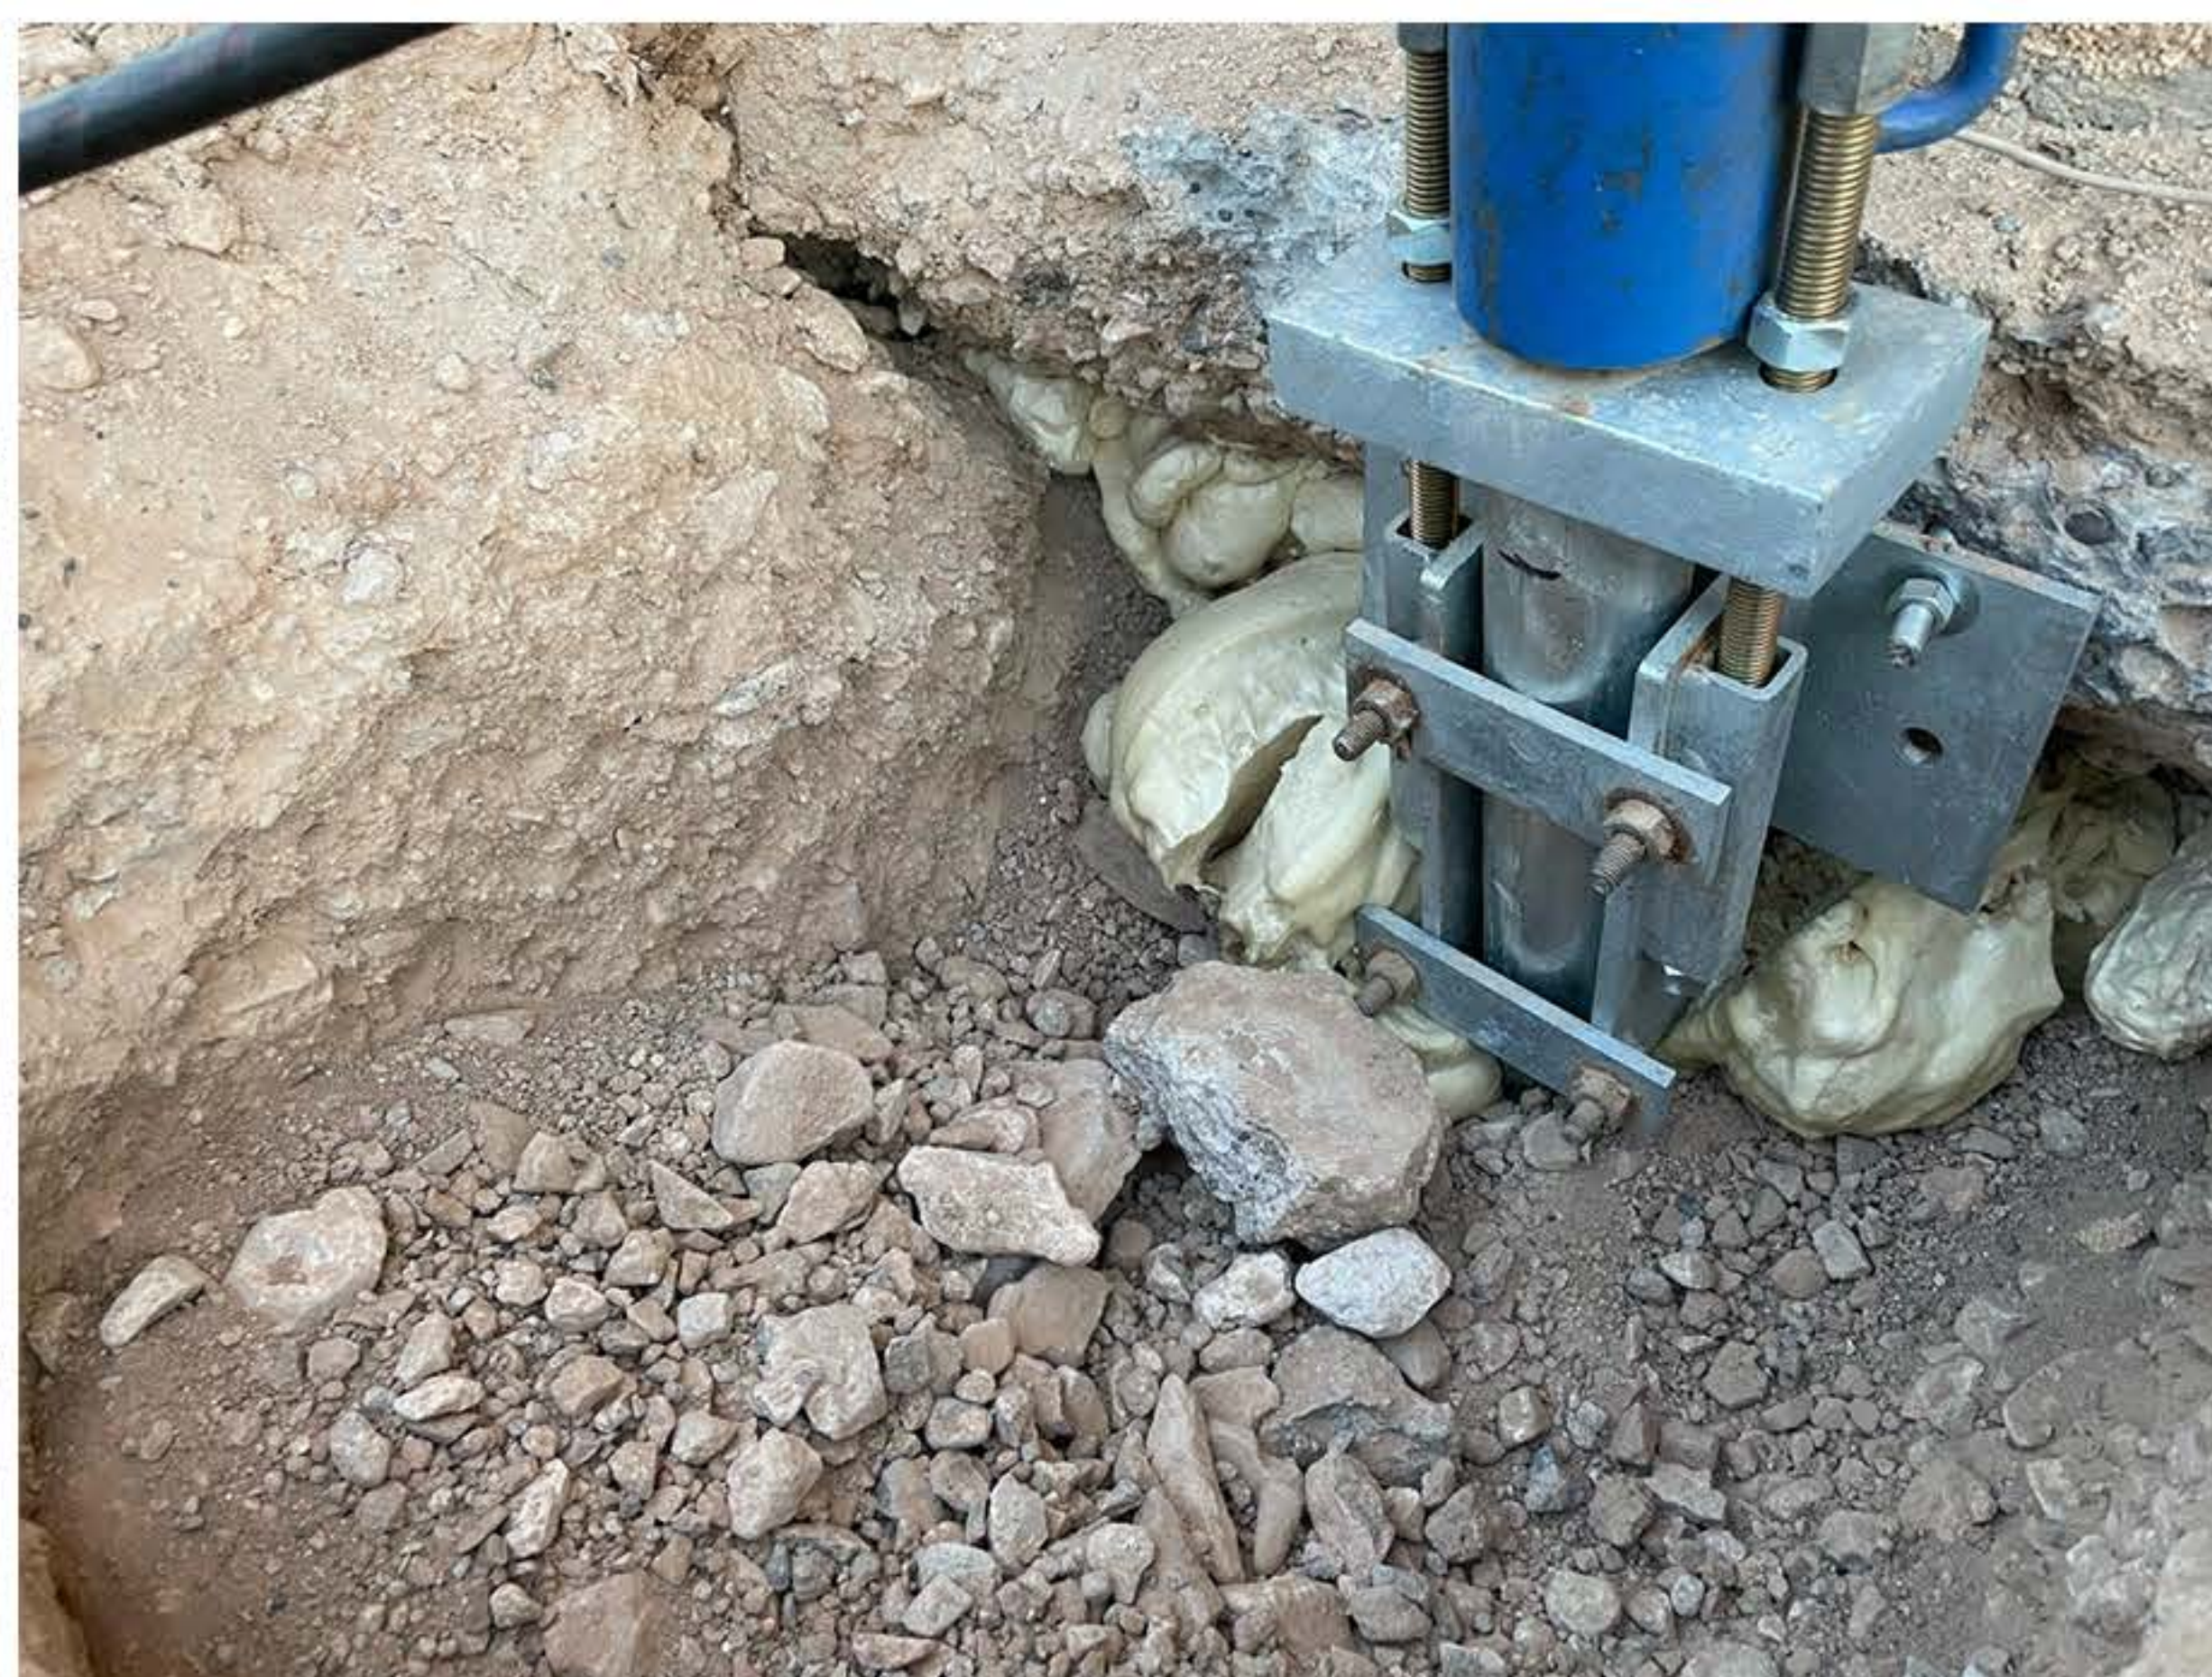
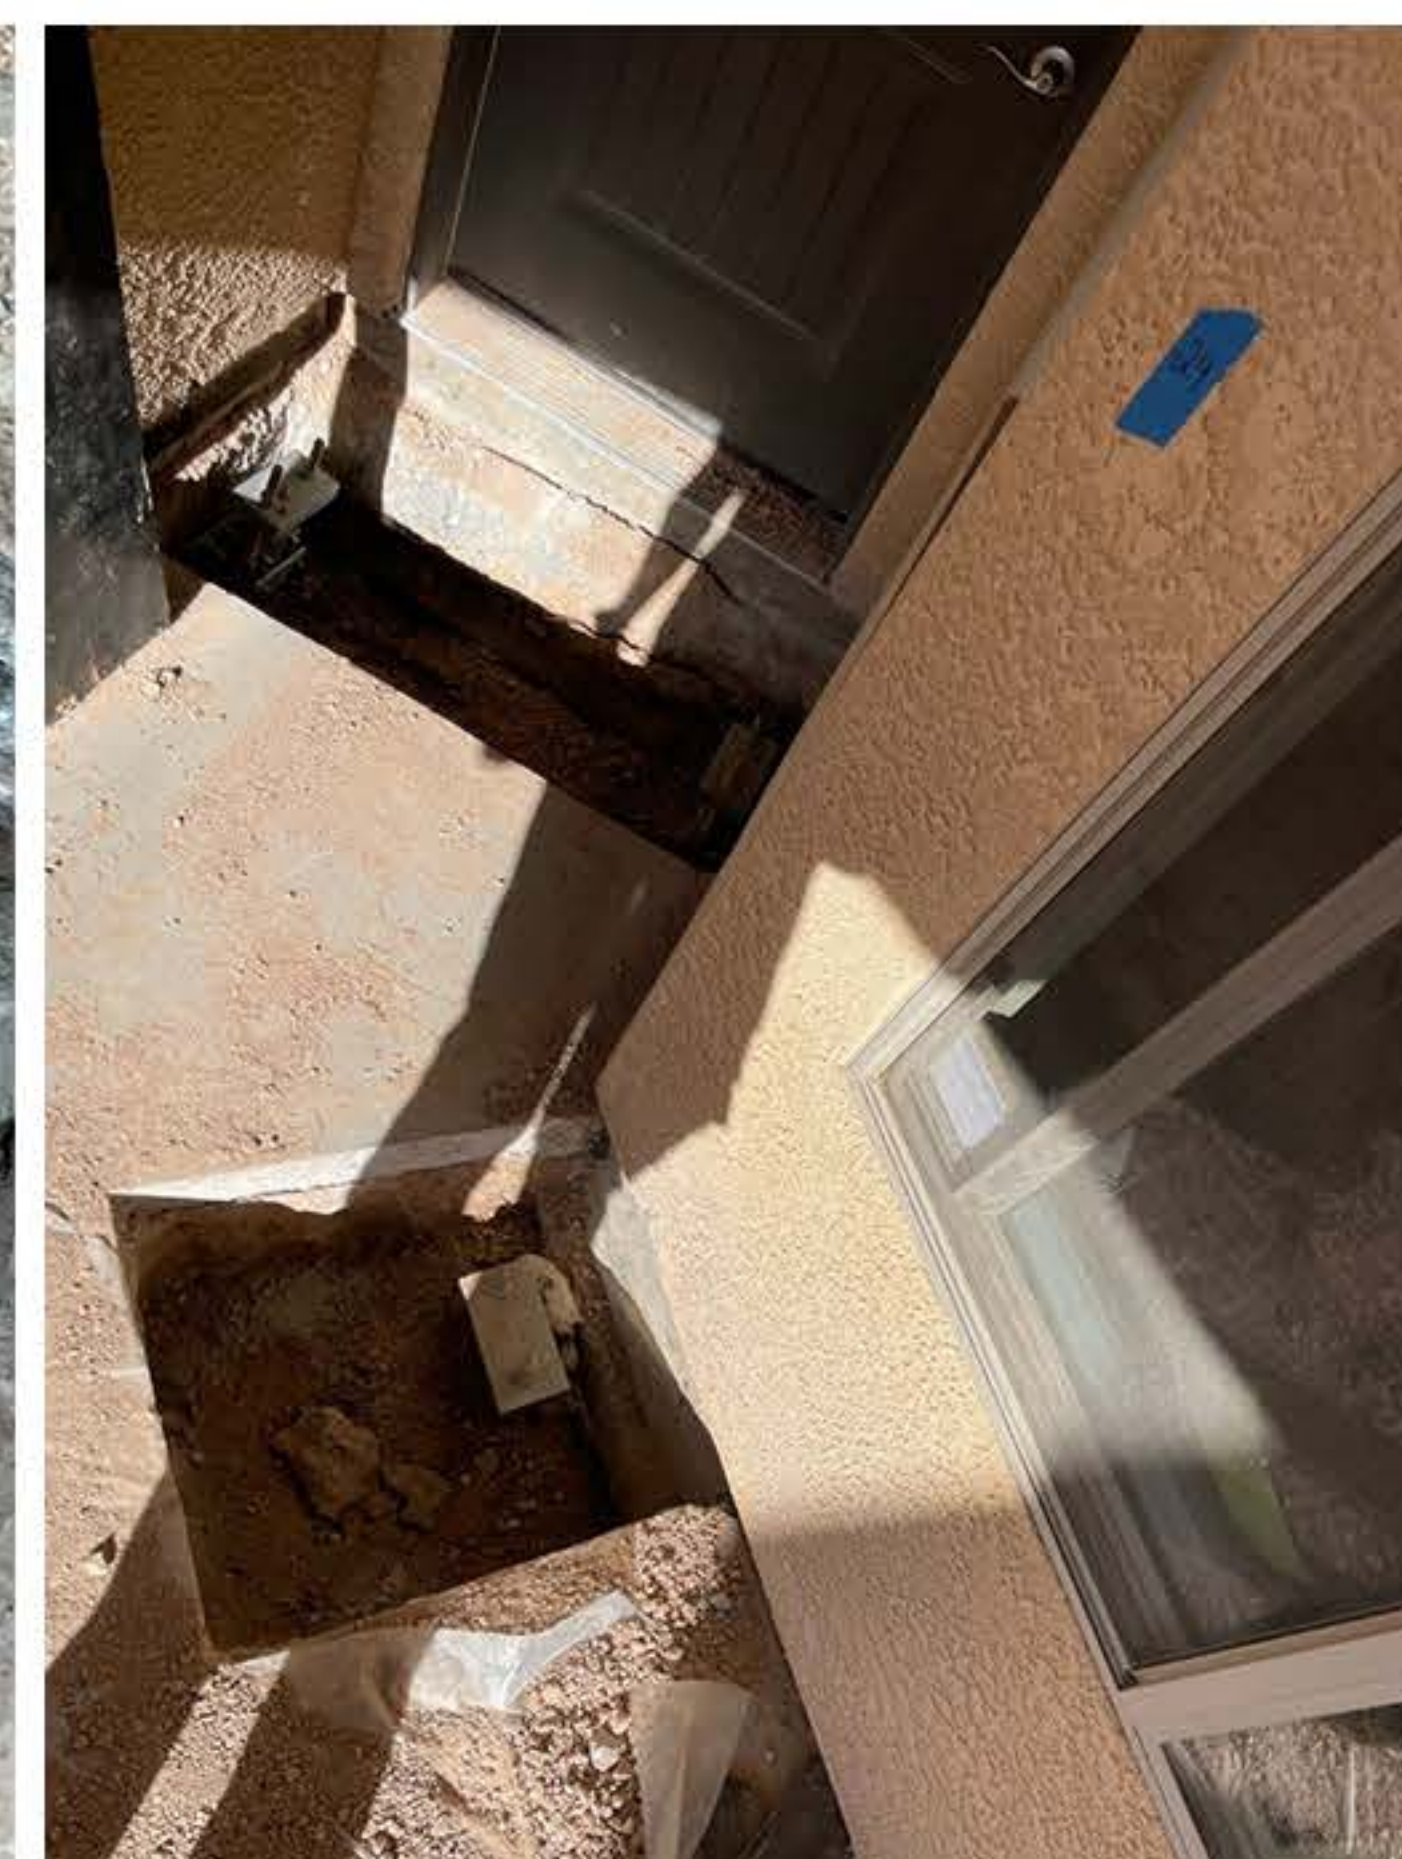
## INSTALLATION OVERVIEW

Utilizing 34 of the TAF-288 helical piles from ECP Noah, Ryan, and their crews made quick work of the project. Due to access around the home all 34 piles would need to be installed with hand equipment. They started by excavating the soils at the pier locations before chipping the footings and driving the piles with a handheld hydraulic setup. The crews found competent, load-bearing soils at depths between 14 and 20 feet. After the piles were installed the crew cut and cap the pile brackets before pressurizing the systems and attempting to lift and recover some of the settlement. Once maximum practical recovery was achieved they locked off the brackets to secure the home for years to come.
