CASESTUDY

17 HELICAL PILES STABILIZE
1960'S HILLSIDE FARMHOUSE
OVERLOOKING LAGUNA BEACH

HELICAL PILES & TIEBACKS SAVE RECENTLY PURCHASED HILLSIDE HOME THAT HAD SETTLED & MOVED Laterally

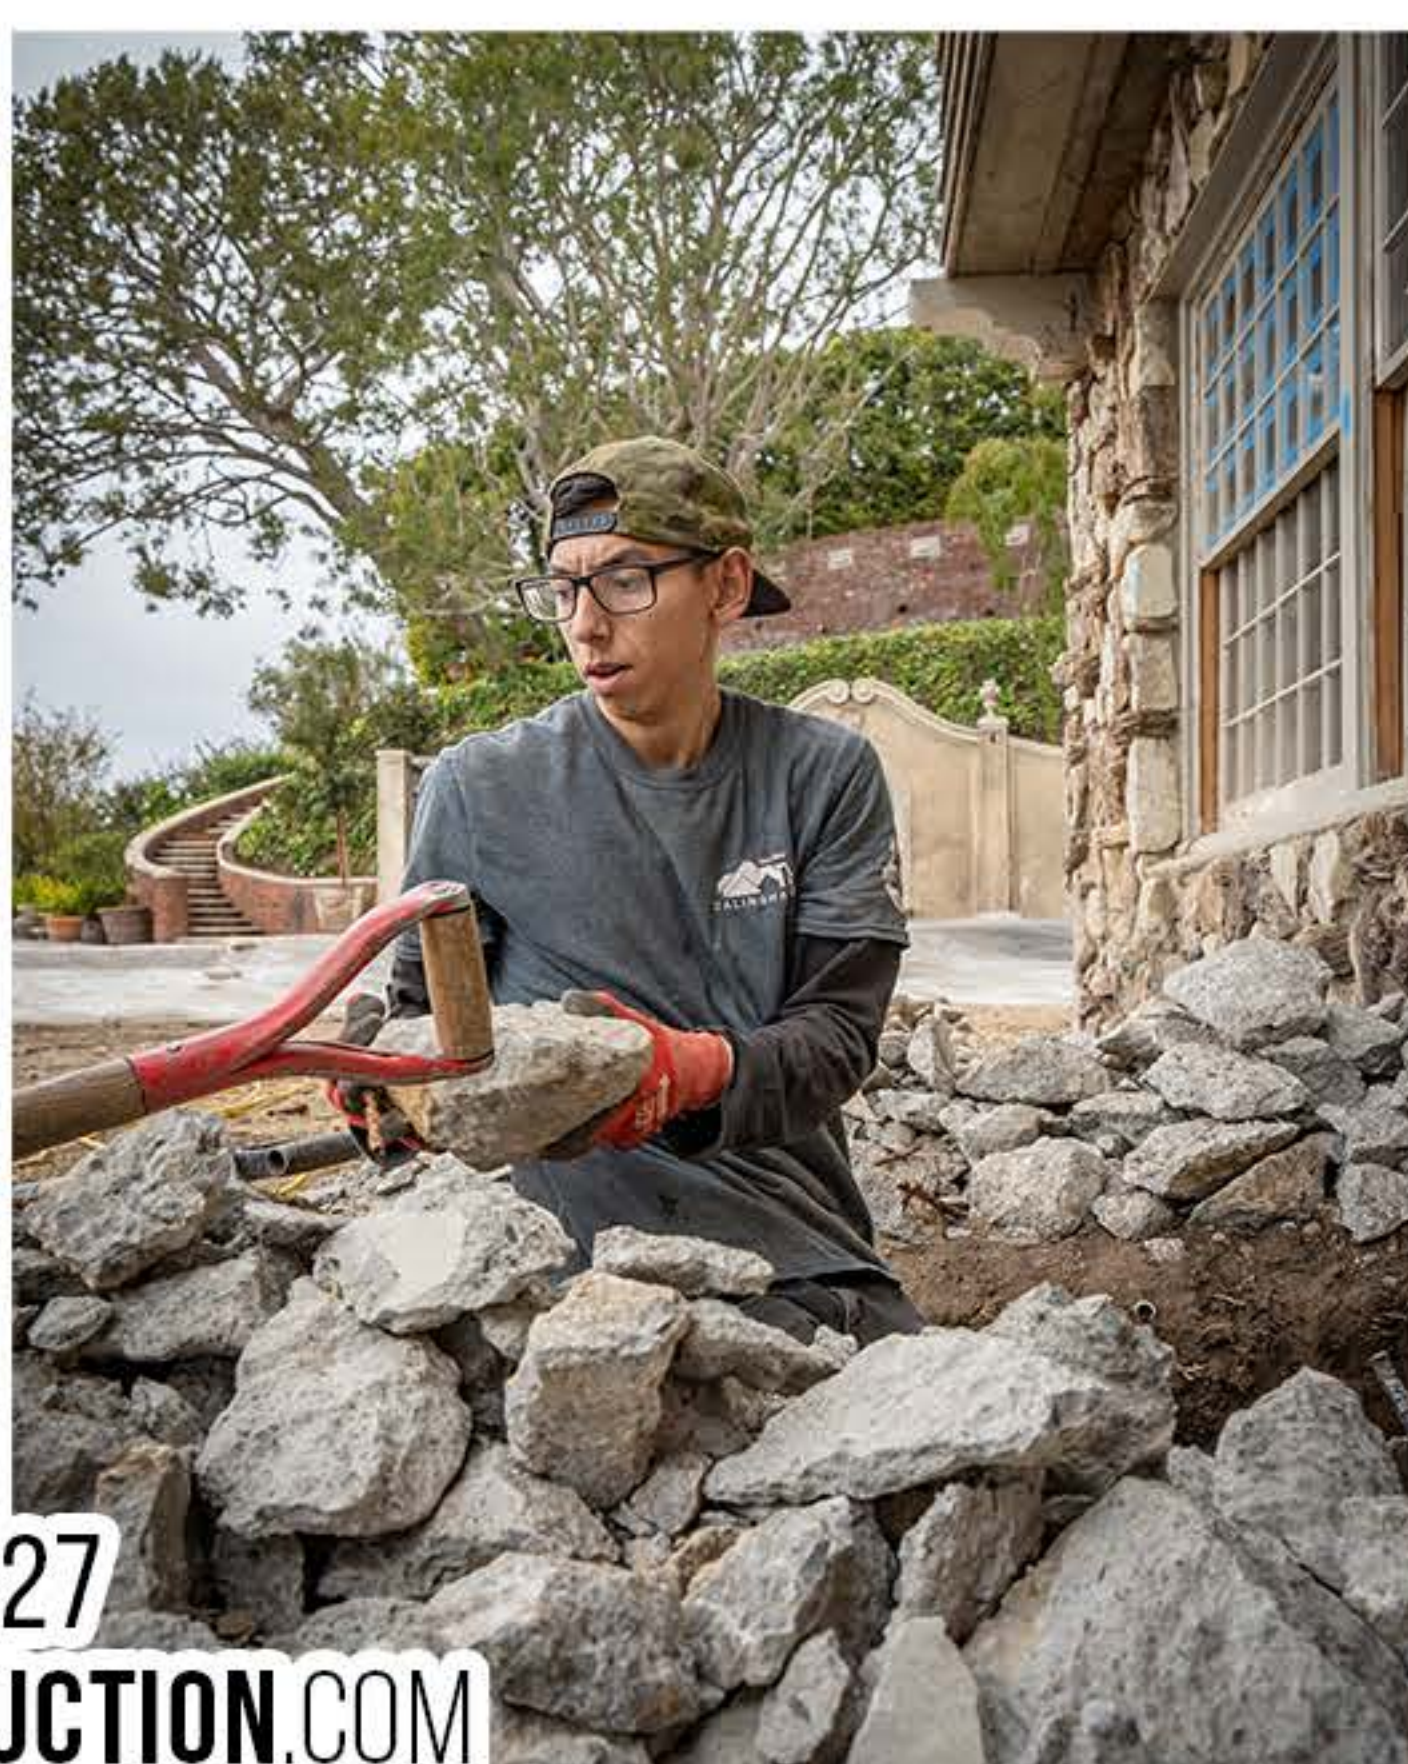
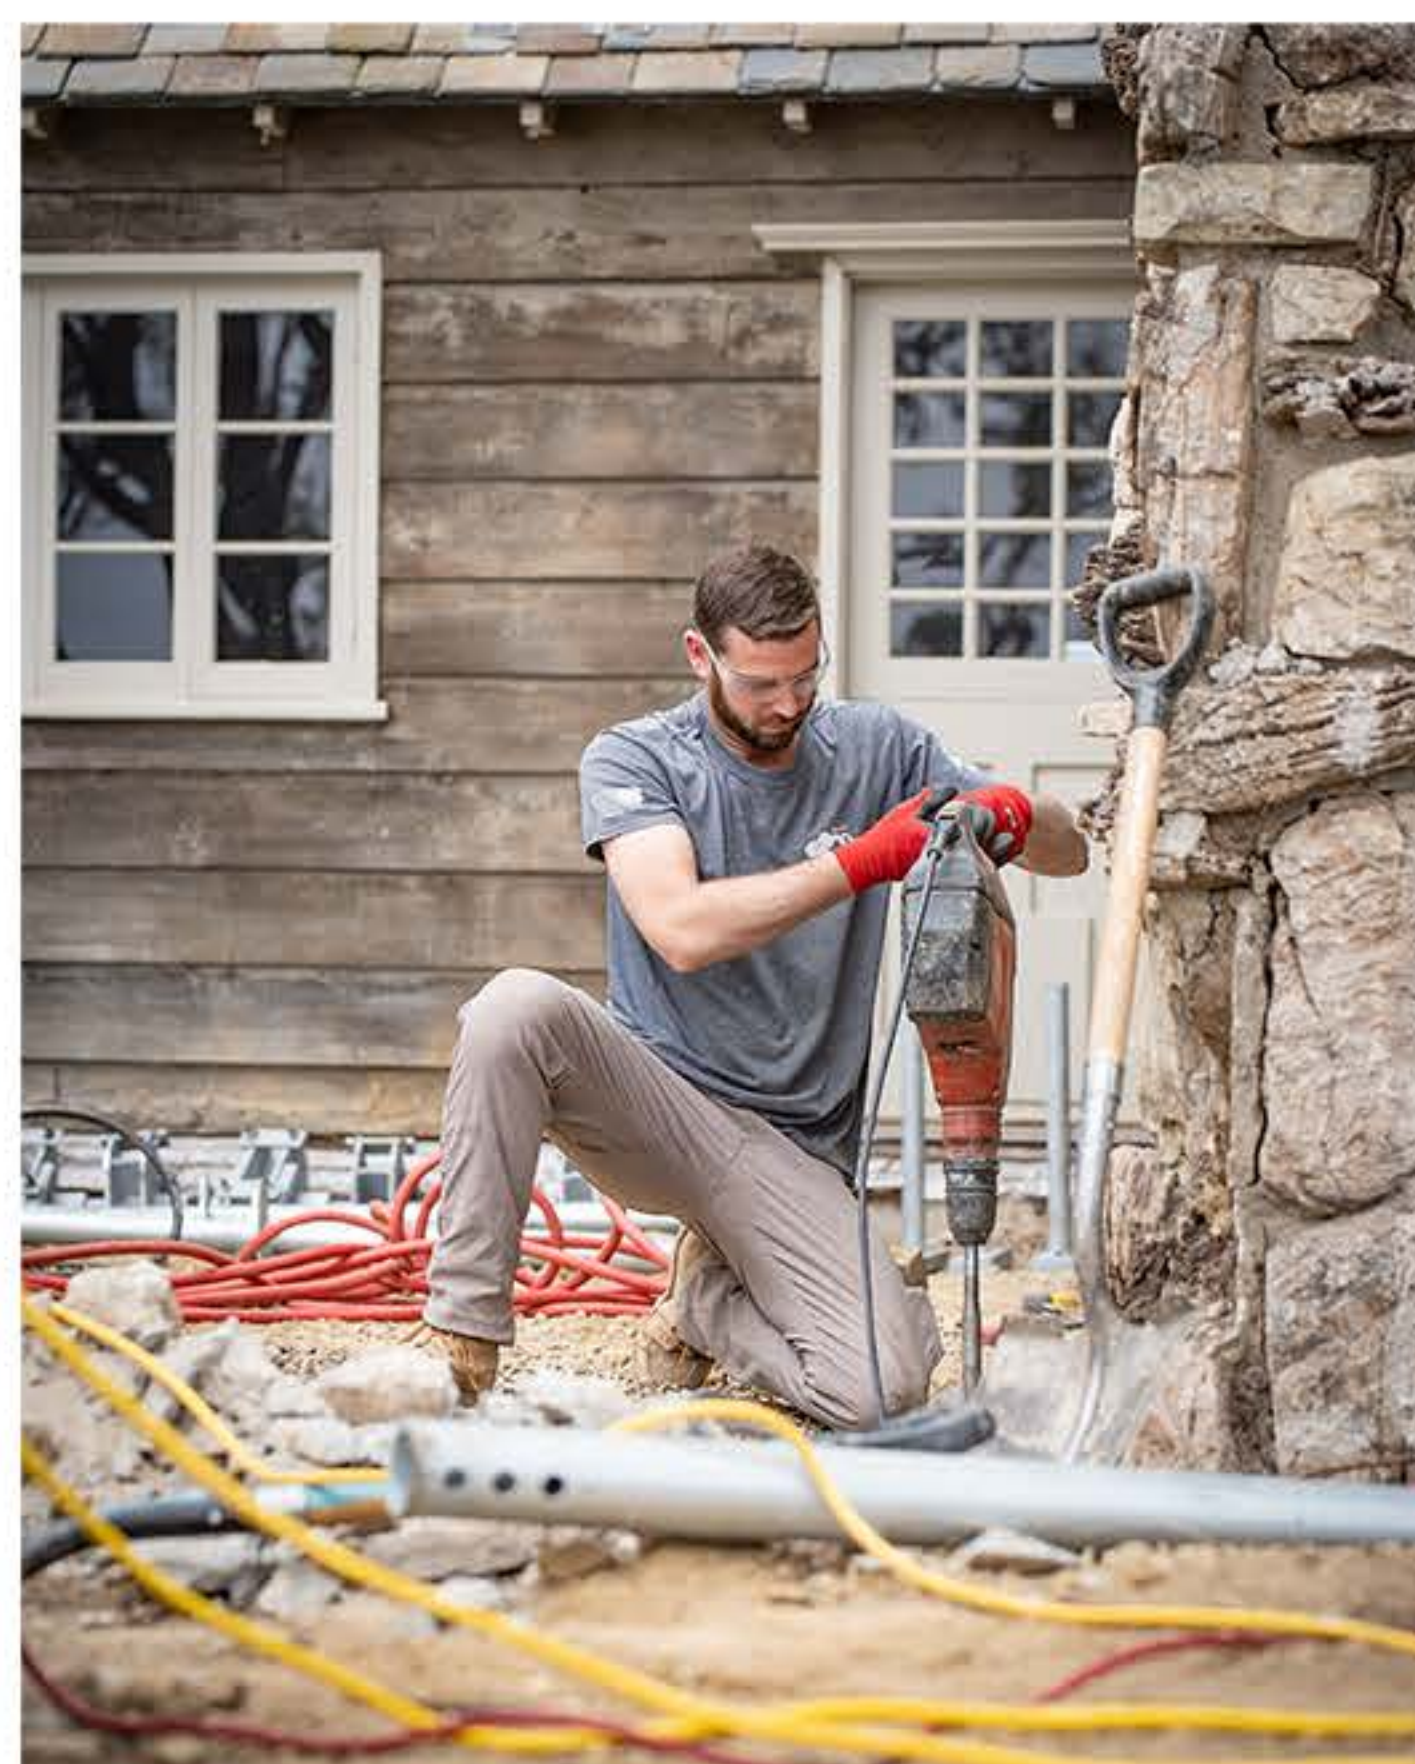
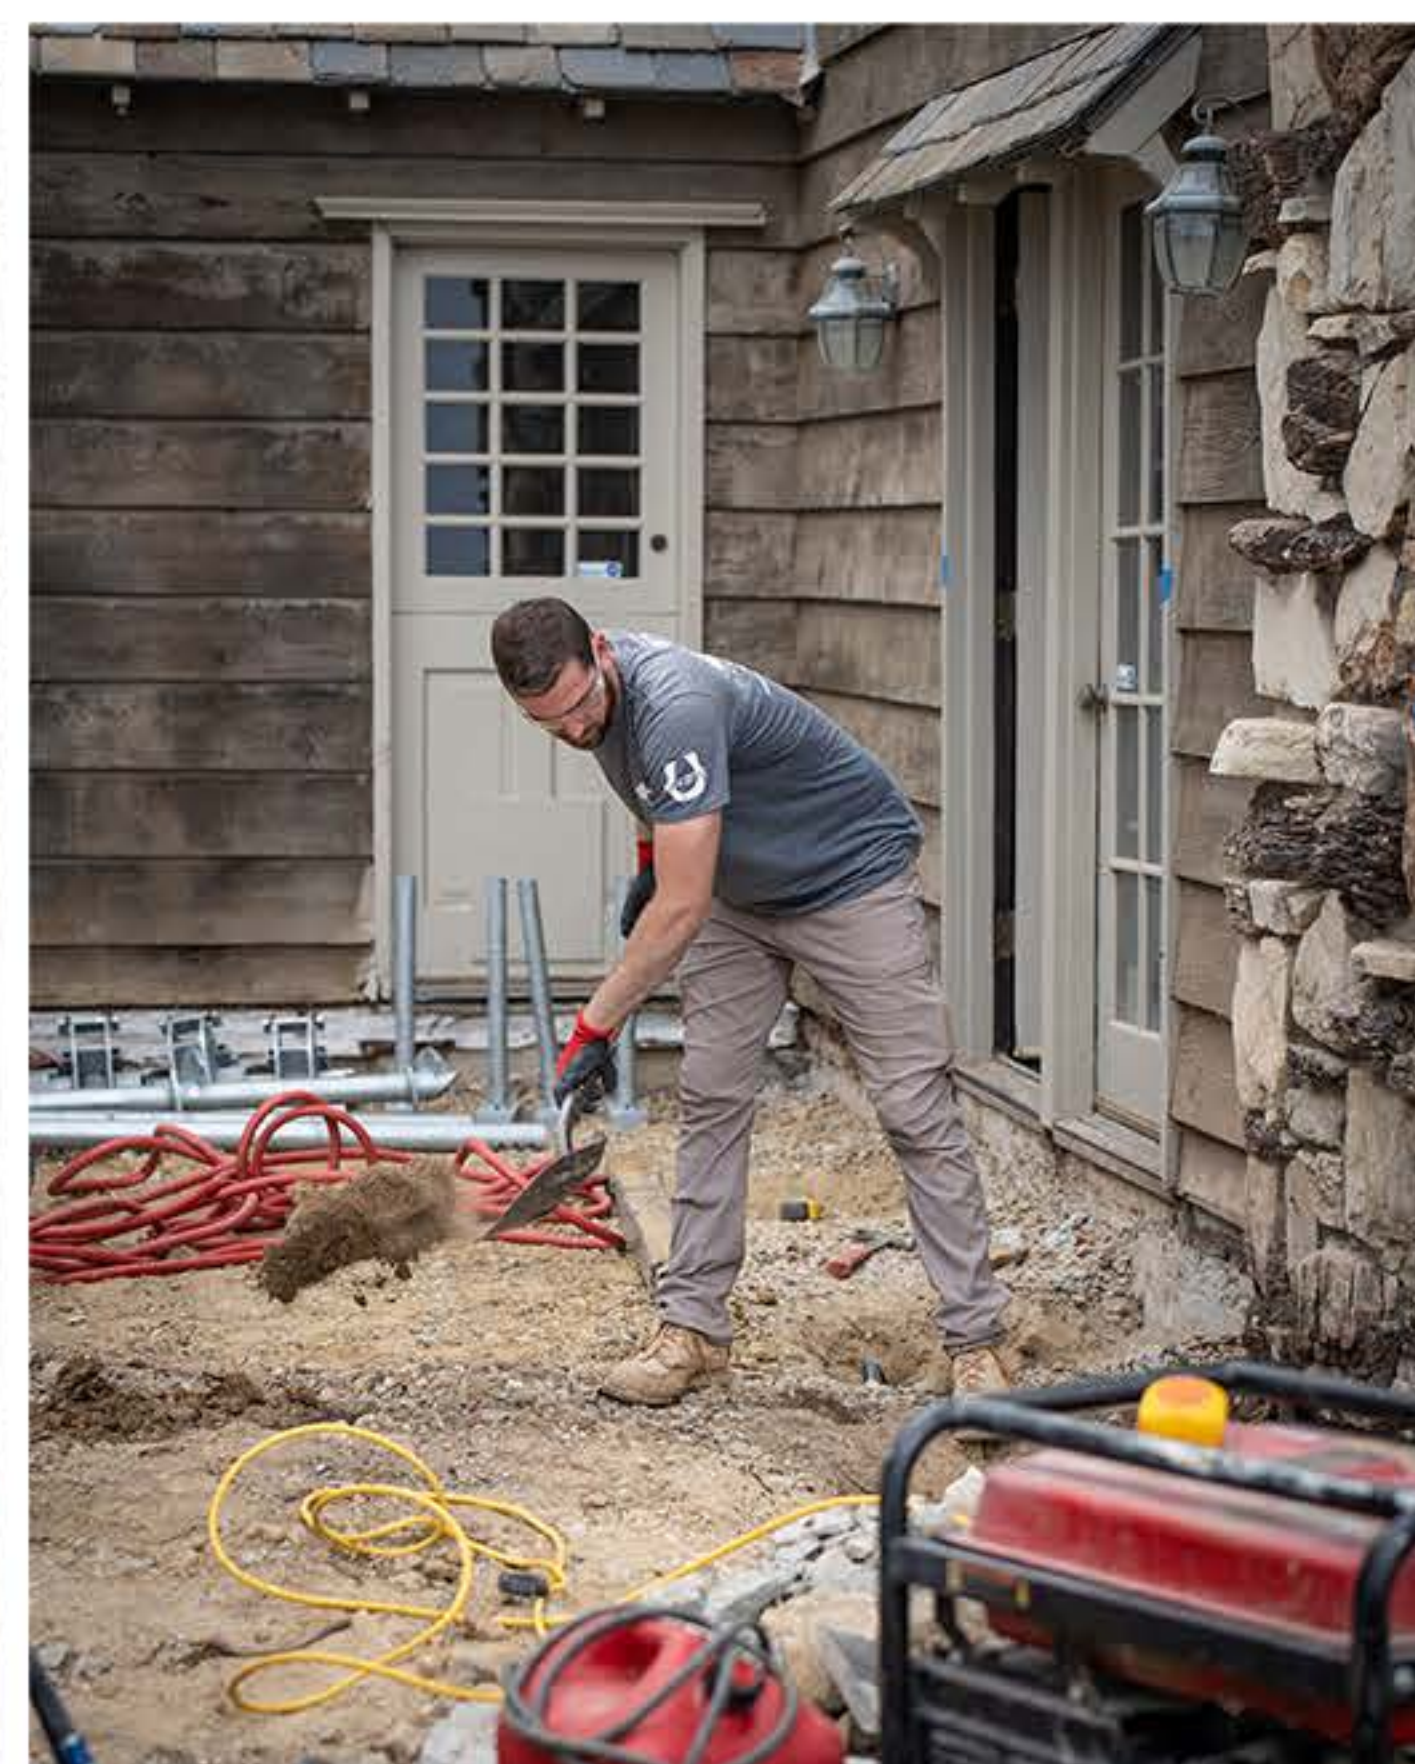
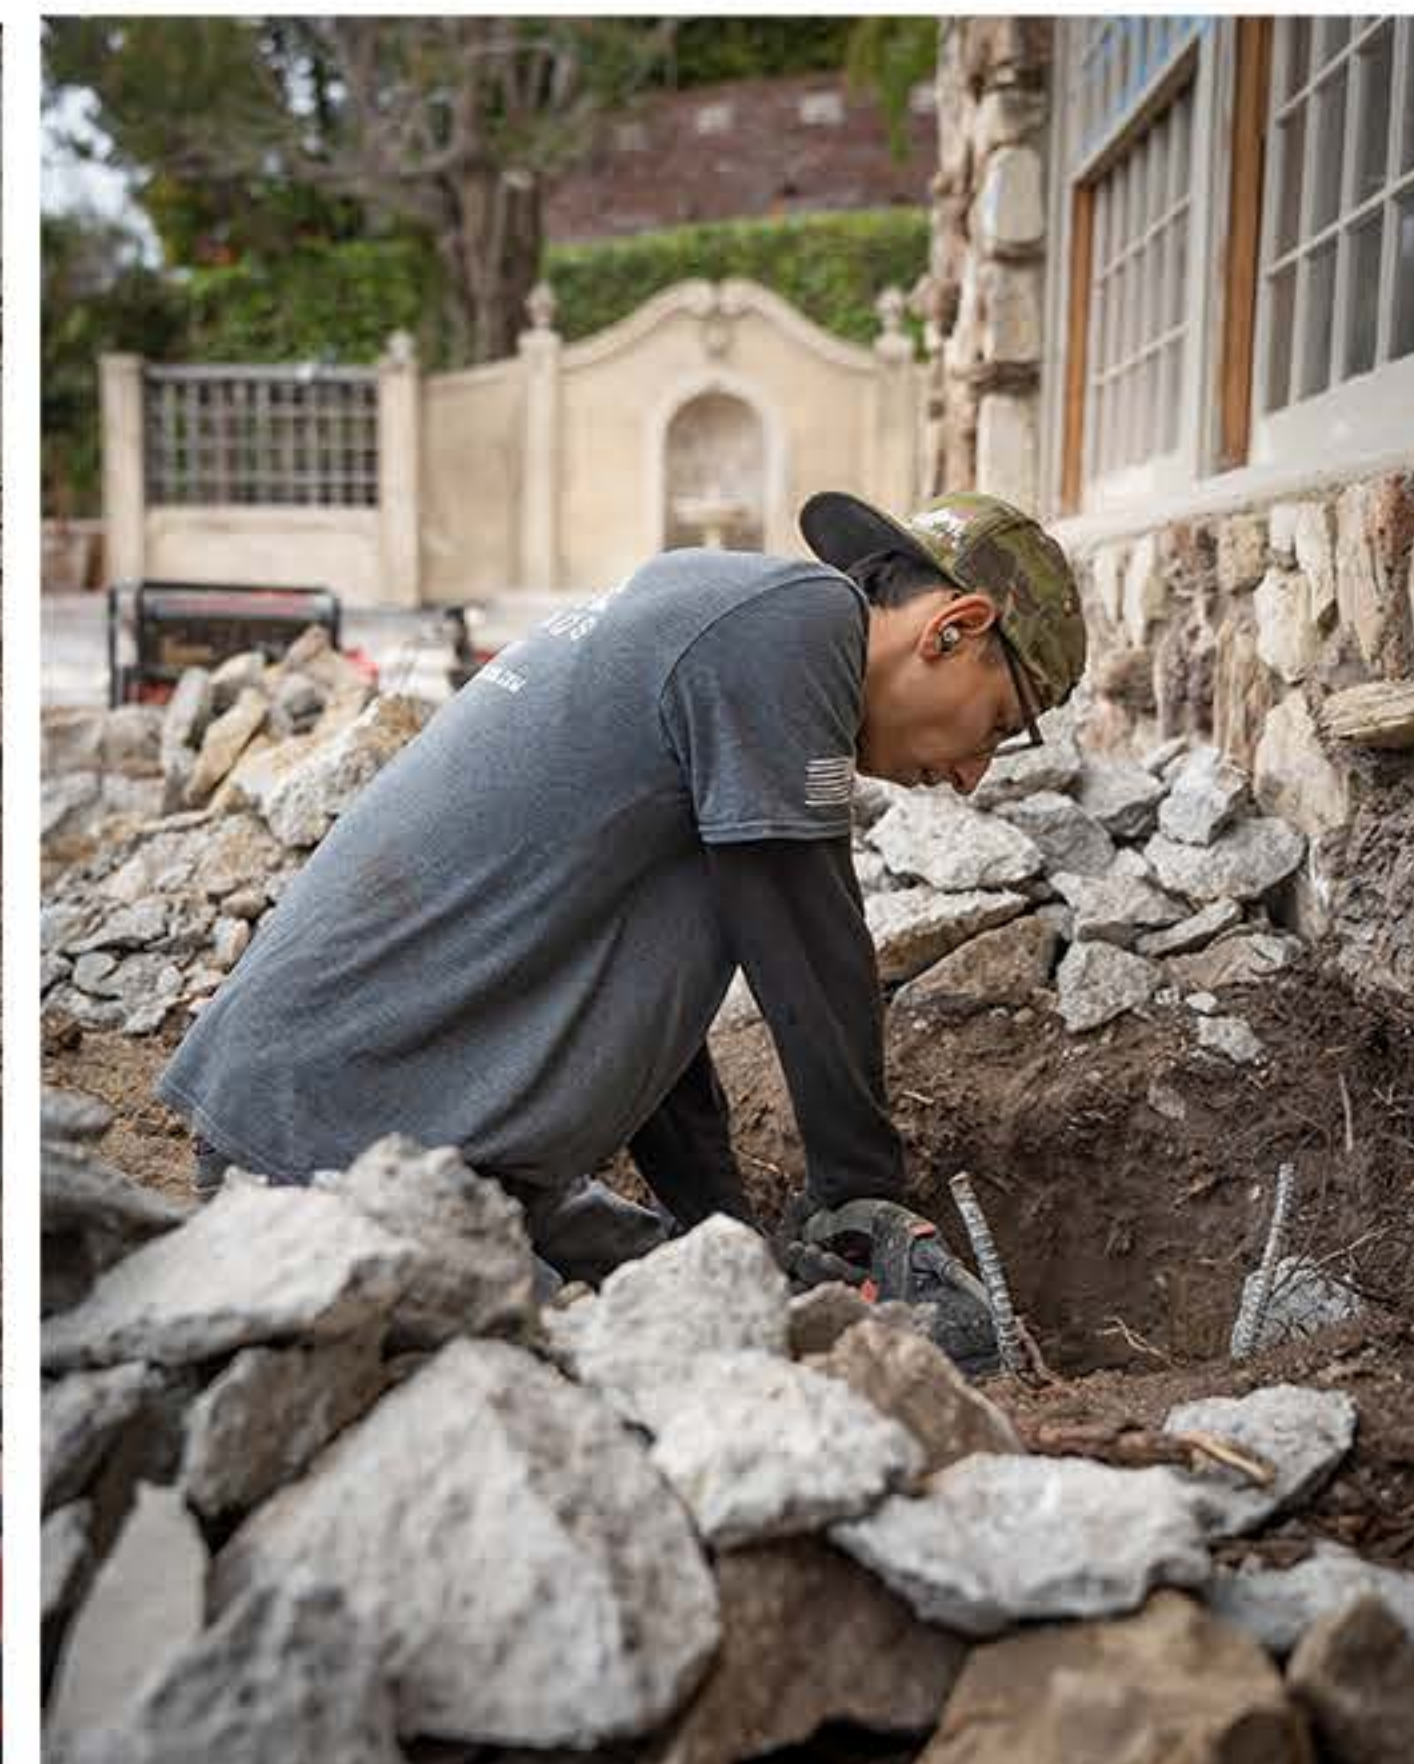
With limited access around the home the crew excavated pier locations, prepped footings, and began installing helical piles with hand equipment. The first pile found competent, load-bearing soils at almost 45 feet and it was pretty consistent for the remaining helical piles. After all of the piles were installed the crew cut and cap each pile and secured them to the home's footing via steel brackets. They were then able to lift the home and recover about 2.5 inches of the settlement.
