13 HELICAL PILES STABILIZE  
LAGUNA NIGUEL HILLSIDE  
HOME THAT SETTLED 7 INCHES

## HELICAL PILES & TIEBACKS STABILIZE SETTLING HILLSIDE HOME IN LAGUNA NIGUEL, CA

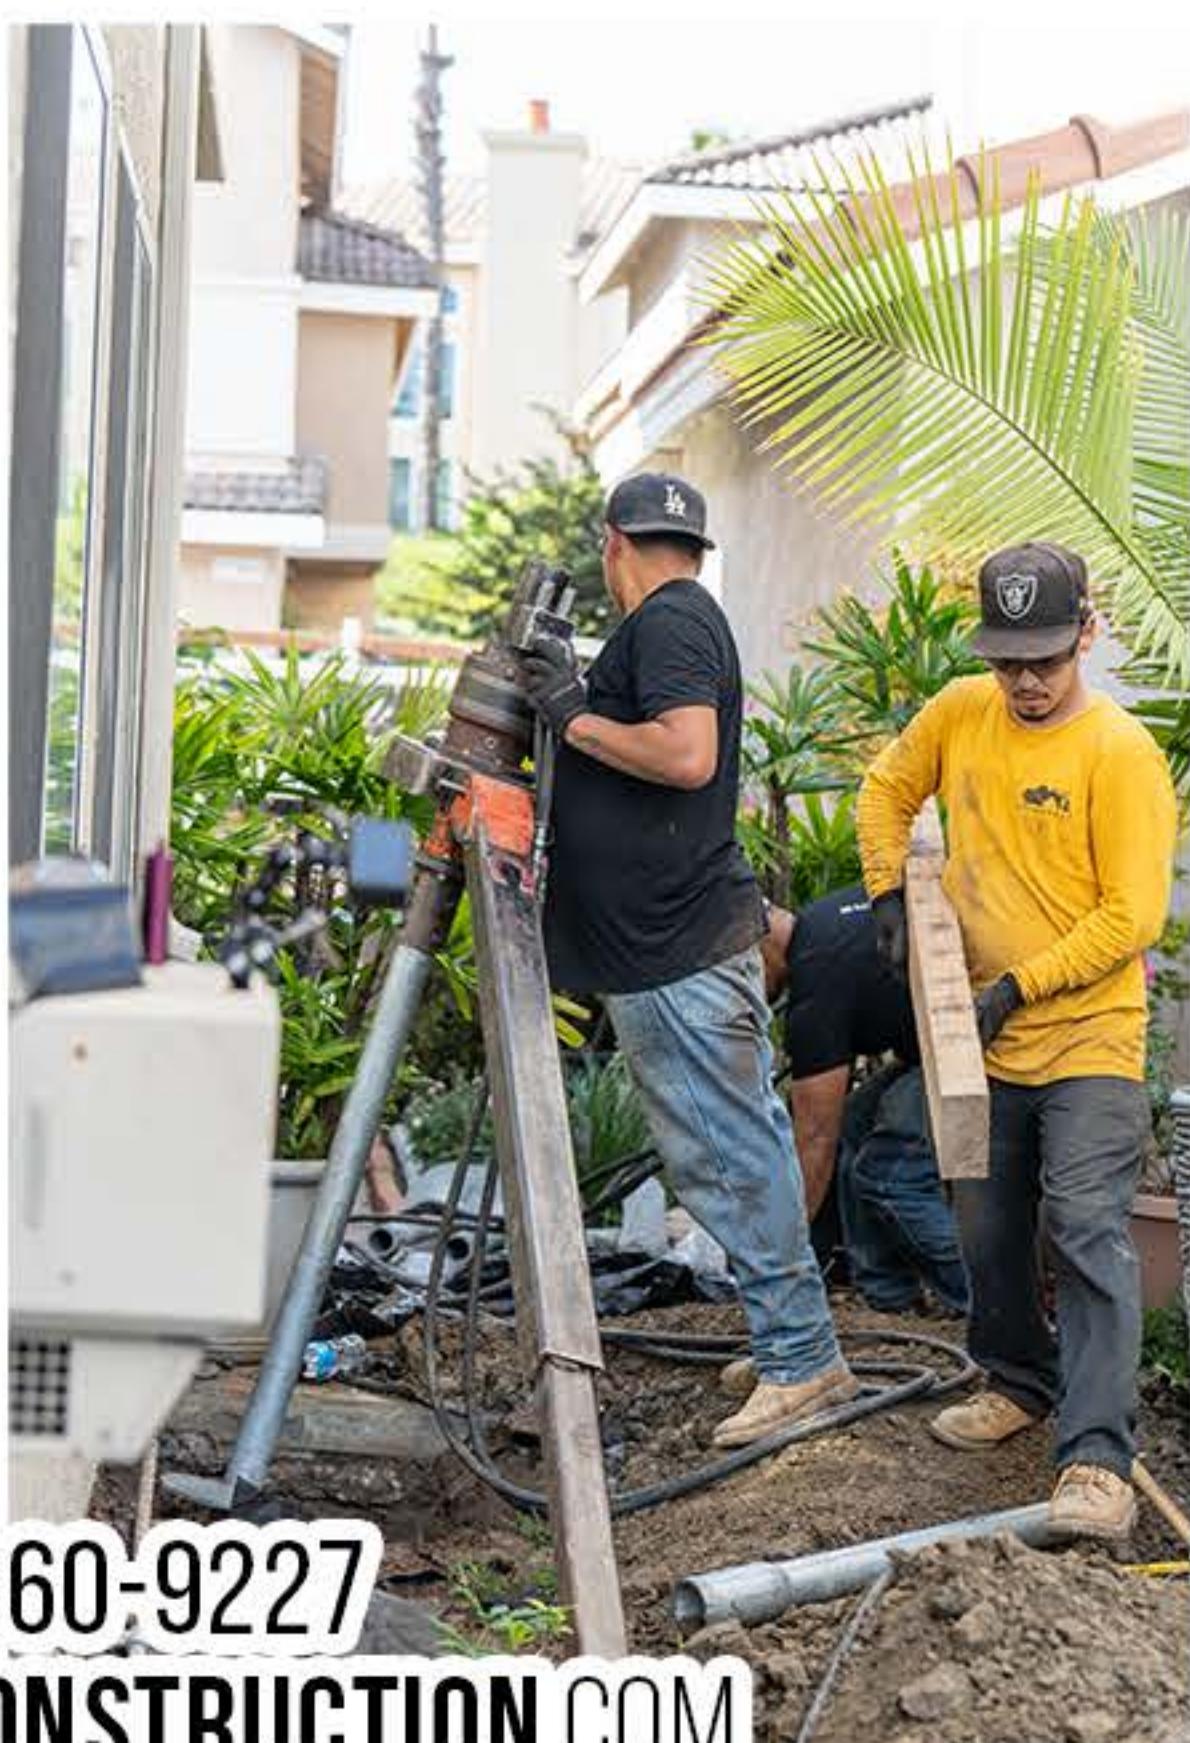
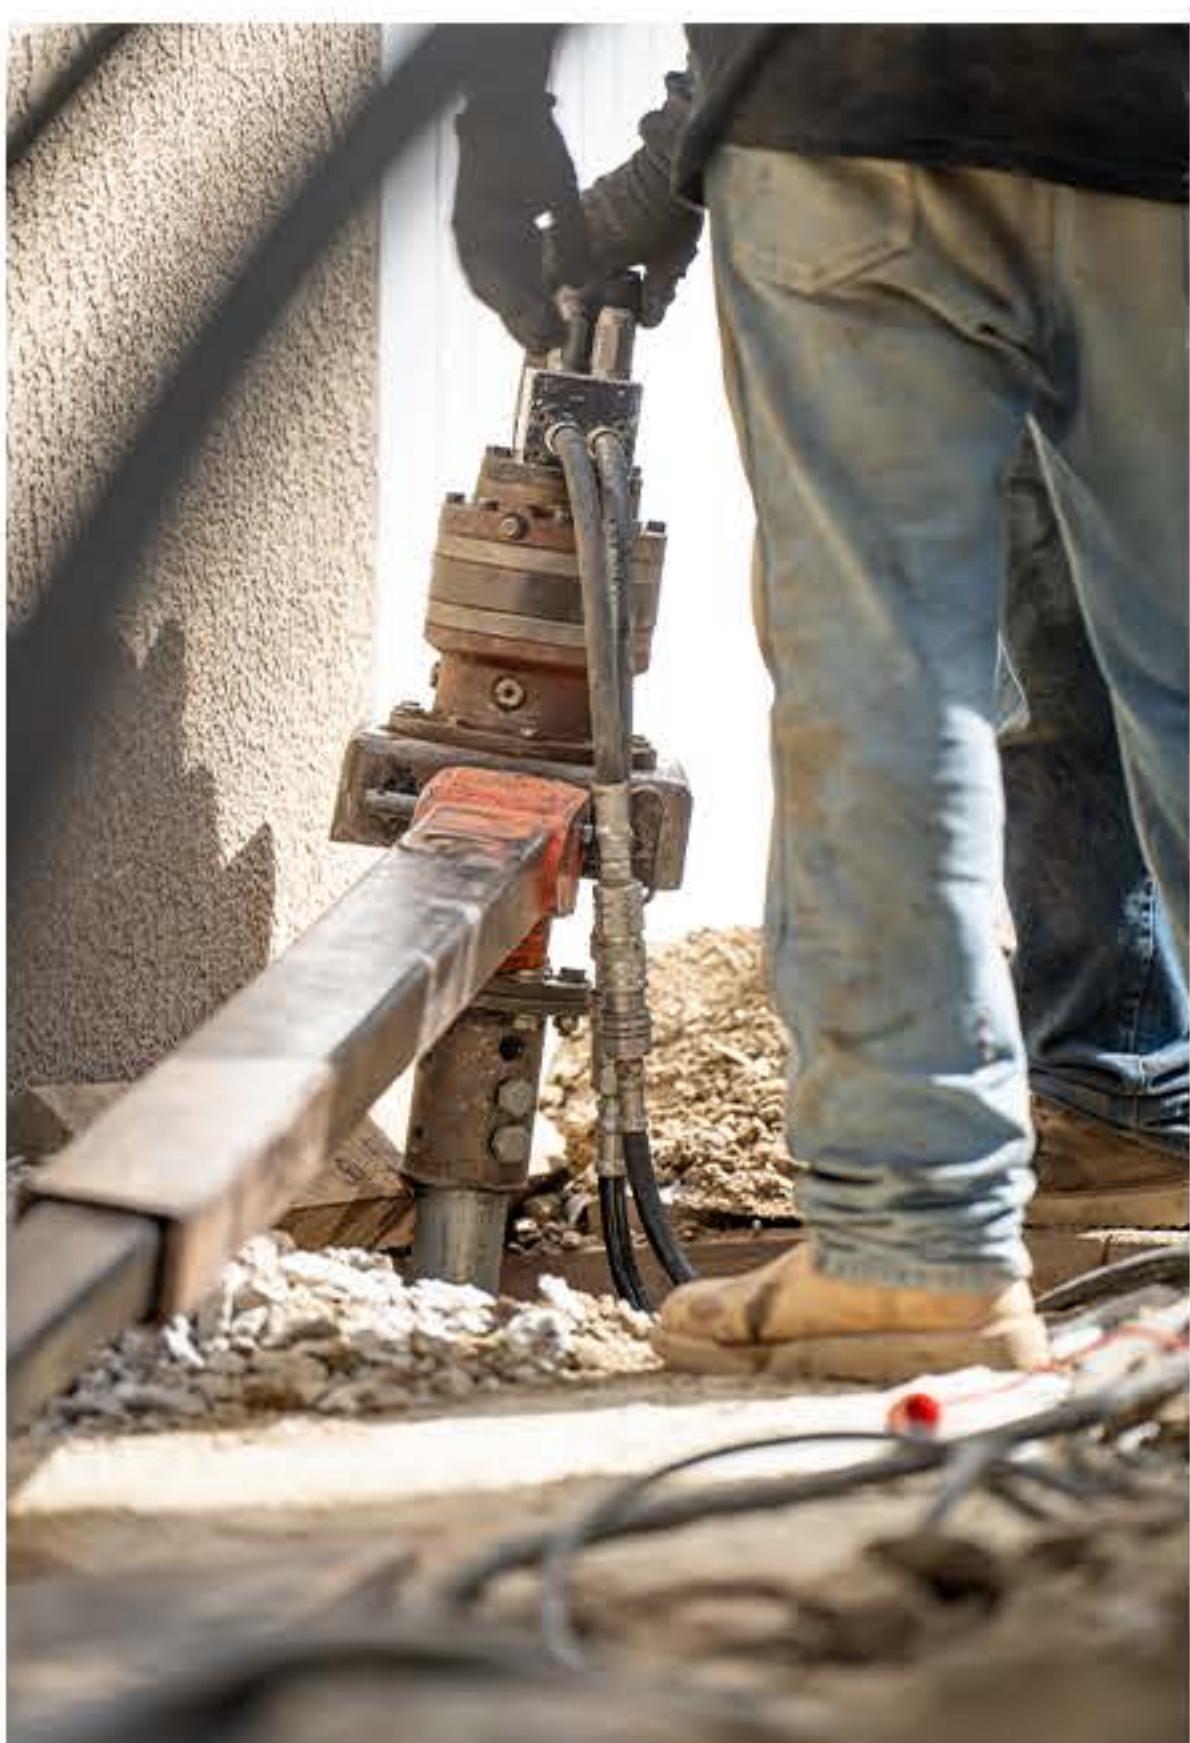
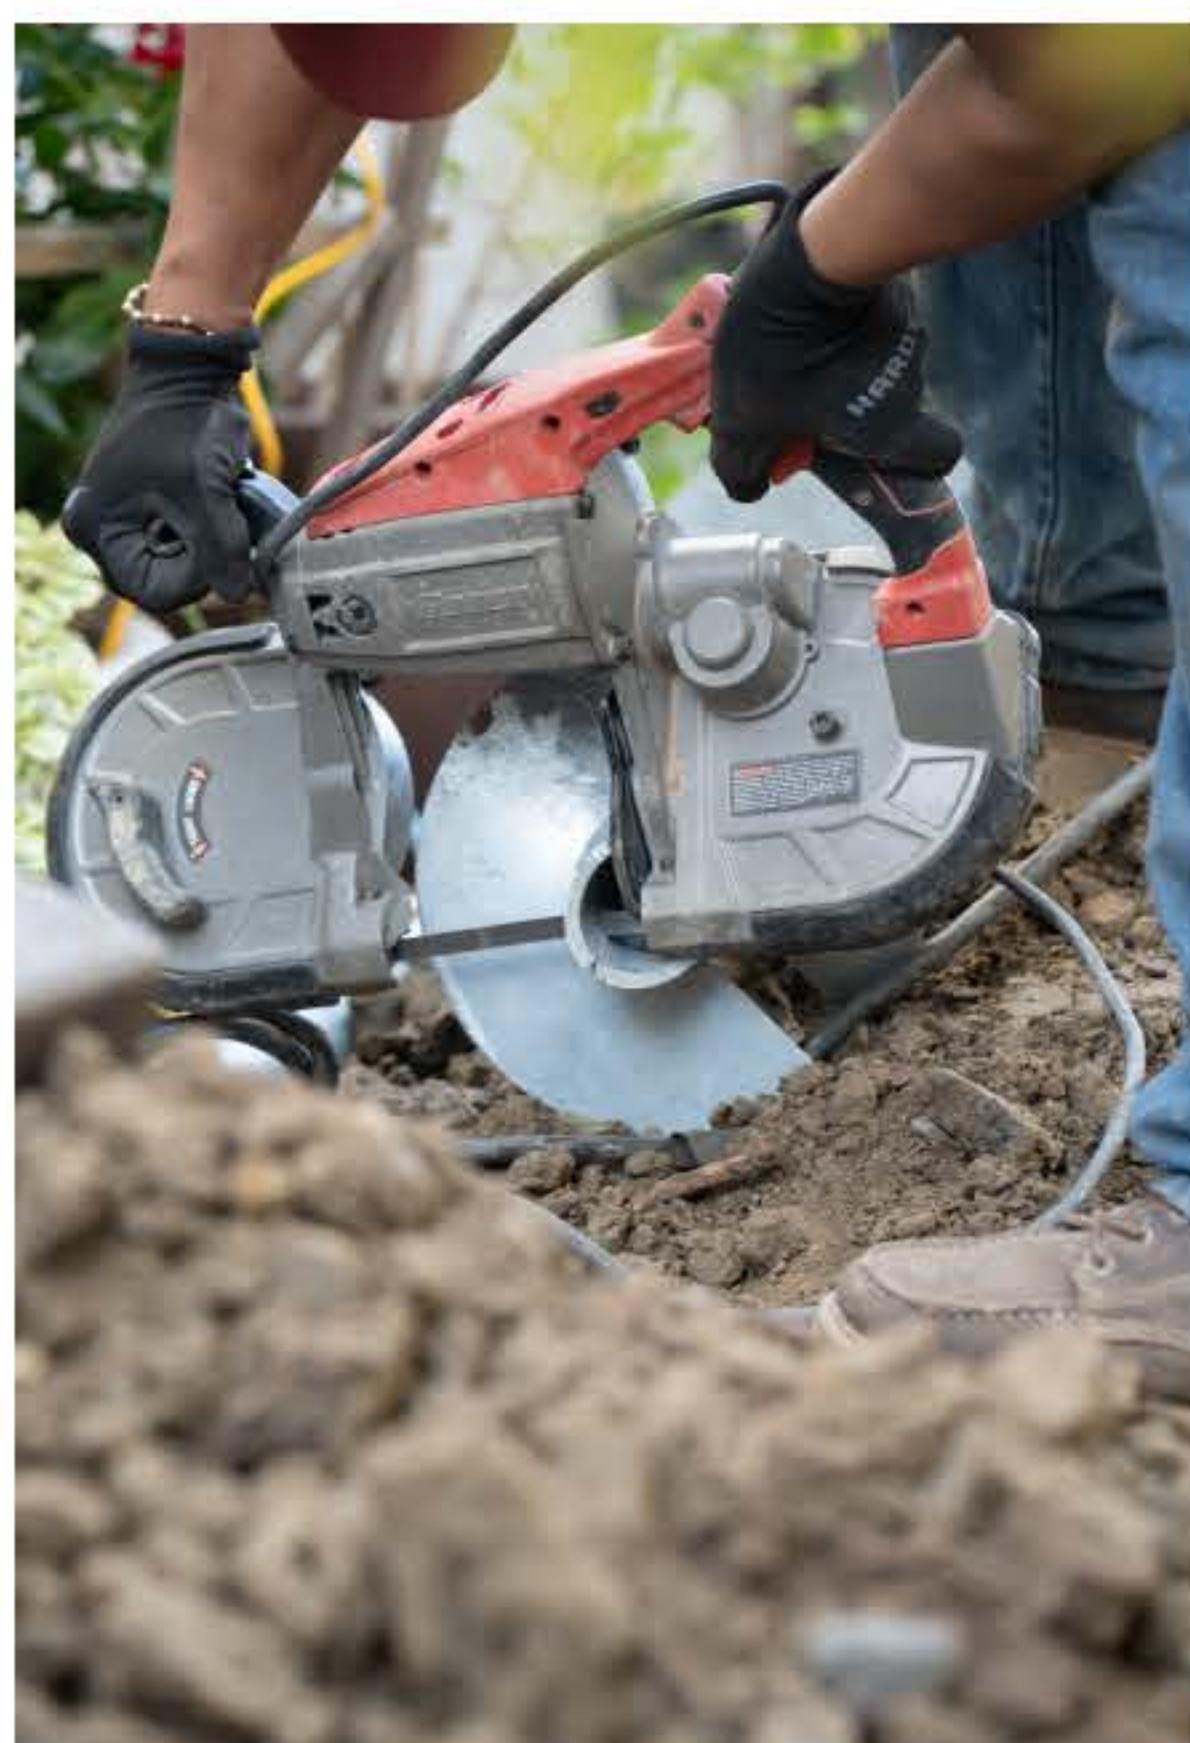
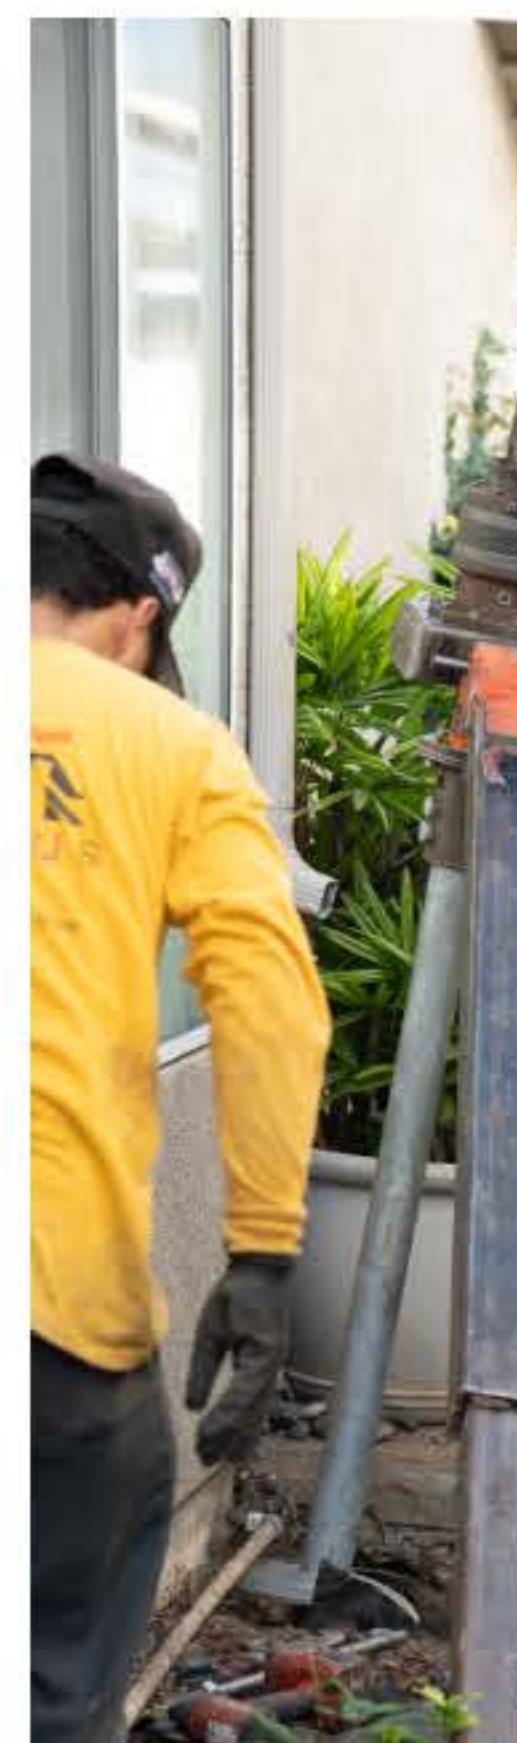
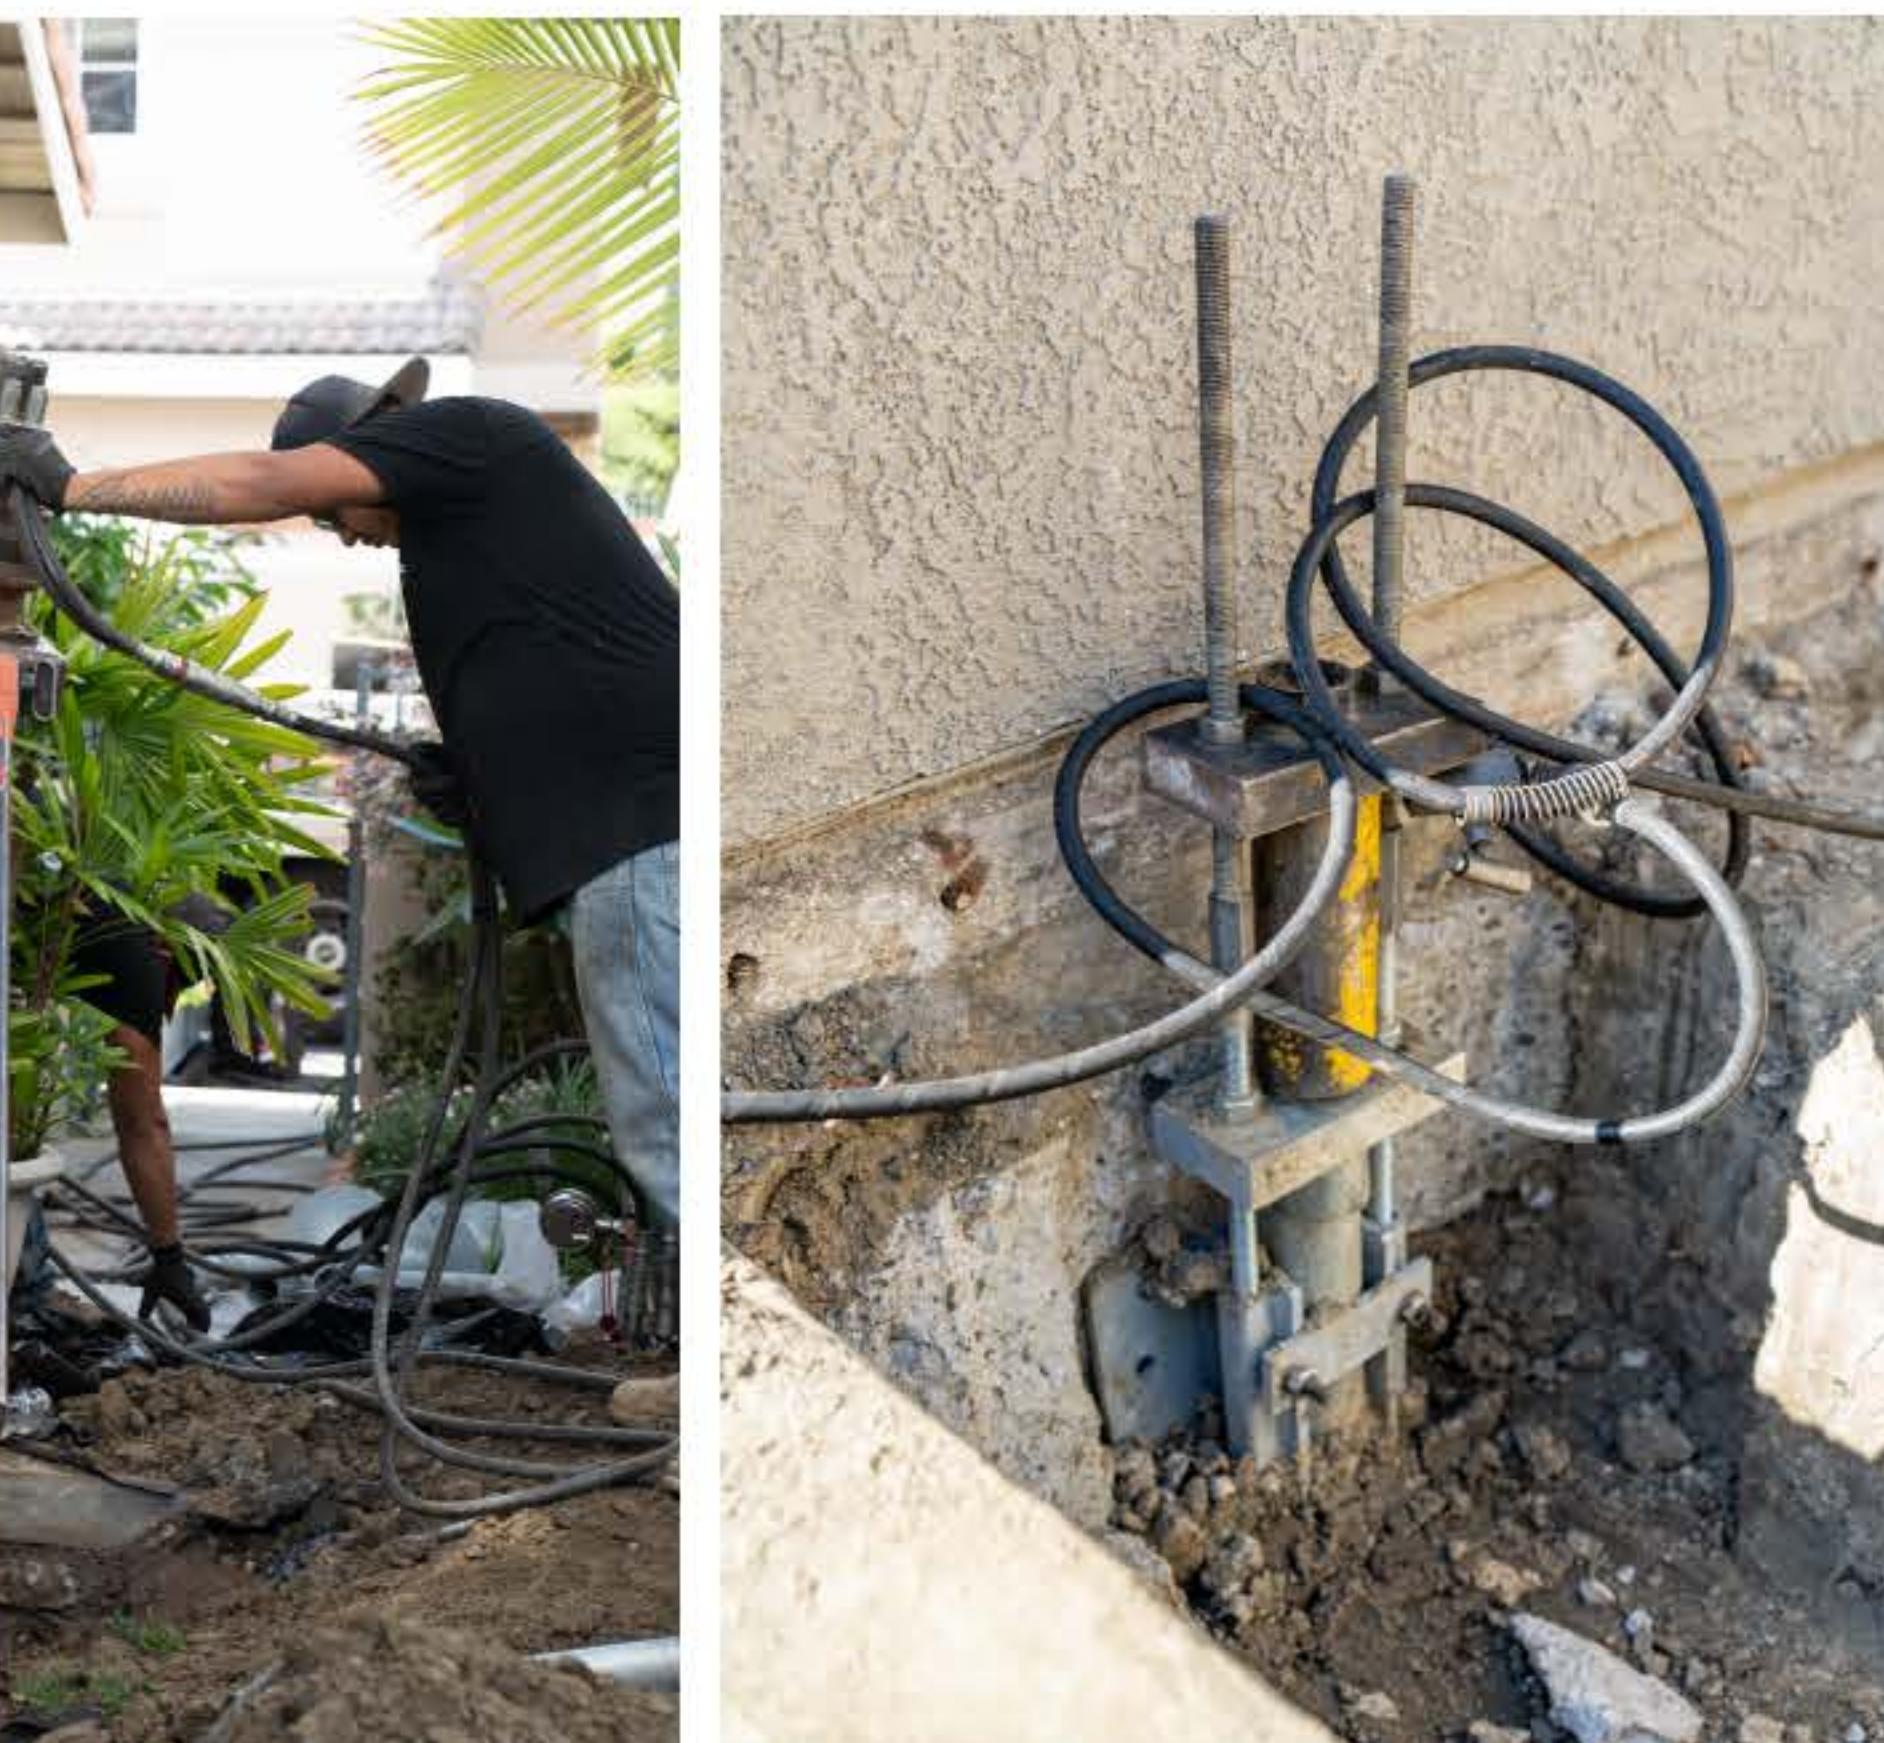
With very tight access around the home our project foreman, Joaquin Salazar, and his crew were forced to install all of the helical piles with handheld equipment. During excavations they found loads of expansive clay soils and ended up finding competent, load-bearing soils at depths of about 30'.

While taking his floor elevation measurements before the crew attempted to lift, Joaquin measured the home had settled an additional inch in several areas since the initial foundation evaluation with Phil!
