## IDEAL Teams with CMI Structural Solutions to Underpin a 100-Year-Old Community Center in Pittsford, NY

Winter, 2018

<b>Project Name &amp; Location:</b>	Community Center - Pittsford, NY
<b>Project Date:</b>	Winter 2018
<b>Project Type:</b>	Helical Piles for Underpinning and Shoring
<b>Helical Pile Installation Contractor:</b>	CMI Structural Solutions - <a href="https://www.cmistructural.com/">https://www.cmistructural.com/</a>
<b>Civil &amp; Structural Engineer:</b>	Jenson BRV Engineering, PLLC - <a href="http://jensenbrv.com/">http://jensenbrv.com/</a>
<b>General Contractor:</b>	LeChase Construction Services, LLC - <a href="https://www.lechase.com/">https://www.lechase.com/</a>
<b>Helical Piles Specifications:</b>	(14) 7.00" x 0.408" Wall with 16"-18" Helix Bearing Plates and (14) 4.50" x .337" Wall with 14"-16" Helical Bearing Plates - Non-Galvanized
<b>Soils &amp; Loads:</b>	Clay with Bedrock Ranging from 20-25 ft. Across Site; Avg Installation Depth 30-40 ft.
<b>Project Timeline:</b>	(8) Days
<b>Helical Pile Manufacturer:</b>	IDEAL Foundation Systems - Webster, NY

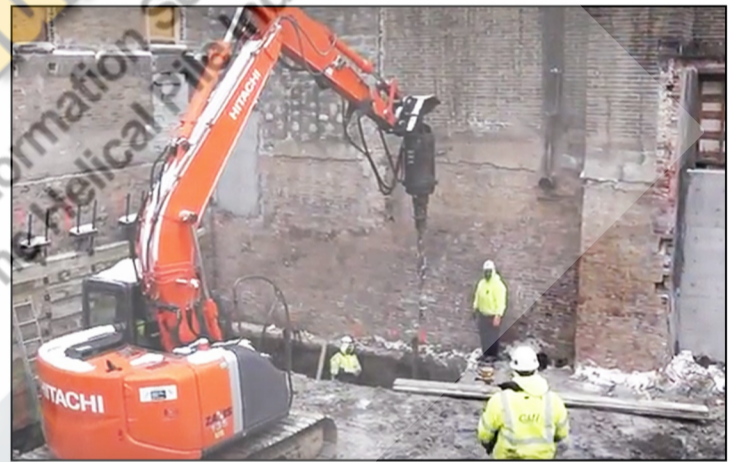
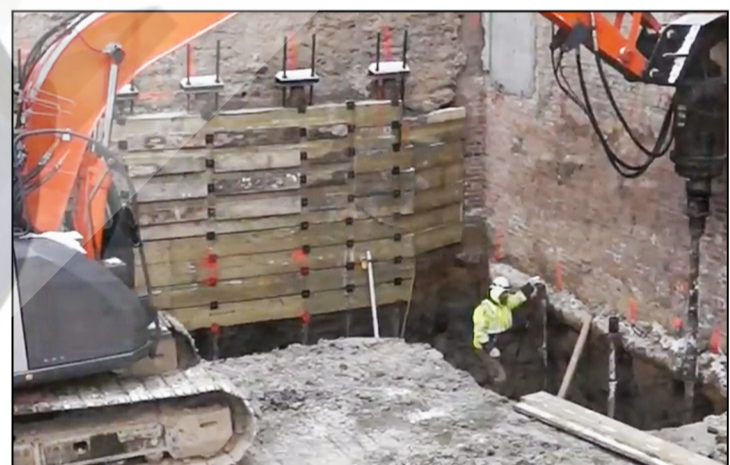
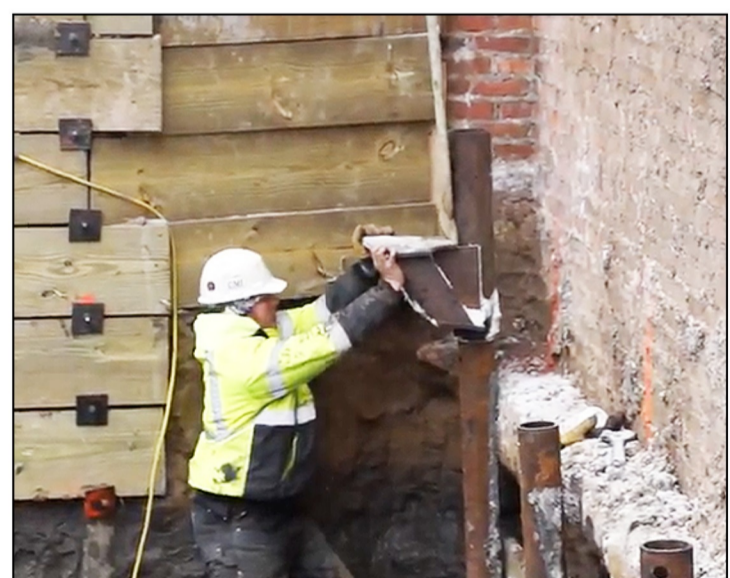
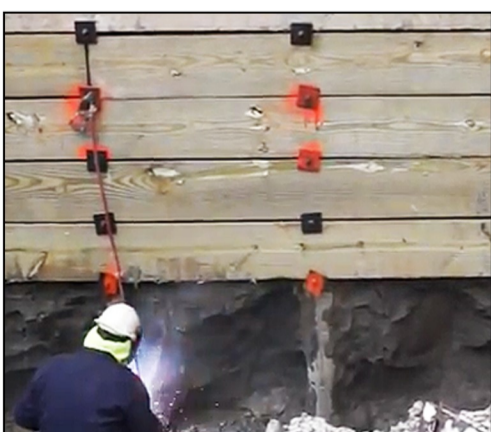
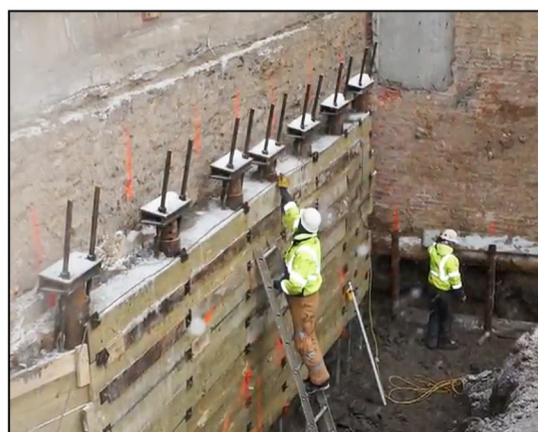
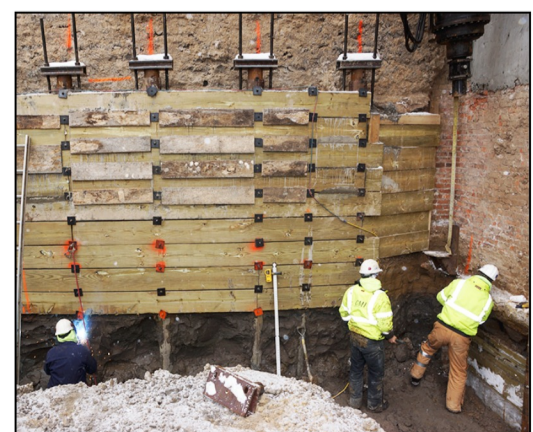
CMI Structural Solutions proposed a solution for the retrofit, underpinning, and shoring of the 100-year-old community center. This included the use of helical piles and Counterforce underpinning brackets from Ideal. To stabilize the structure, CMI installed fourteen 7" OD. x 408" WT and 4.5" OD x 337" WT helical piles. The piles were installed to 20-foot and 30-foot depths. Counterforce underpinning brackets were used at each pile location. Once all of the piles were installed, timber lagging was attached to the face of the piles as the excavation continued. A unique feature and advantage of this temporary shoring is that the timber lagging can be removed as the excavation is backfilled, and re-used elsewhere in the future.
