2016 CASE STUDY

Type: Residential | Issue: IL201601

New Foundation for Sinkhole- Damaged Garage

MULTI-HELIX PILES SUPPORT NEW GARAGE FOUNDATION

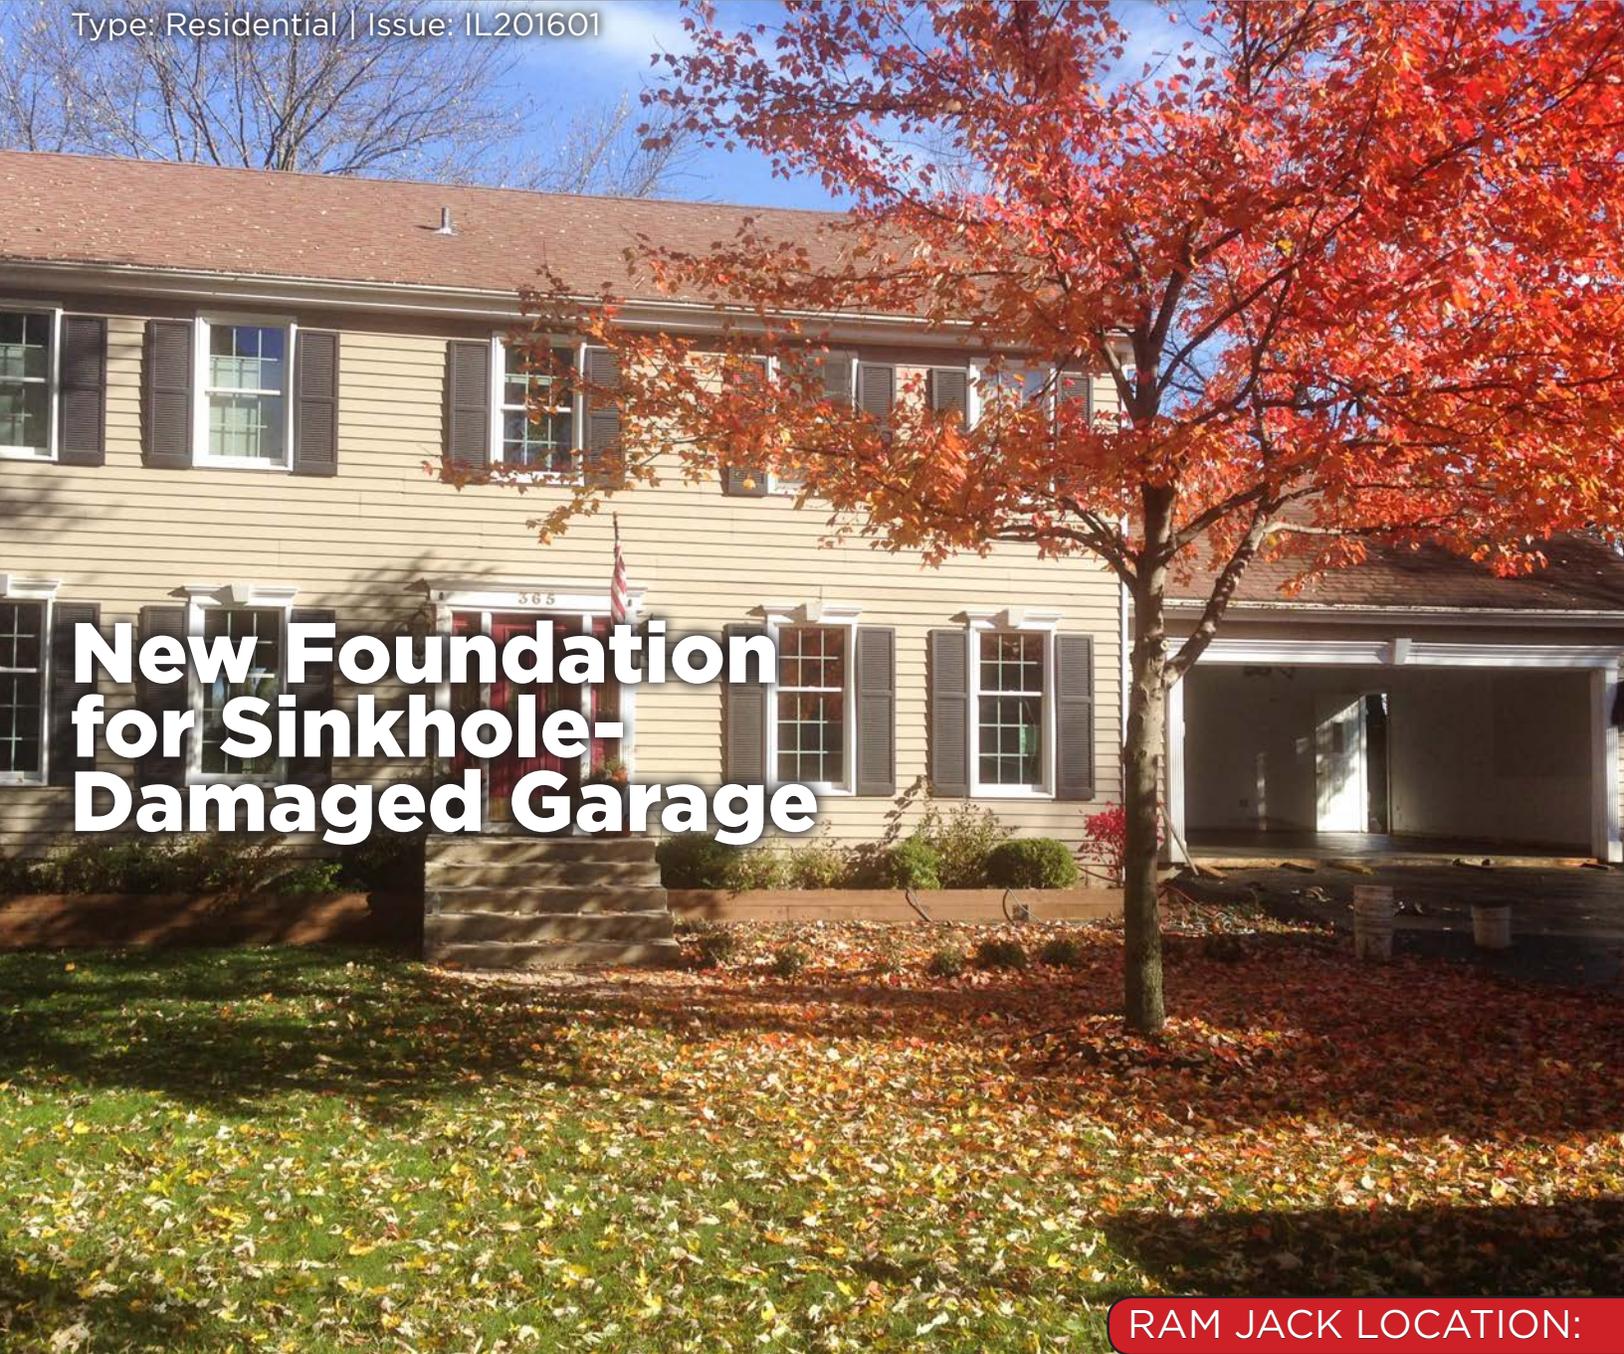
A sinkhole opened in the garage floor of a home in Barrington, IL, that backs up to Cuba Marsh, which is affected by poor soil conditions. The Structural Shop LTD investigated the initial damage. They contacted Ram Jack Illinois to remove debris and take elevations and measurements for an engineer to design a repair plan.

All eight (8) piles were installed as planned to an average depth of 40 ft. with guide sleeves used for the full depth. After pile installation, 80 tons of CA-6 granular material was placed in lifts and compacted to prepare the soil for the new reinforced slab with grade beams. While helical piles can accept loads immediately, the newly poured slab required a week to cure. The homeowner was pleased to be able to use the garage just in time for the cold winter months.

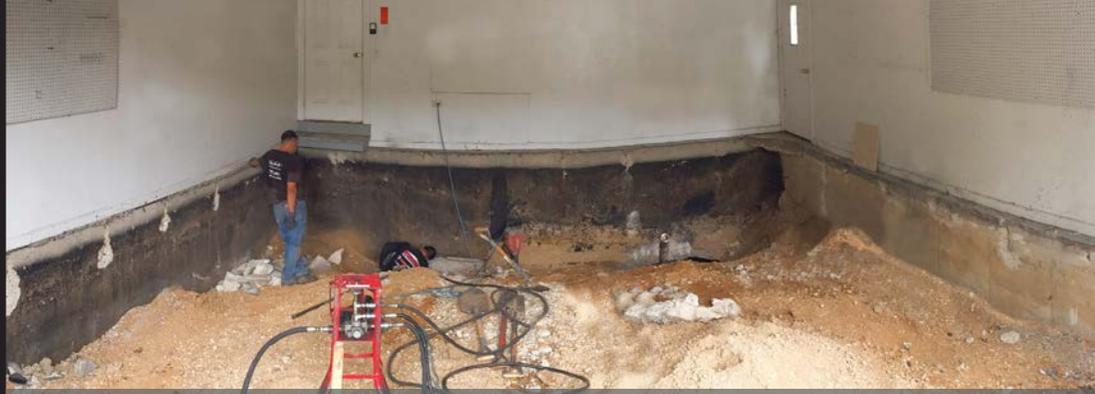
Installation of helical piles to remedy sinkhole damage to basement

the garage foundation and pouring a reinforced structural slab. Guide sleeves would be used due to soft soils. Ram Jack was hired to install four (4) helical piles with a multi-helix configuration on the existing foundation. Four (4) additional multi-helix piles were to be installed with new construction brackets to support a new slab.
