CASESTUDY

JAN 2024

**CITY OF ORANGE CONDO
SETTLED ALMOST 6 INCHES
STABILIZED WITH HELICALS**

HELICAL PILES ABLE TO LIFT & RECOVER 6 INCHES OF SETTLEMENT AT HILLSIDE MOUNTAIN COMMUNITY DUPLEX

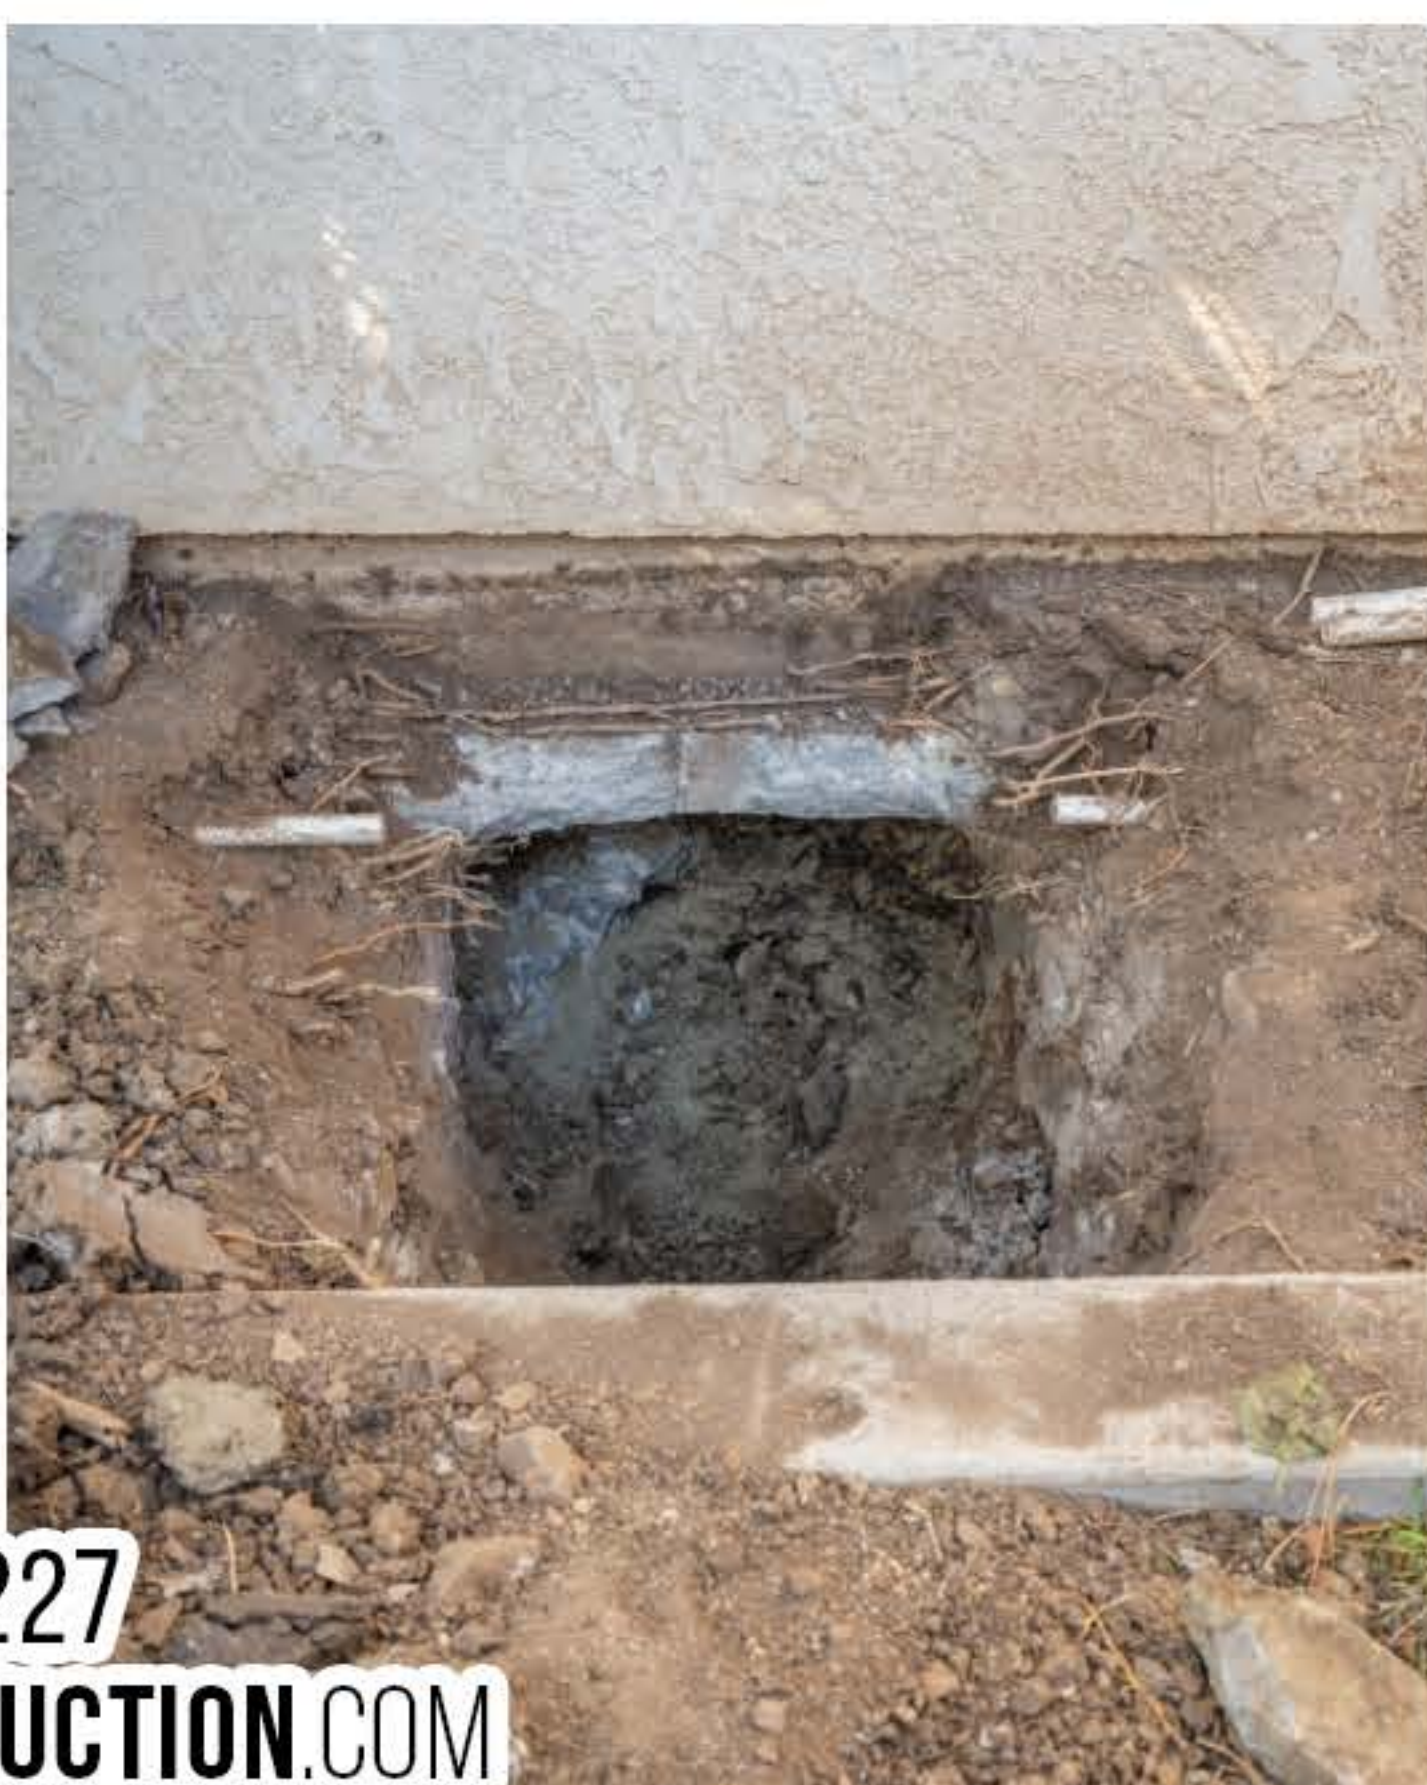
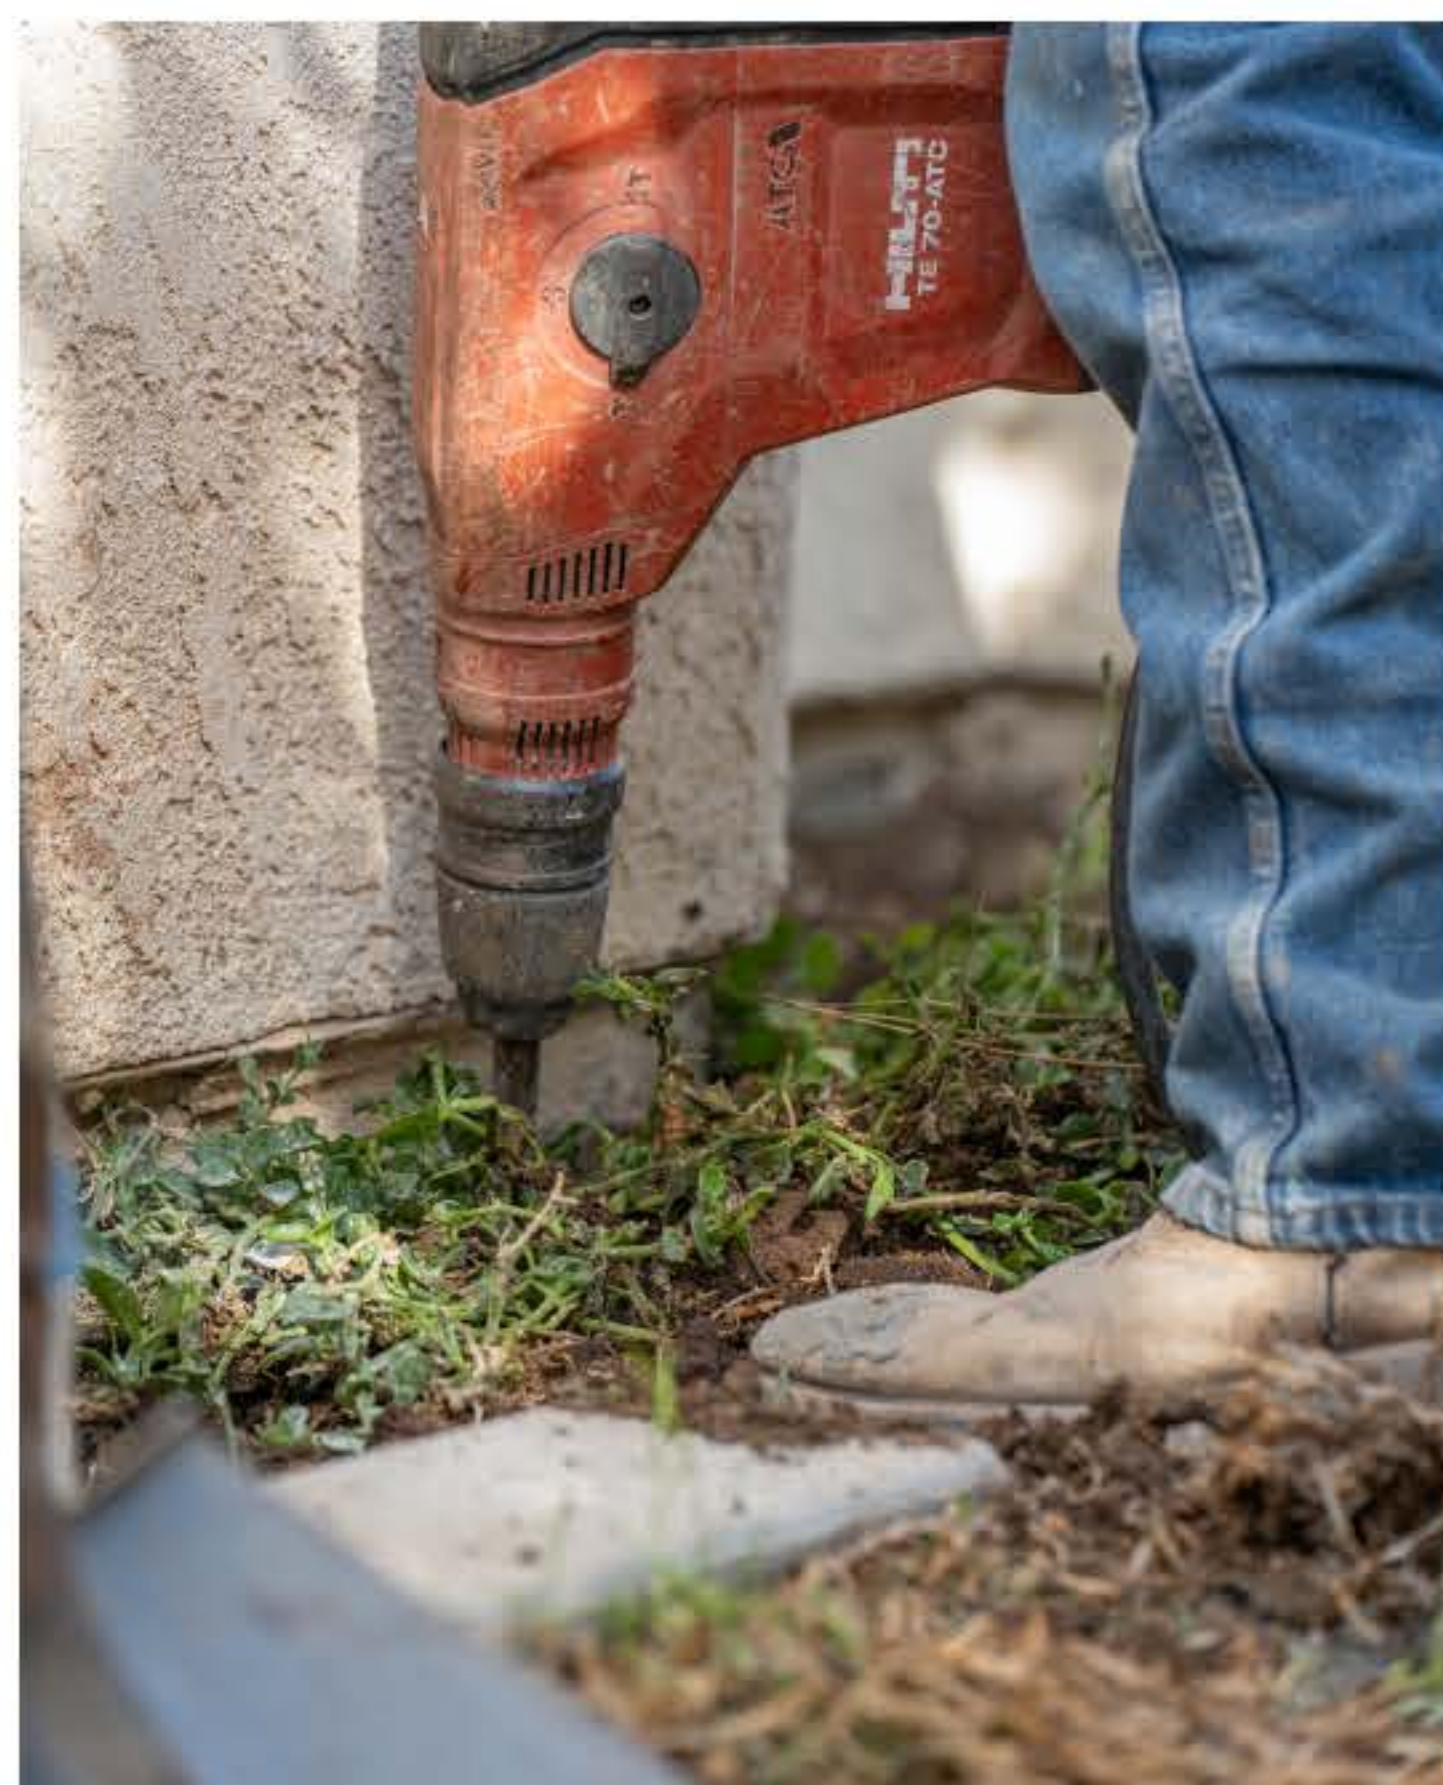
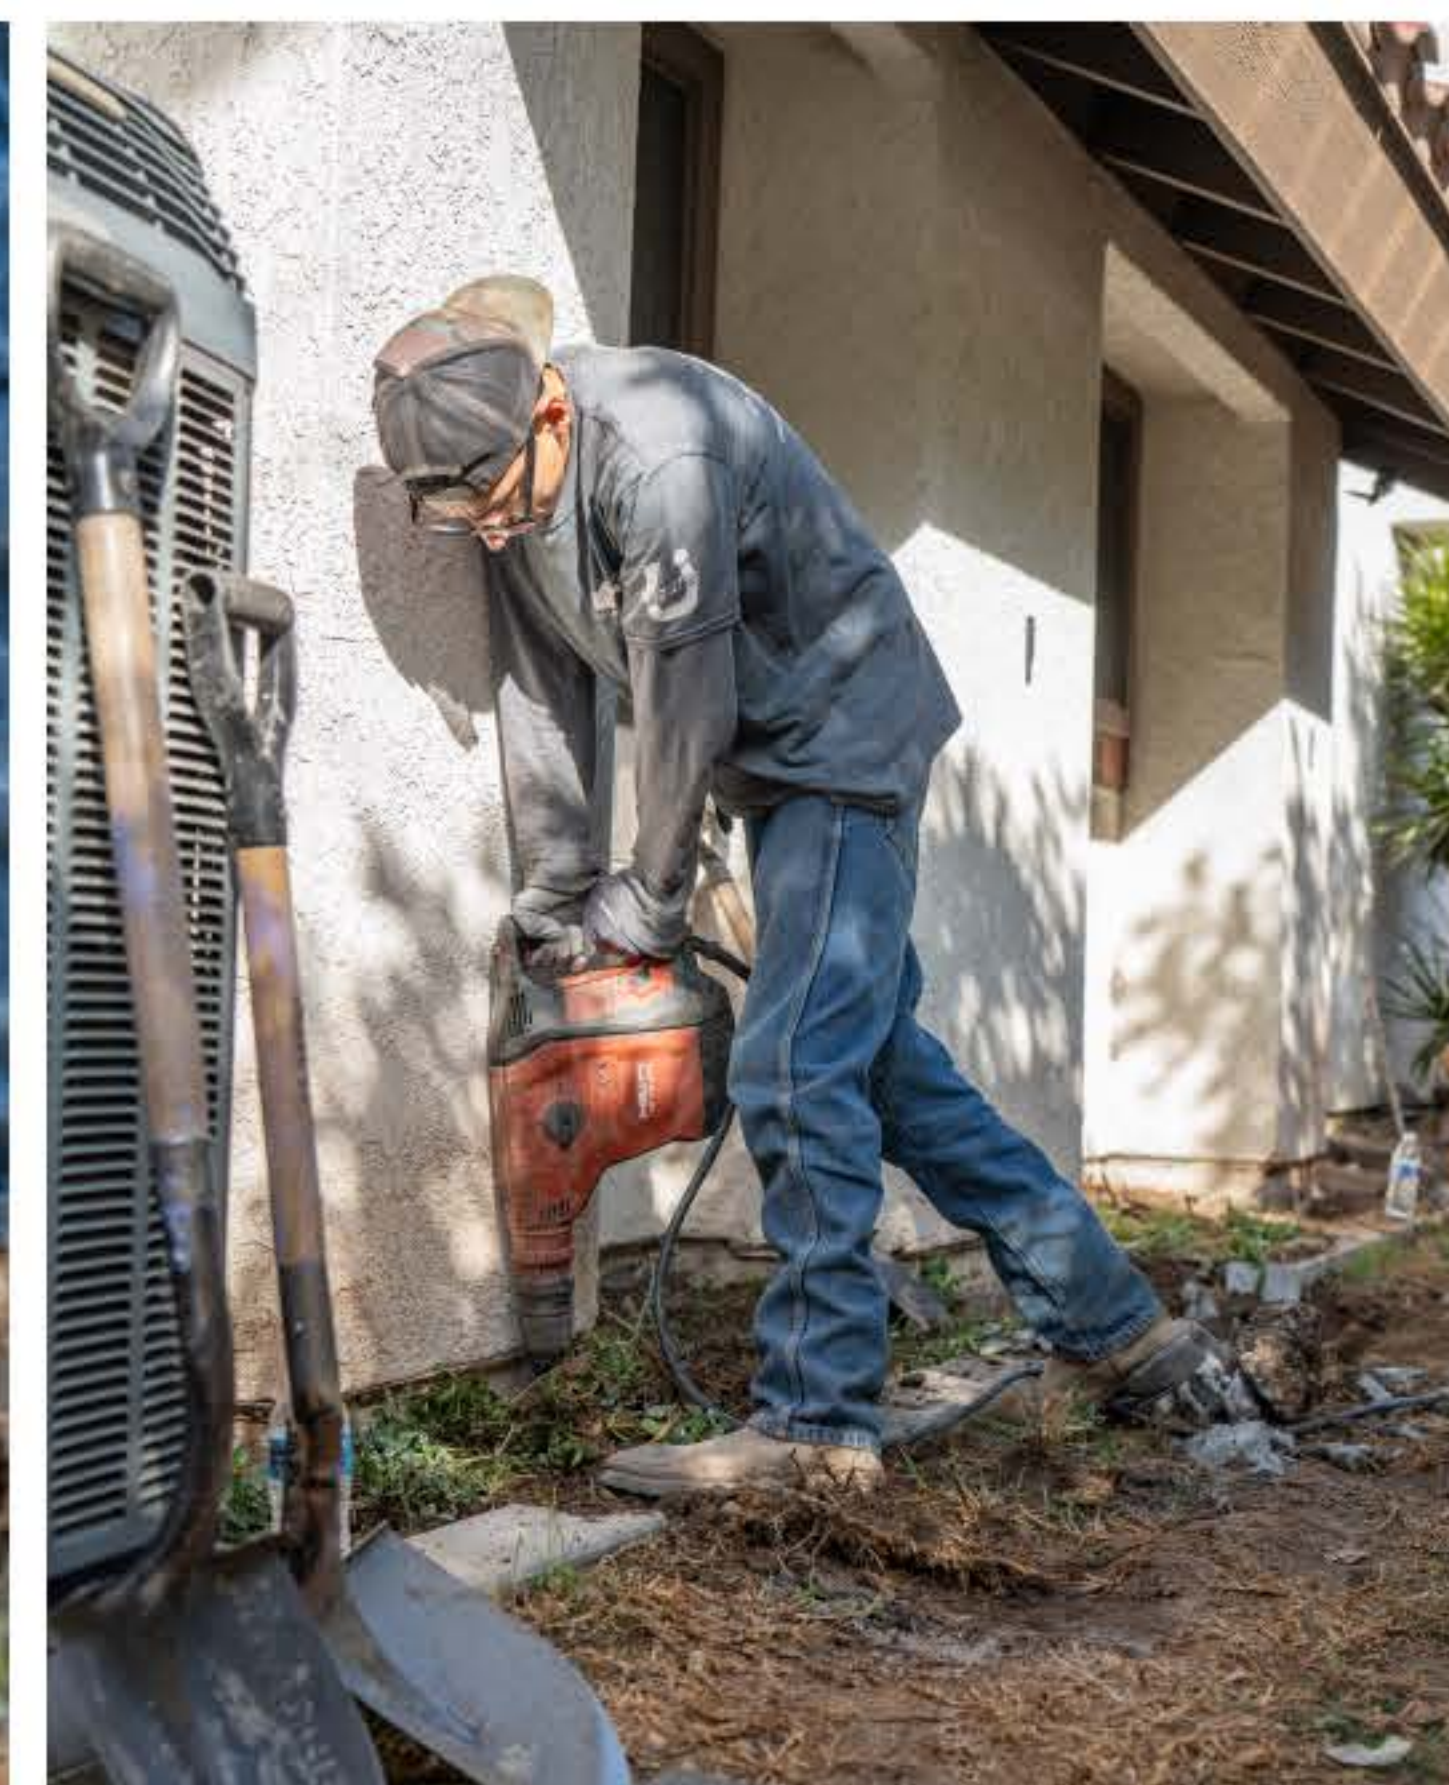
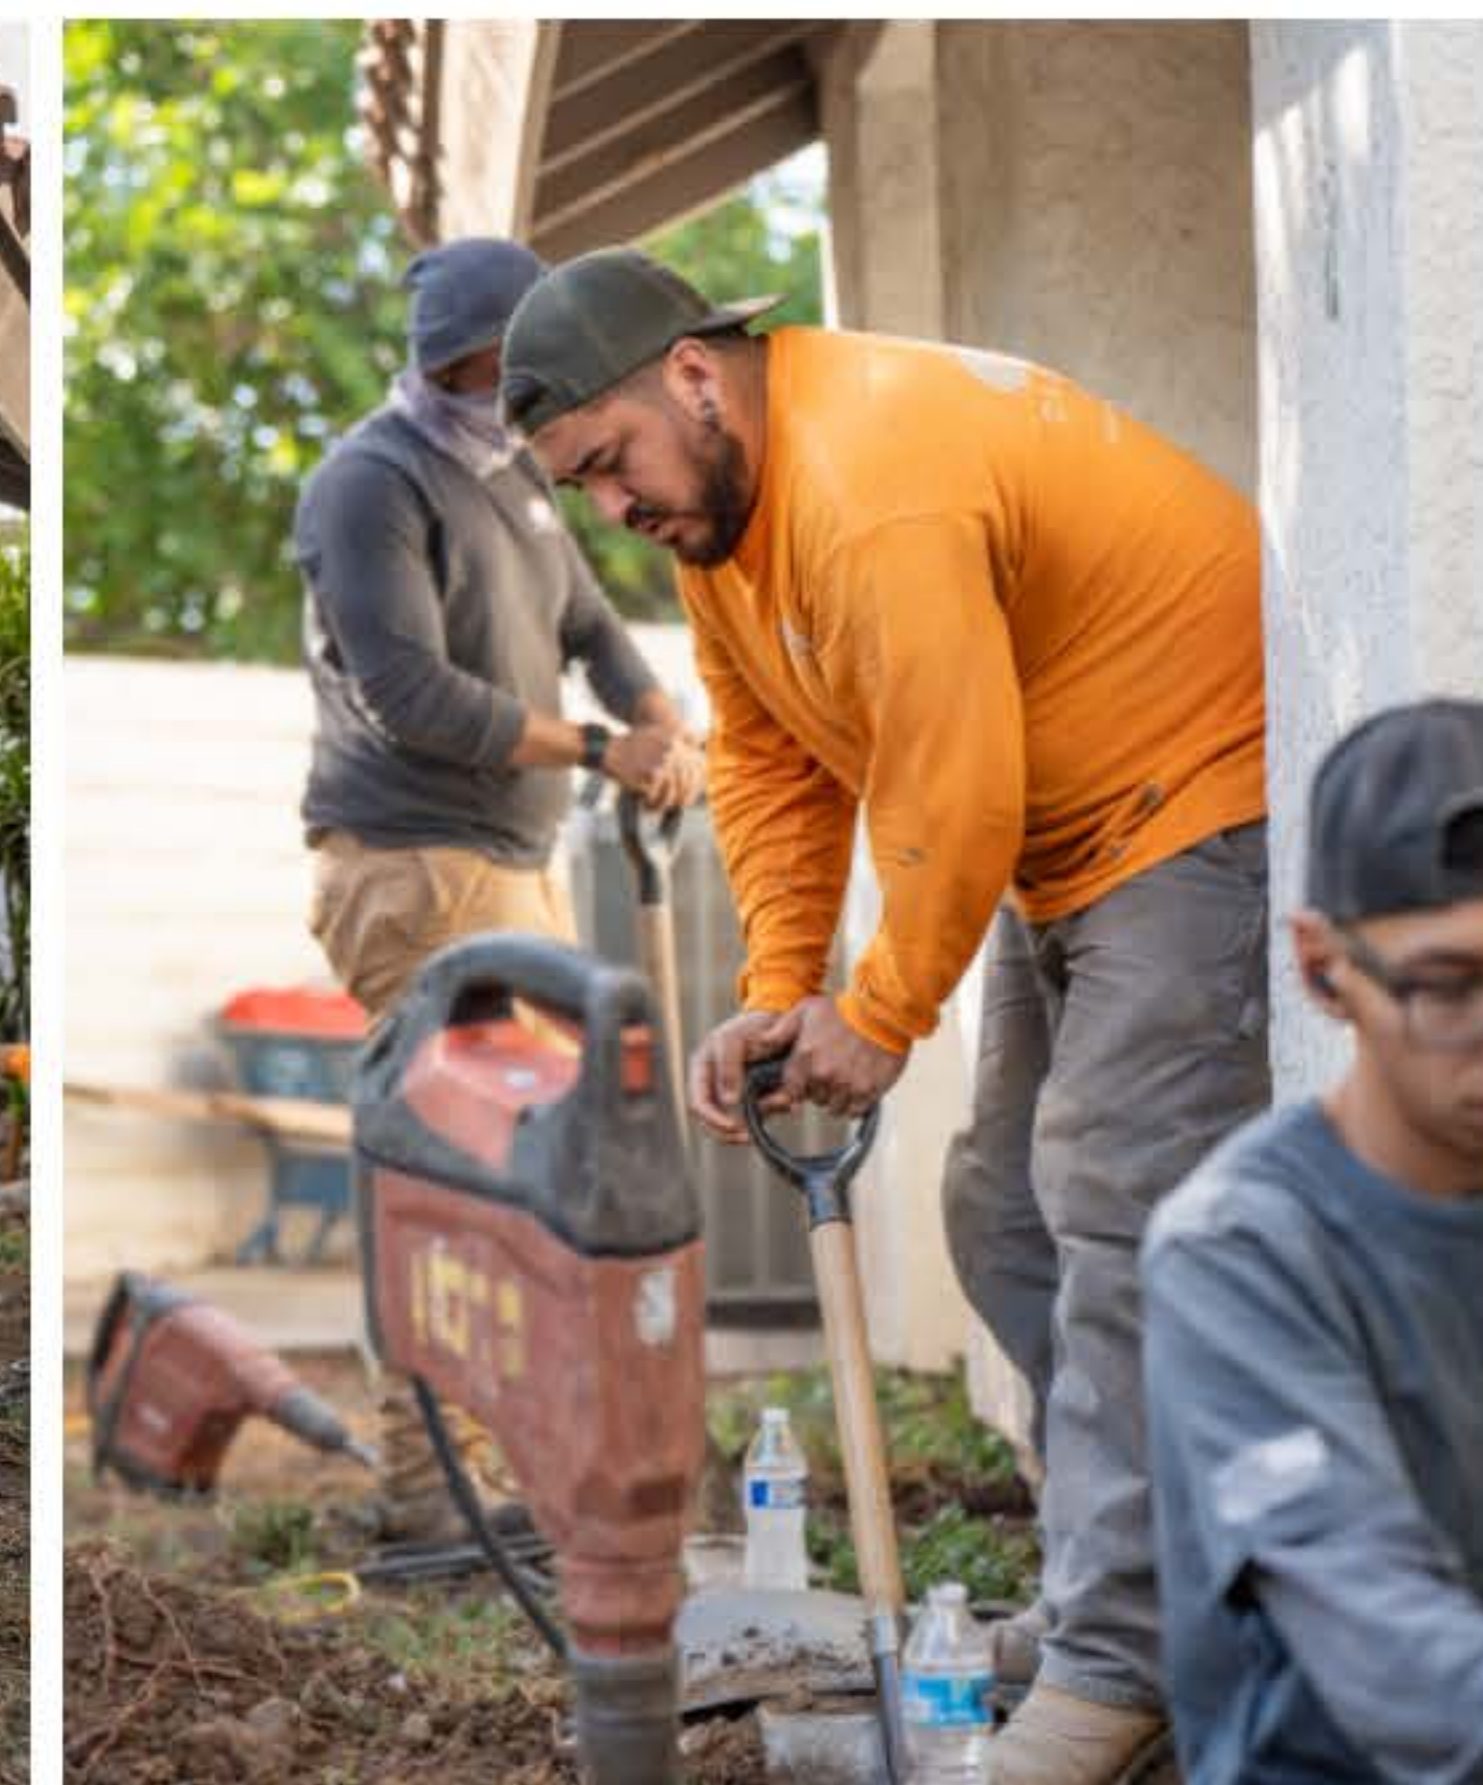
Upon starting their excavations the crew found relatively shallow footings, which meant they wouldn't need to excavate too much soil to expose the footings and allow for the helical brackets to be mounted. They found competent, load-bearing soils at an average depth of about 16 feet below the home's footing. Once the helical piles were installed our polyurethane crew arrived on site to inject poly while simultaneously hydraulically lifting the home. During the lift the crews were able to recover about 5 of the 6 inches of settlement before locking off the brackets and ensuring this area of the home would not settle again in the future.
