CASE HISTORY

Vaspoli Custom Builders

Palmyra, NJ

Korman Suites

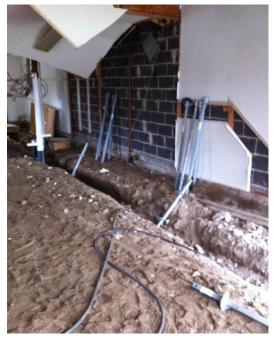
The apartments were built on piles however, the slab-on-grade was not. The first floor SOG starting settling drastically due to the FILL layers below. In some instances, the differential settlement was 8 inches or more. To make the situation worse, the original contractors poured another slab on top of the SOG to try and solve the issue. Unfortunately, this made the slab settle more due to the addition weight. This is where Steve Vaspoli's team stepped in to resolve the issue using ChanceTM helical piles.

- # of ChanceTM Helical Piles = 10 piles per building 48 Buildings
 = 480 piles and the project is still going as of May 2012
- SS5 with 6", 8" diameter helices
- Installation Length = 25 FEET to the River Rock Stratum.
- Removal of the existing SOG was followed by digging a grade beam ditch around the perimeter. Then Chance™ helical piles were installed to support the grade beam. The new structural slabs were poured and tied into the helical pile supported grade beams.
