Void in Soil Causes Severe Foundation Settlement

Twelve piles stabilize failing foundation

HOME SECURED AFTER SINKING FOUNDATION CAUSES TROUBLE

CRAWLSPACE FOUNDATION STABILIZATION
MCCOLL, SOUTH CAROLINA

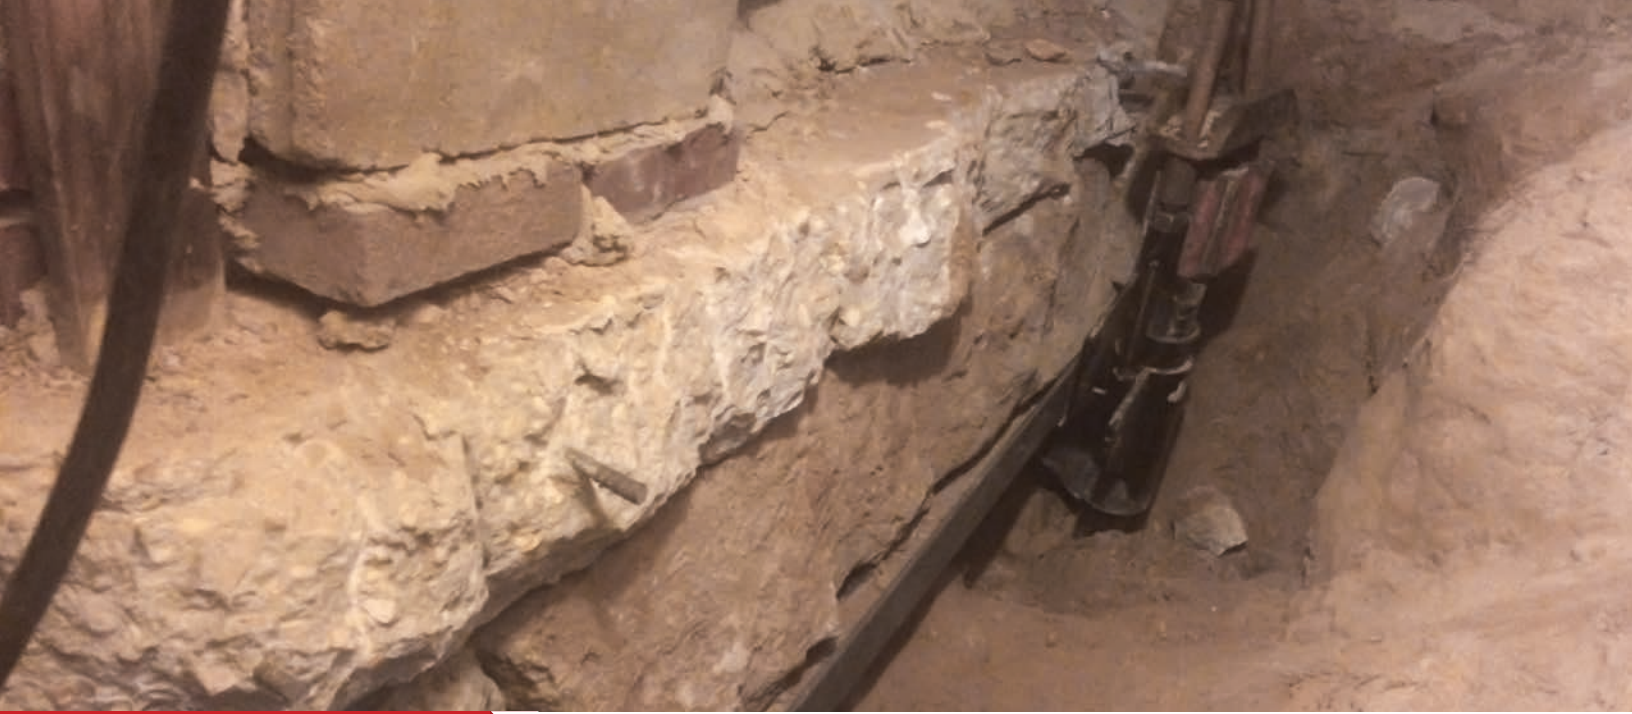
While performing an inspection of the home in the crawlspace, the pest control technician noticed cracks in the foundation of the home.

During installation, Ram Jack discovered a void in the soil which was causing the house to sink significantly. Ram Jack installed two (2) more helical piles on the backside of the porch. While there, the severely damaged footing was reinforced with continuous lengths of angle iron to support it on the west side of the home further. The residence was lifted six (6) in. for maximum practical recovery.

Ram Jack South Carolina initially proposed installing seven (7) driven piles and two (2) helical piles along the perimeter of the west side of the

home and one (1) helical pile on the interior to stabilize and support the cracking foundation.
