## **Void in Soil Causes Severe Foundation Settlement**

**Twelve piles stabilize failing foundation**

## HOME SECURED AFTER SINKING FOUNDATION CAUSES TROUBLE

CRAWLSPACE FOUNDATION STABILIZATION  
MCCOLL, SOUTH CAROLINA

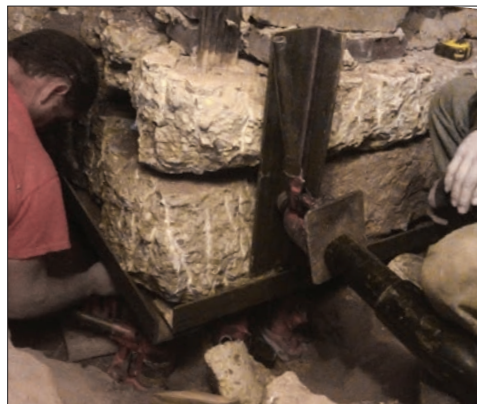
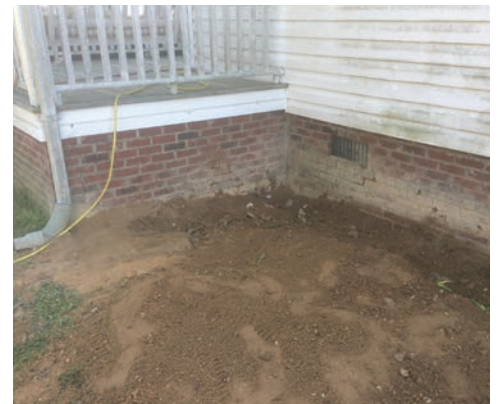
While performing an inspection of the home in the crawlspace, the pest control technician noticed cracks in the foundation of the home.

During installation, Ram Jack discovered a void in the soil which was causing the house to sink significantly. Ram Jack installed two (2) more helical piles on the backside of the porch. While there, the severely damaged footing was reinforced with continuous lengths of angle iron to support it on the west side of the home further. The residence was lifted six (6) in. for maximum practical recovery.

Ram Jack South Carolina initially proposed installing seven (7) driven piles and two (2) helical piles along the perimeter of the west side of the

home and one (1) helical pile on the interior to stabilize and support the cracking foundation.
