Structural Systems Repair Group (SSRG) Installs (9) Helical Piles for Historic Building Renovations in Cincinnati

Project Name & Location:	Manse Apartments – Cincinnati, OH
Project Date:	January 2020
Project Type:	Helical Piles Deep Foundations
Helical Pile Installation Contractor:	Structural Systems Repair Group , Cincinnati, OH
Structural Engineer:	GEI Engineering, Inc. , Cincinnati, OH
General Contractor:	Model Group , Cincinnati, OH
Helical Pile Specifications:	(9) 2.875" Round shaft galvanized helical piles with 10", 12", 14" helix bearing plates; 20 Ton ultimate compression capacity
Soils & Embedment Depth:	Soils Consisted of Layers of Fat Lean Clays Average Pile Embedment 15 ft.
Project Timeline:	3 Days
Helical Pile Manufacturer:	Helical Anchors, Inc. - Minneapolis, MN

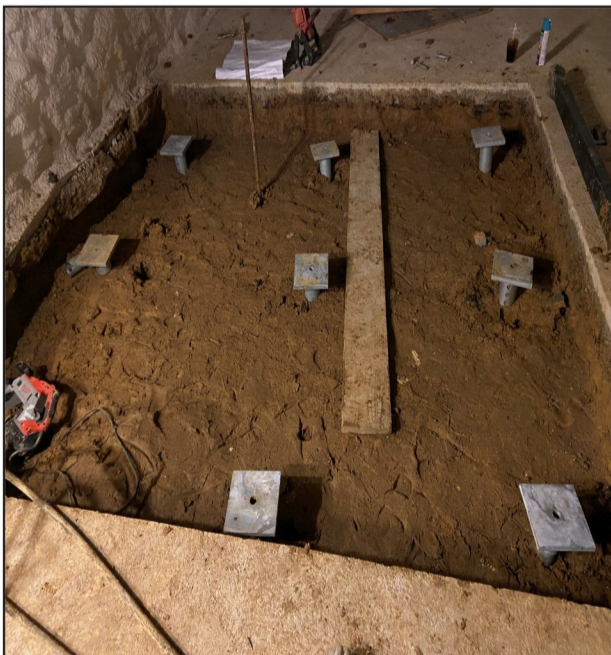
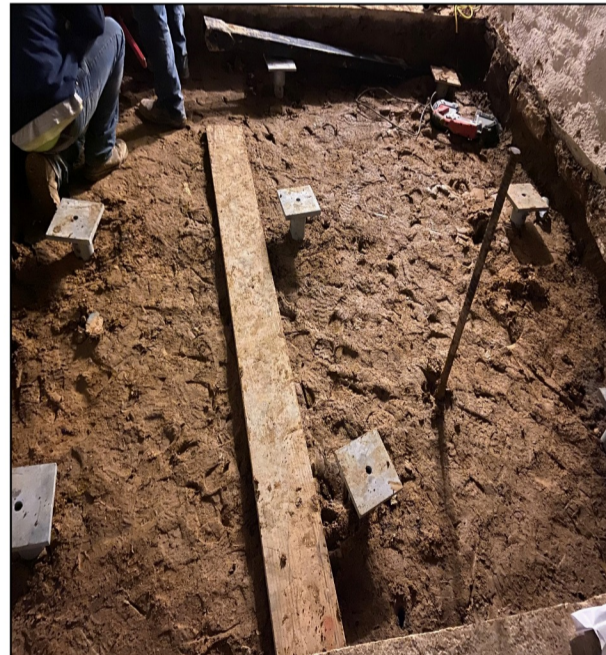
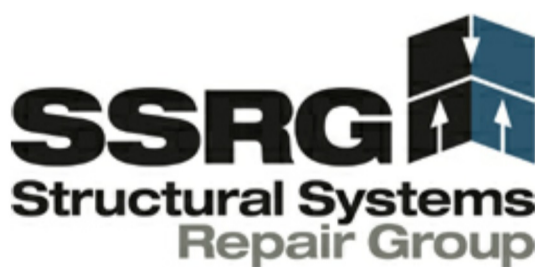
The major challenge involved in installation of helical piles at this location was poor bearing soils with soft consistency and limited access to elevator pit location. SSRG installed these piles in 5 ft. sections to achieve the required 20-ton ultimate capacity with the hand-held torque drive in this tight access basement. Engineers recommended helical piles due to limited access for equipment and capabilities of hand-held drive to install helical piles in such tight building areas.
