## Model 150 Helical Tiebacks

**Project:** Storage Facility Wall Stabilization

**Location:** Tallahassee, FL

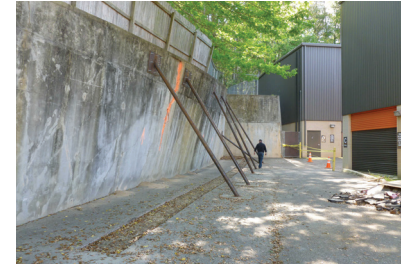
Retaining wall temporarily stabilized with steel tube bracing

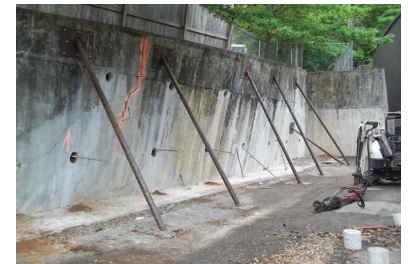
Bottom row of helical tiebacks being installed around bracing

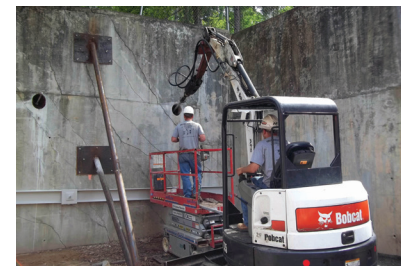
Installing top row of tiebacks; bottom waler complete

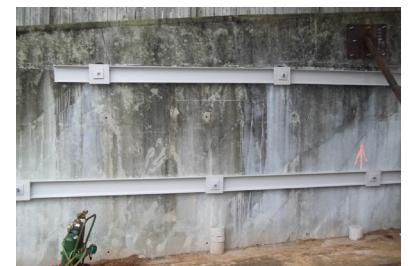
Completed tieback and waler system

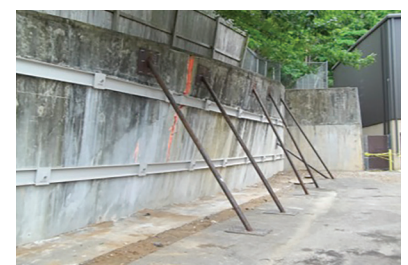
Completed tieback and waler system
