CASESTUDY

19 HELICAL PIERS USED TO STABILIZE & LIFT A SINKING GILBERT, AZ HOME

GILBERT HOMEOWNER CALLS DALINGHAUS CONSTRUCTION TO STABILIZE FOUNDATION THAT HAD SETTLED 1.5 INCHES!

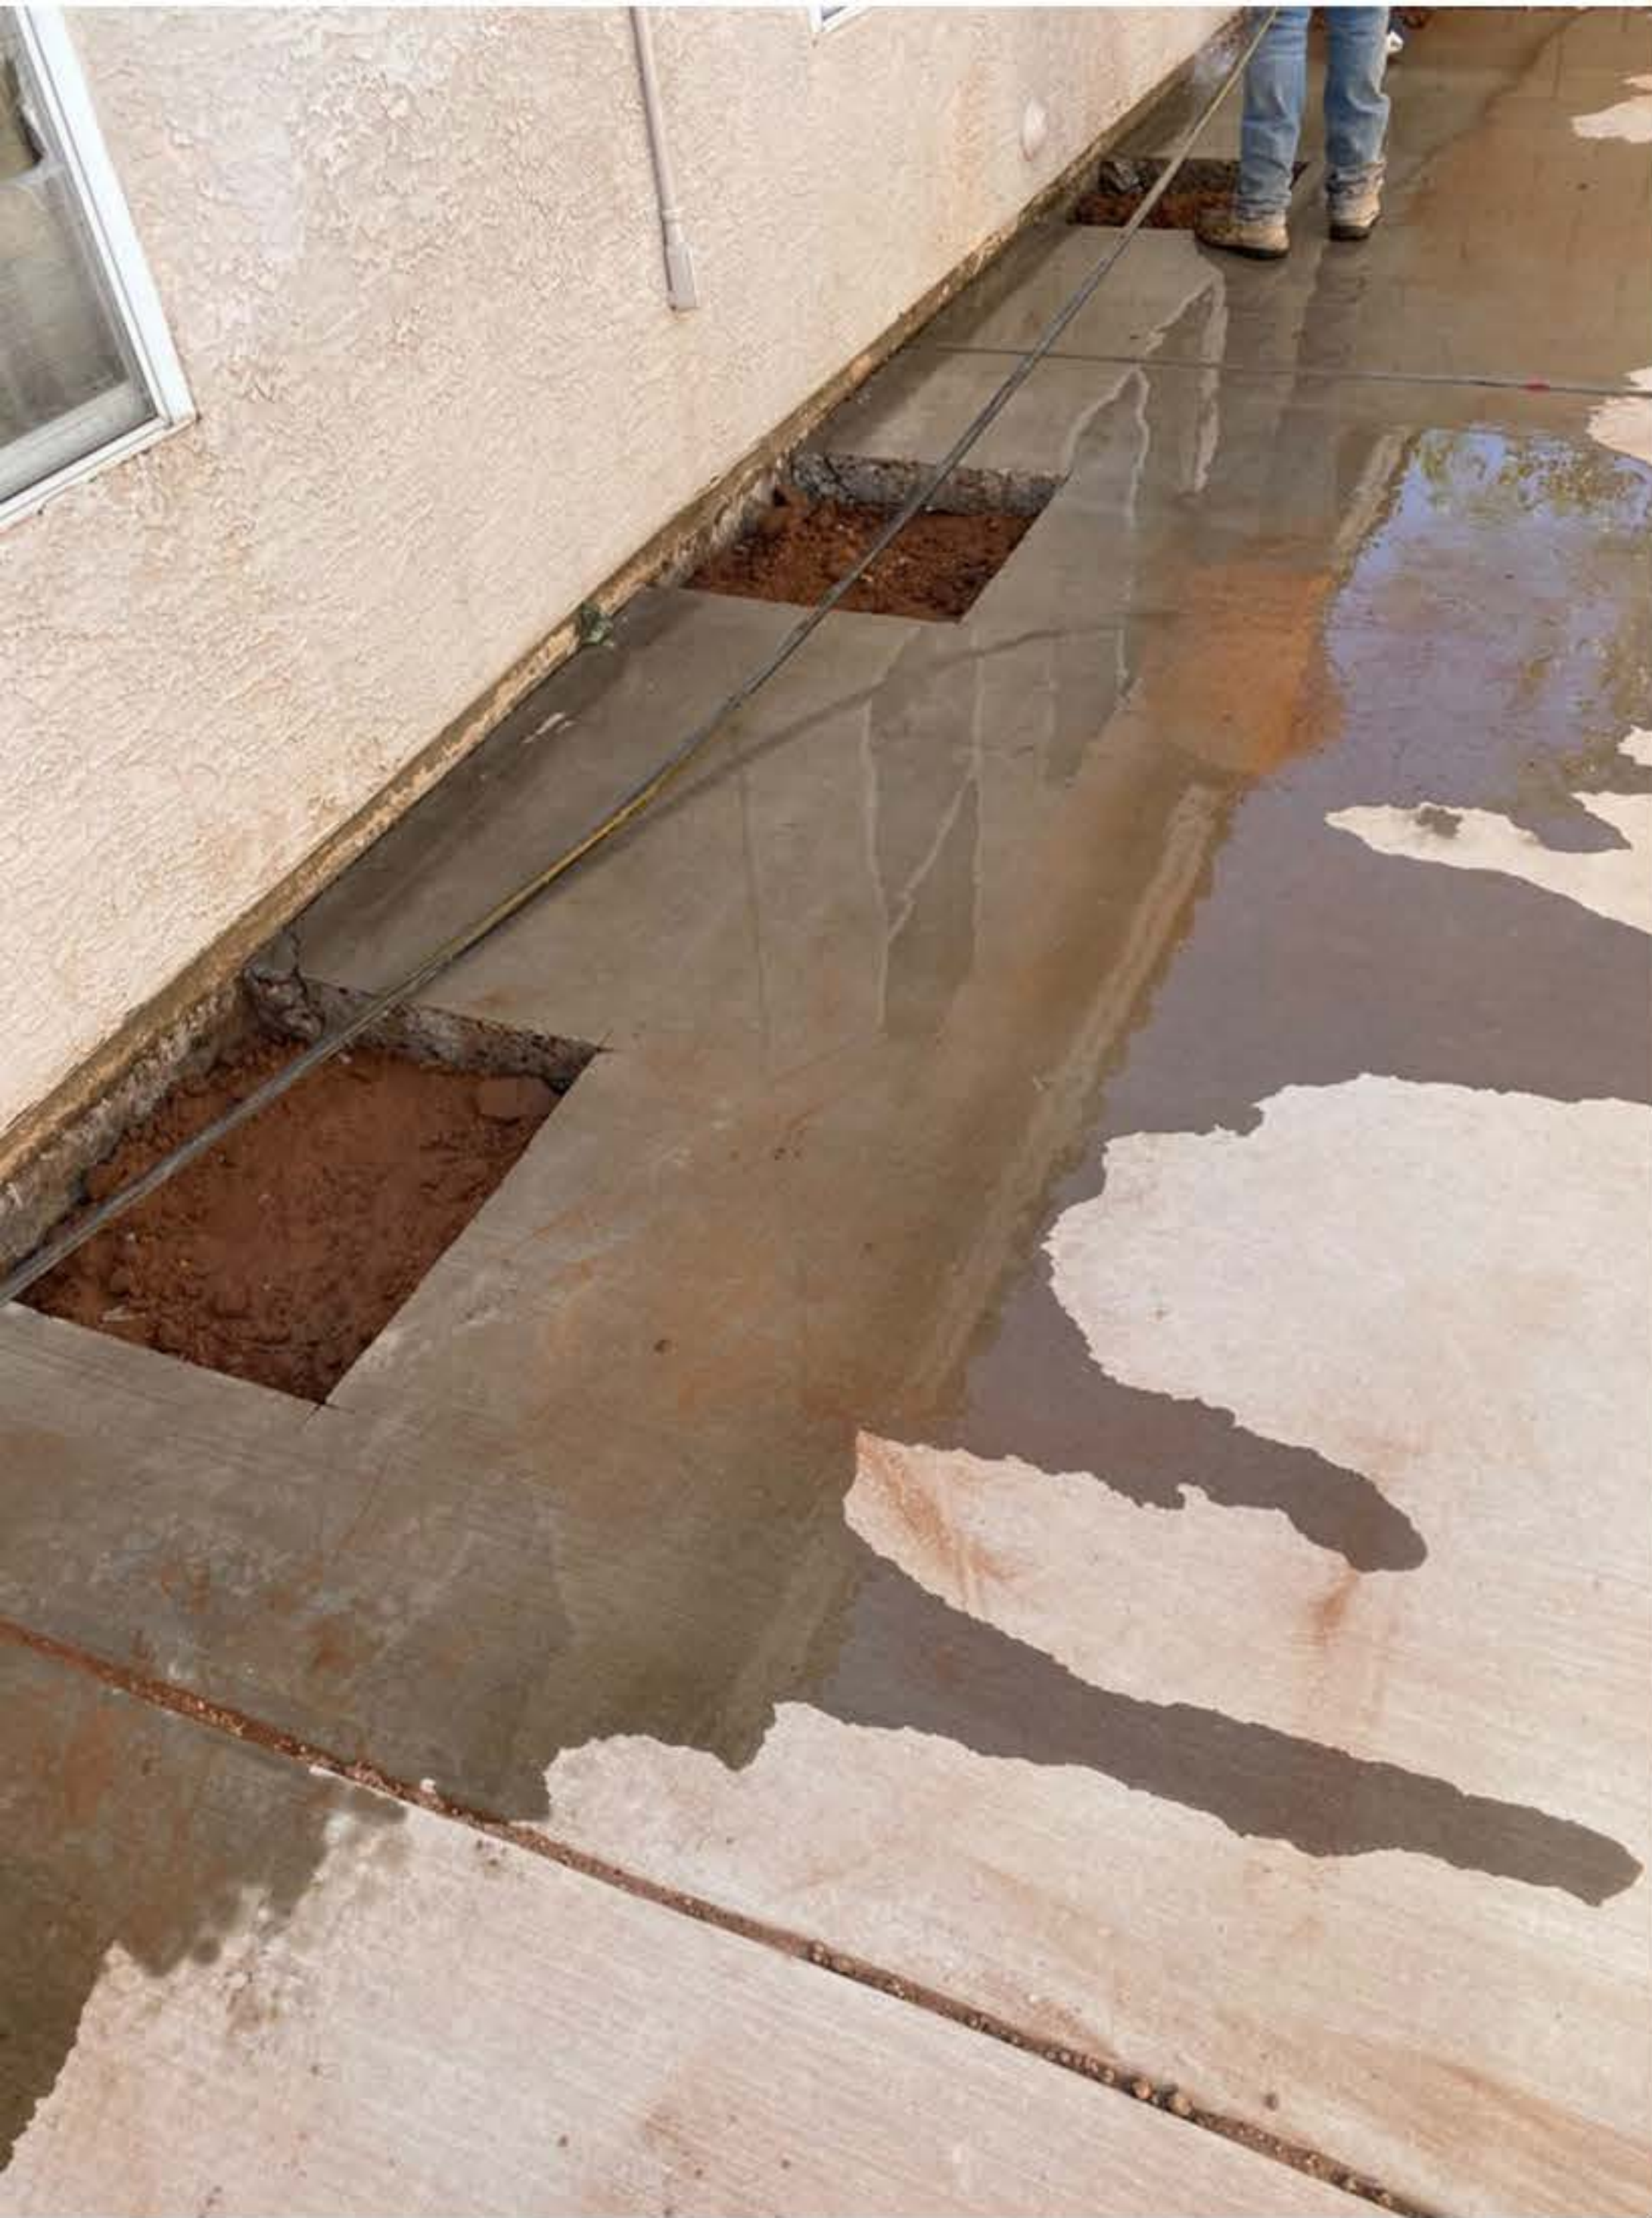
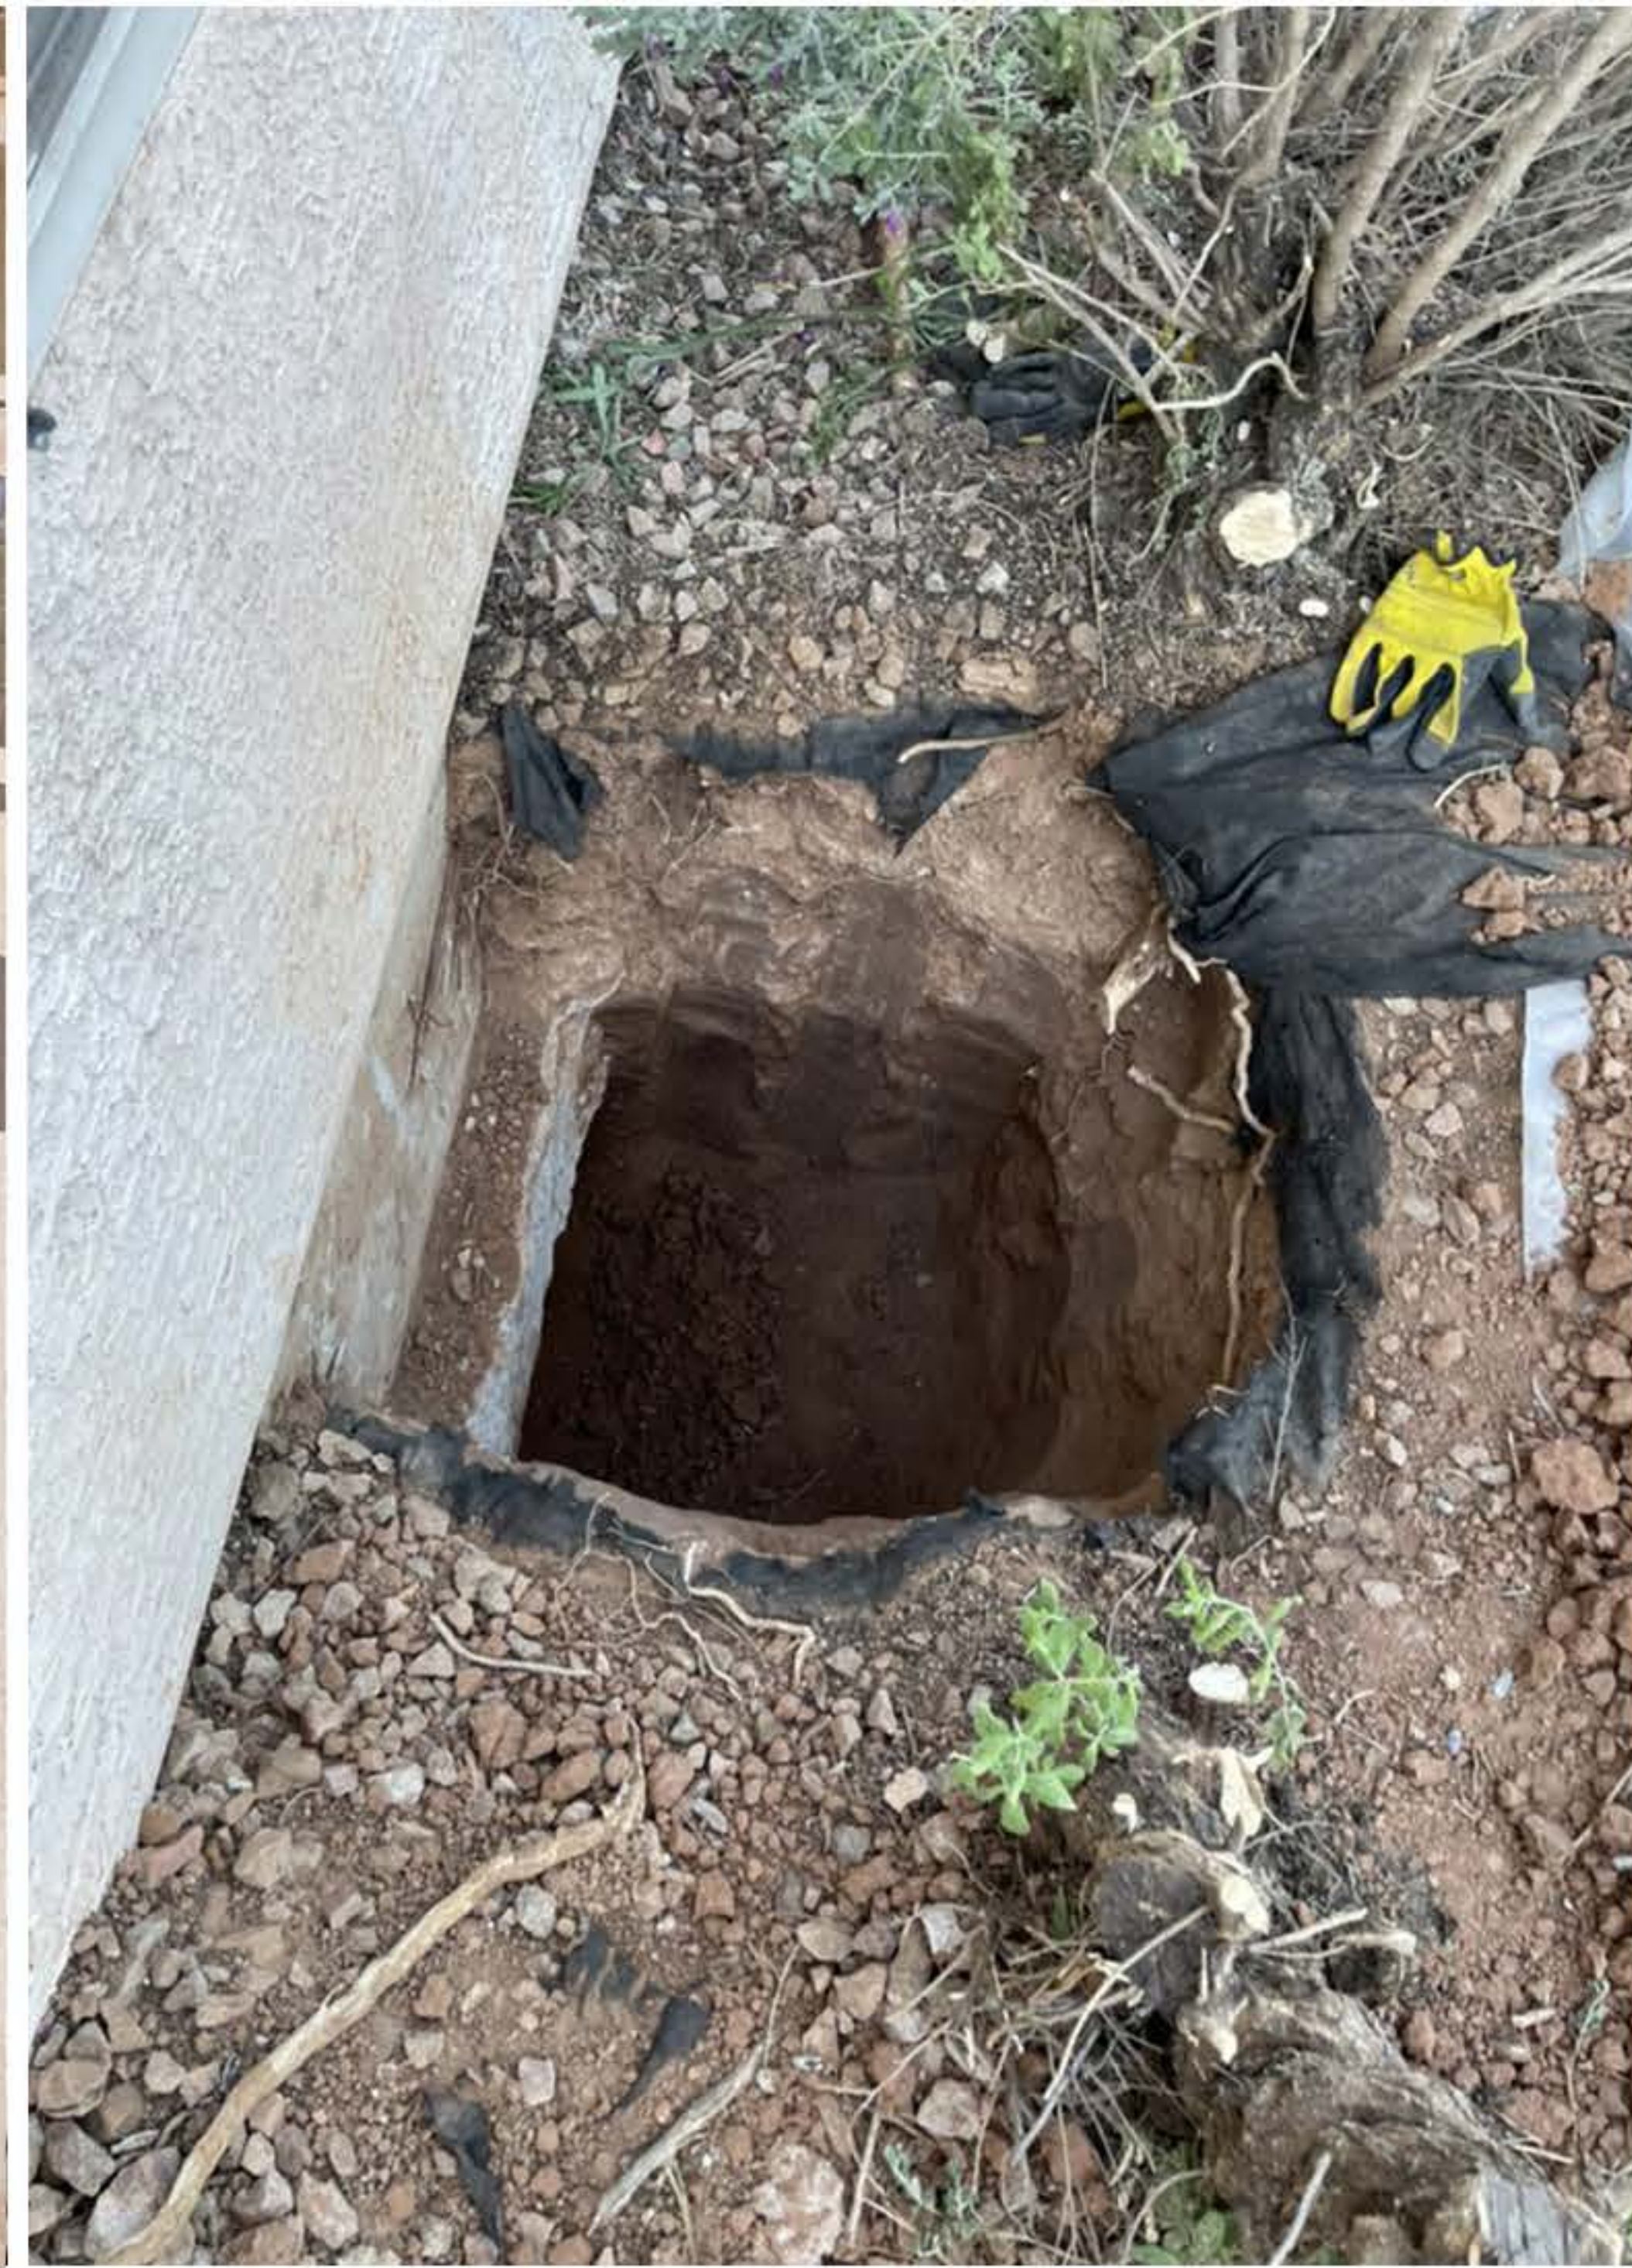
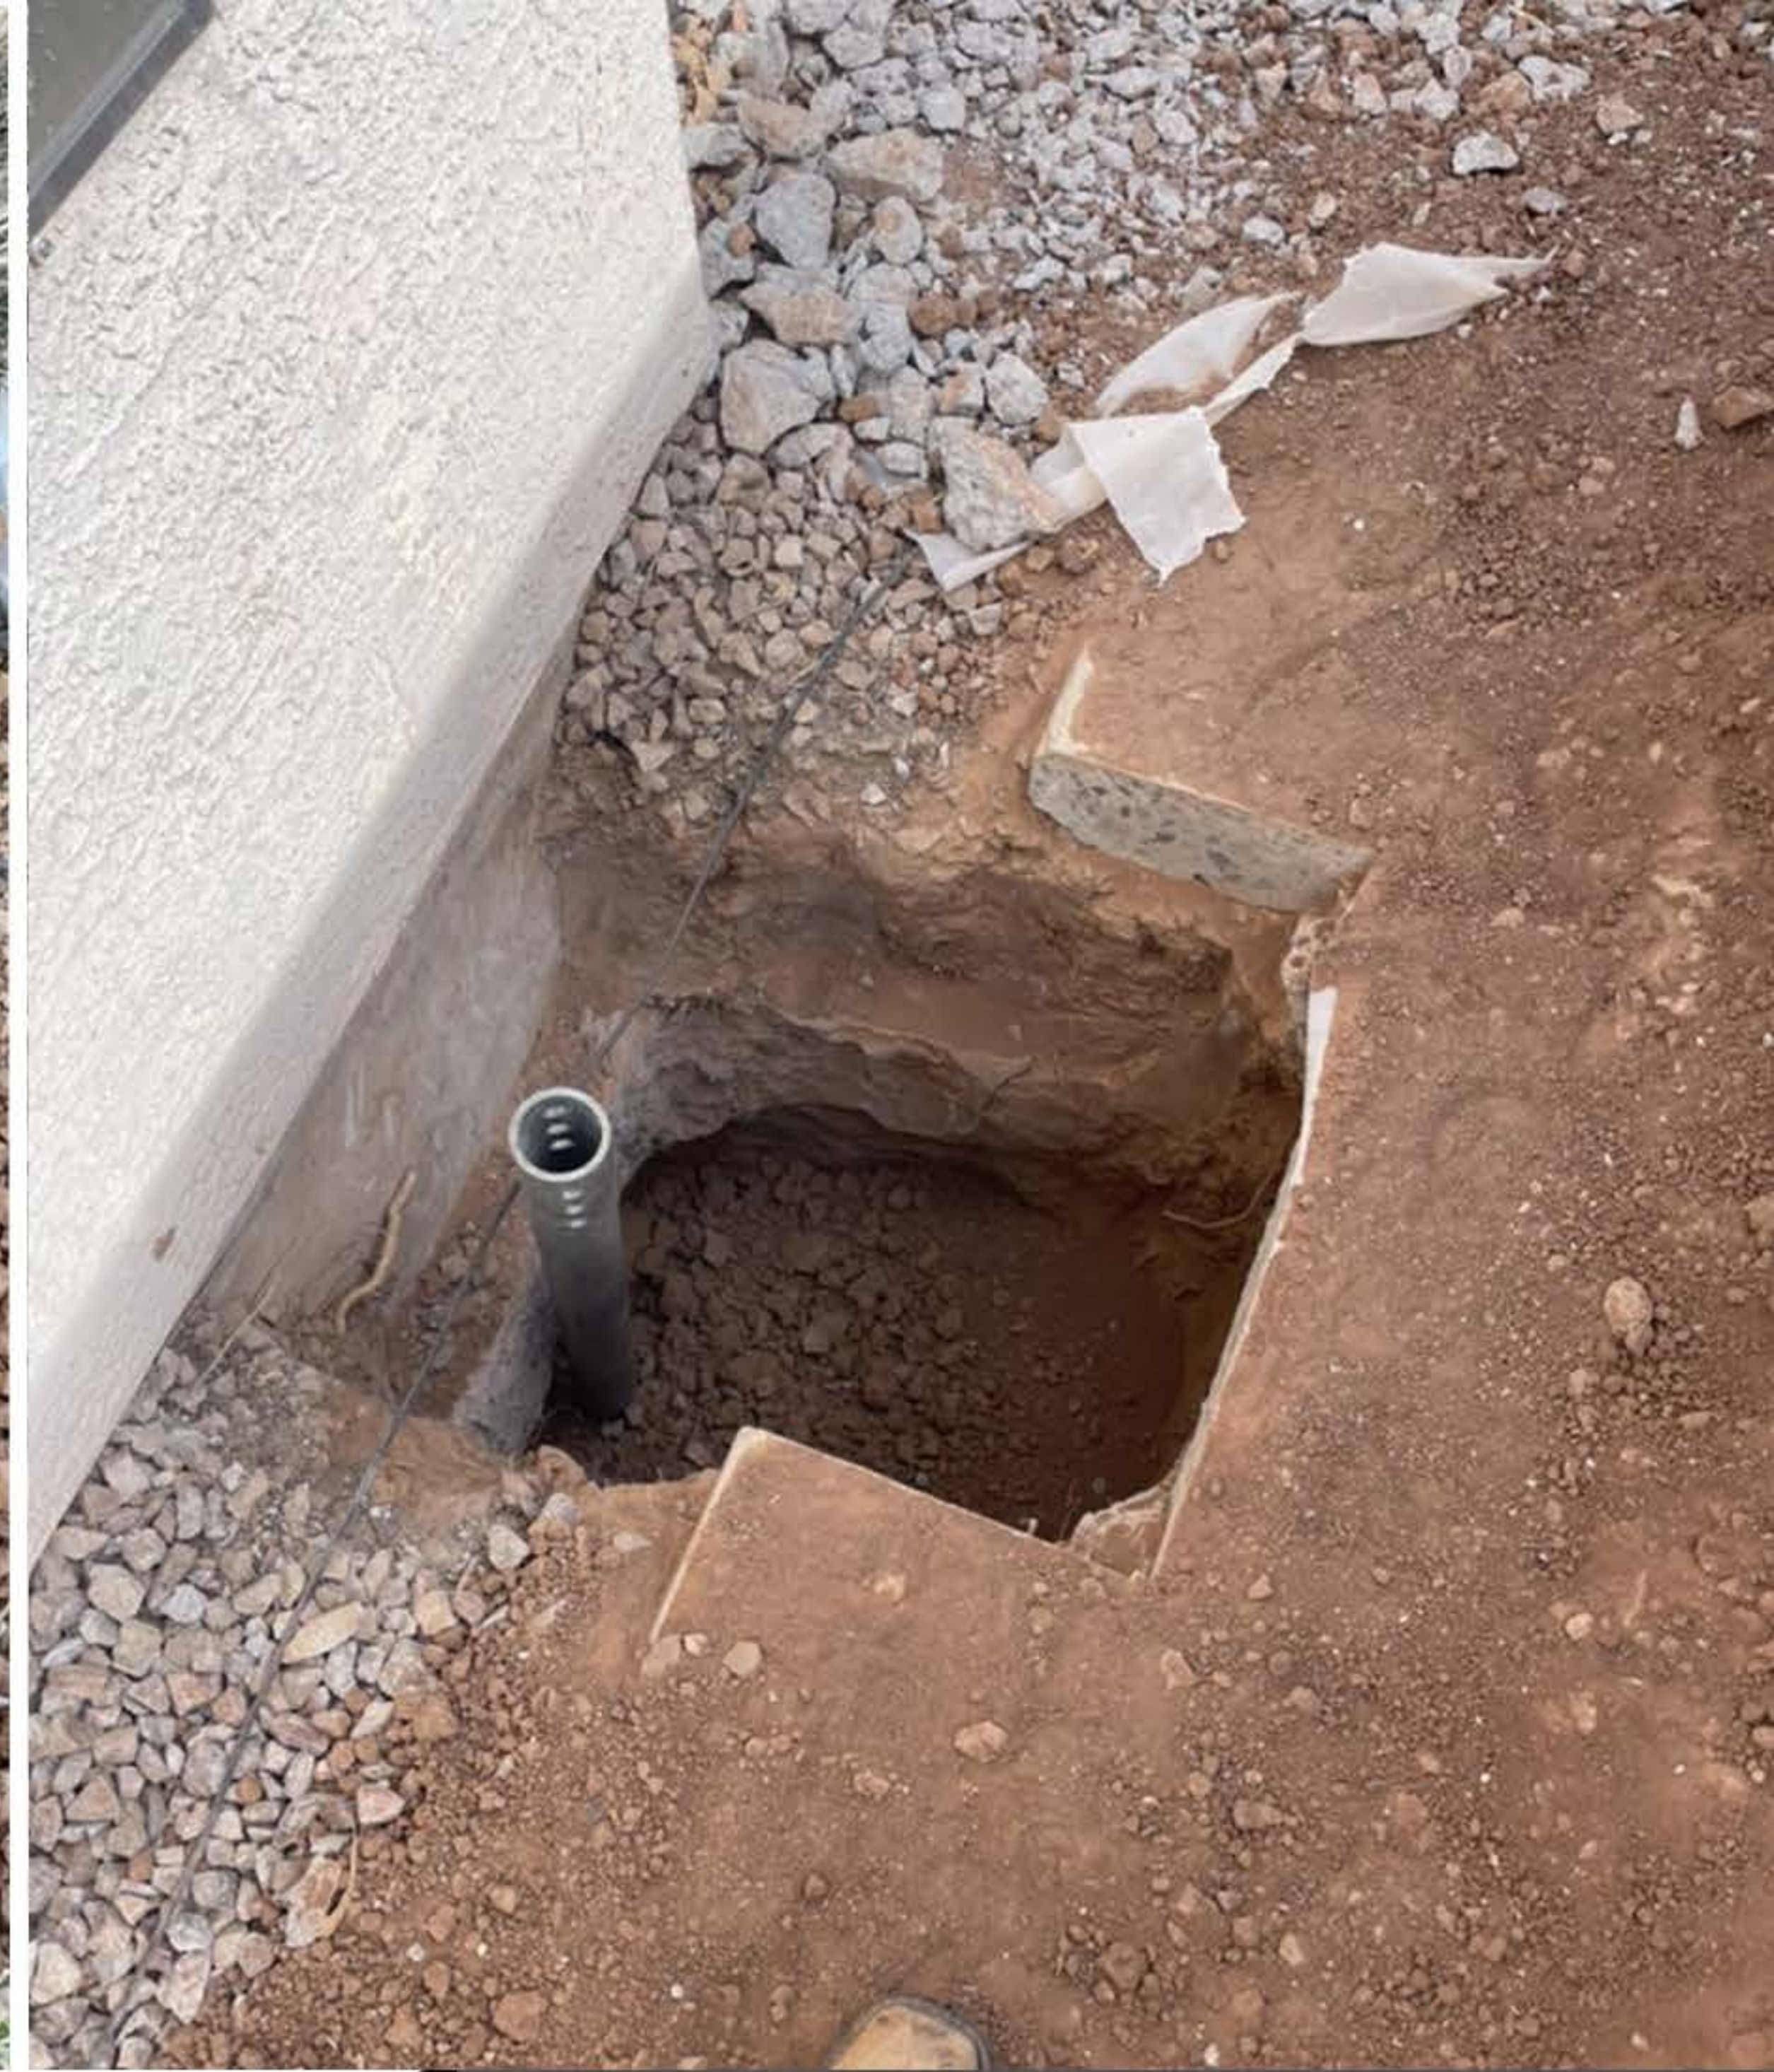
Utilizing 19 of the TAF-288 helical piles from ECP our crew made quick work of the project. They started by excavating the soils at the pier locations before chipping the footings and driving the helical piles with a handheld hydraulic setup. They found competent, load-bearing soils after breaking through a hard pan layer known as caliche that can be as hard as concrete. This caliche layer of soil and rock can be found in most of Arizona, and makes for some fun to break through.

After the helical piles were installed the weight of the home was transferred to the piles to ensure this home never settles or sinks again in the future.

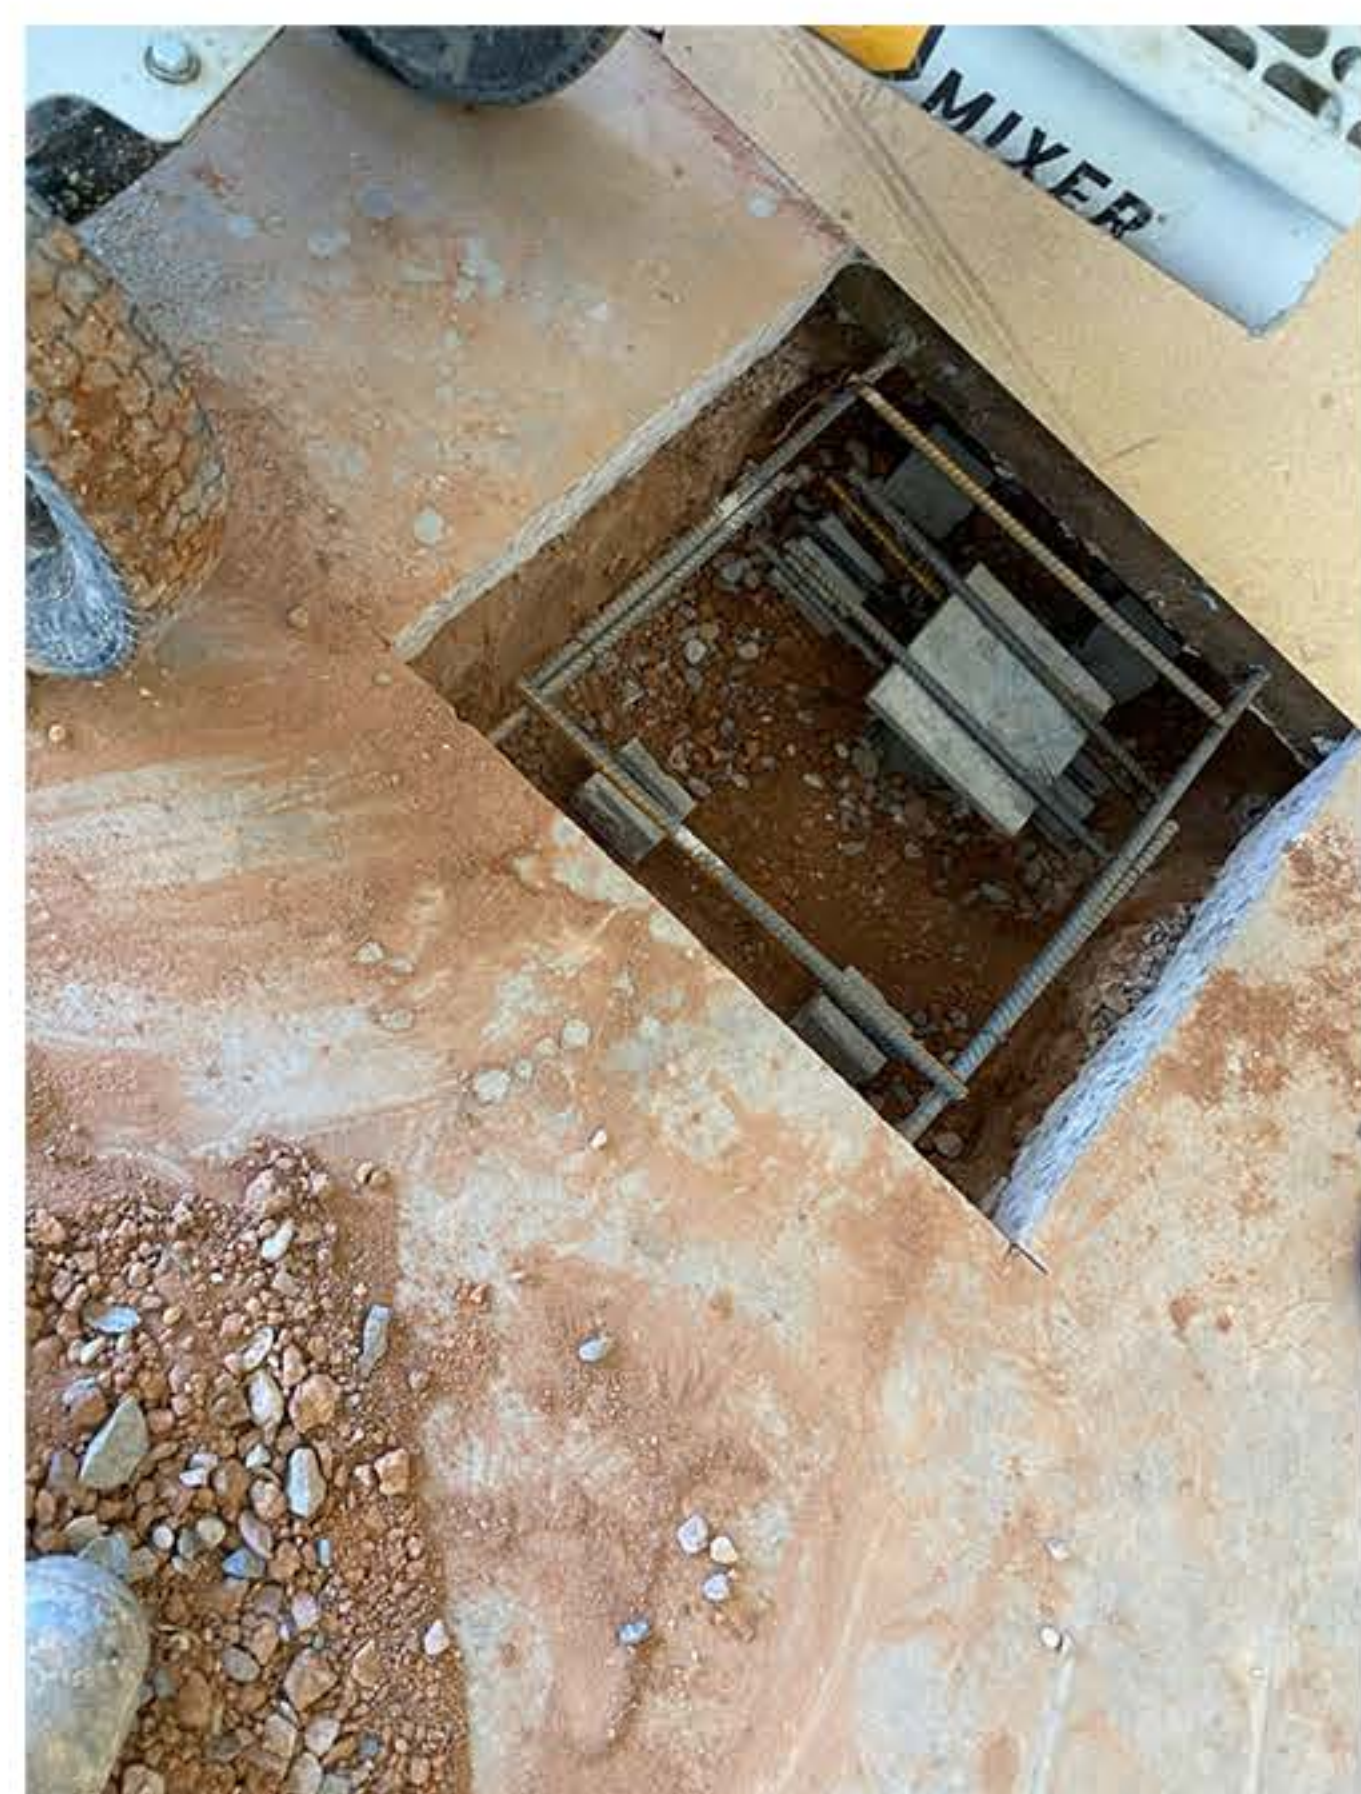
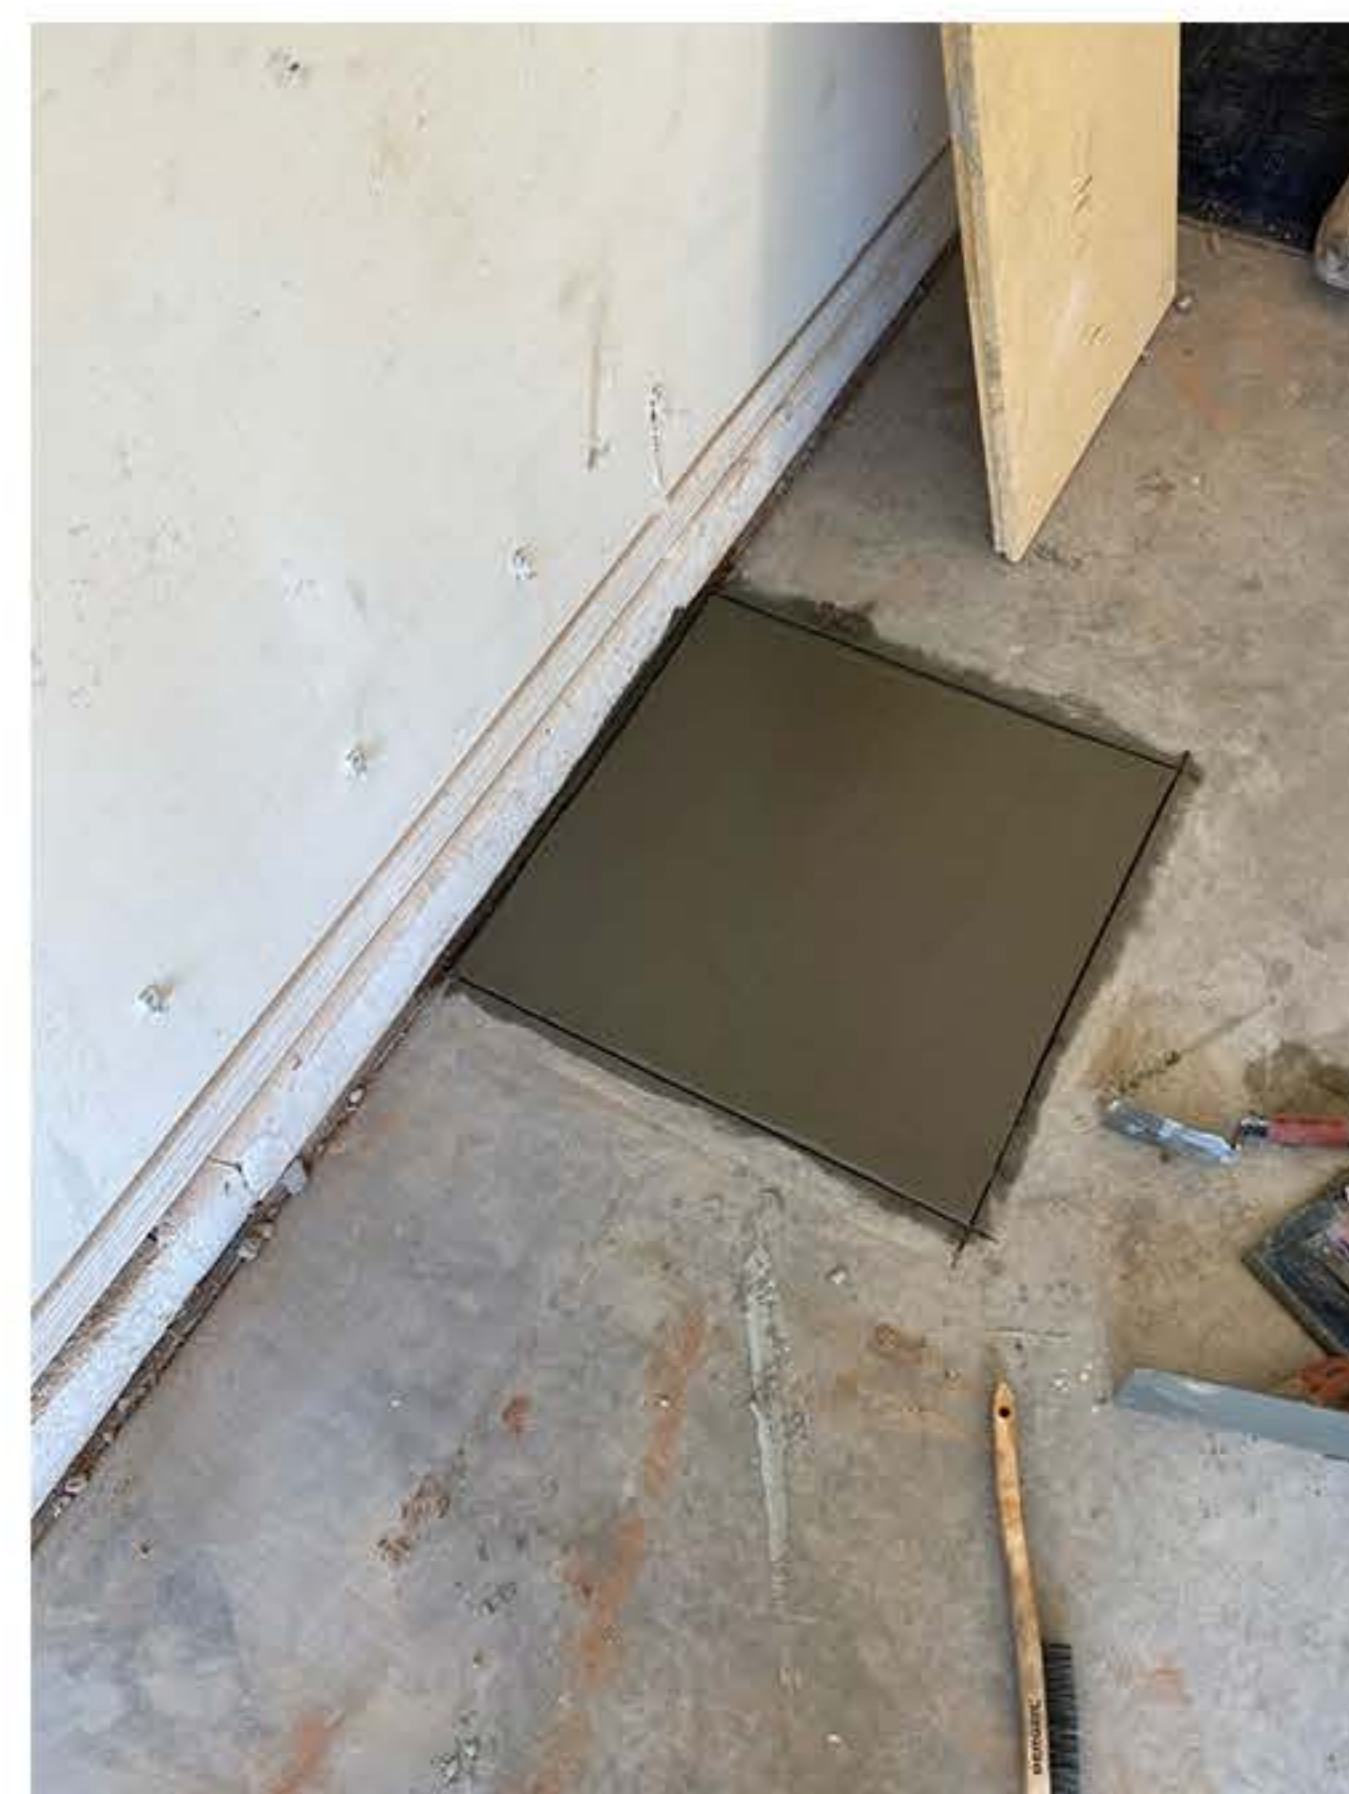
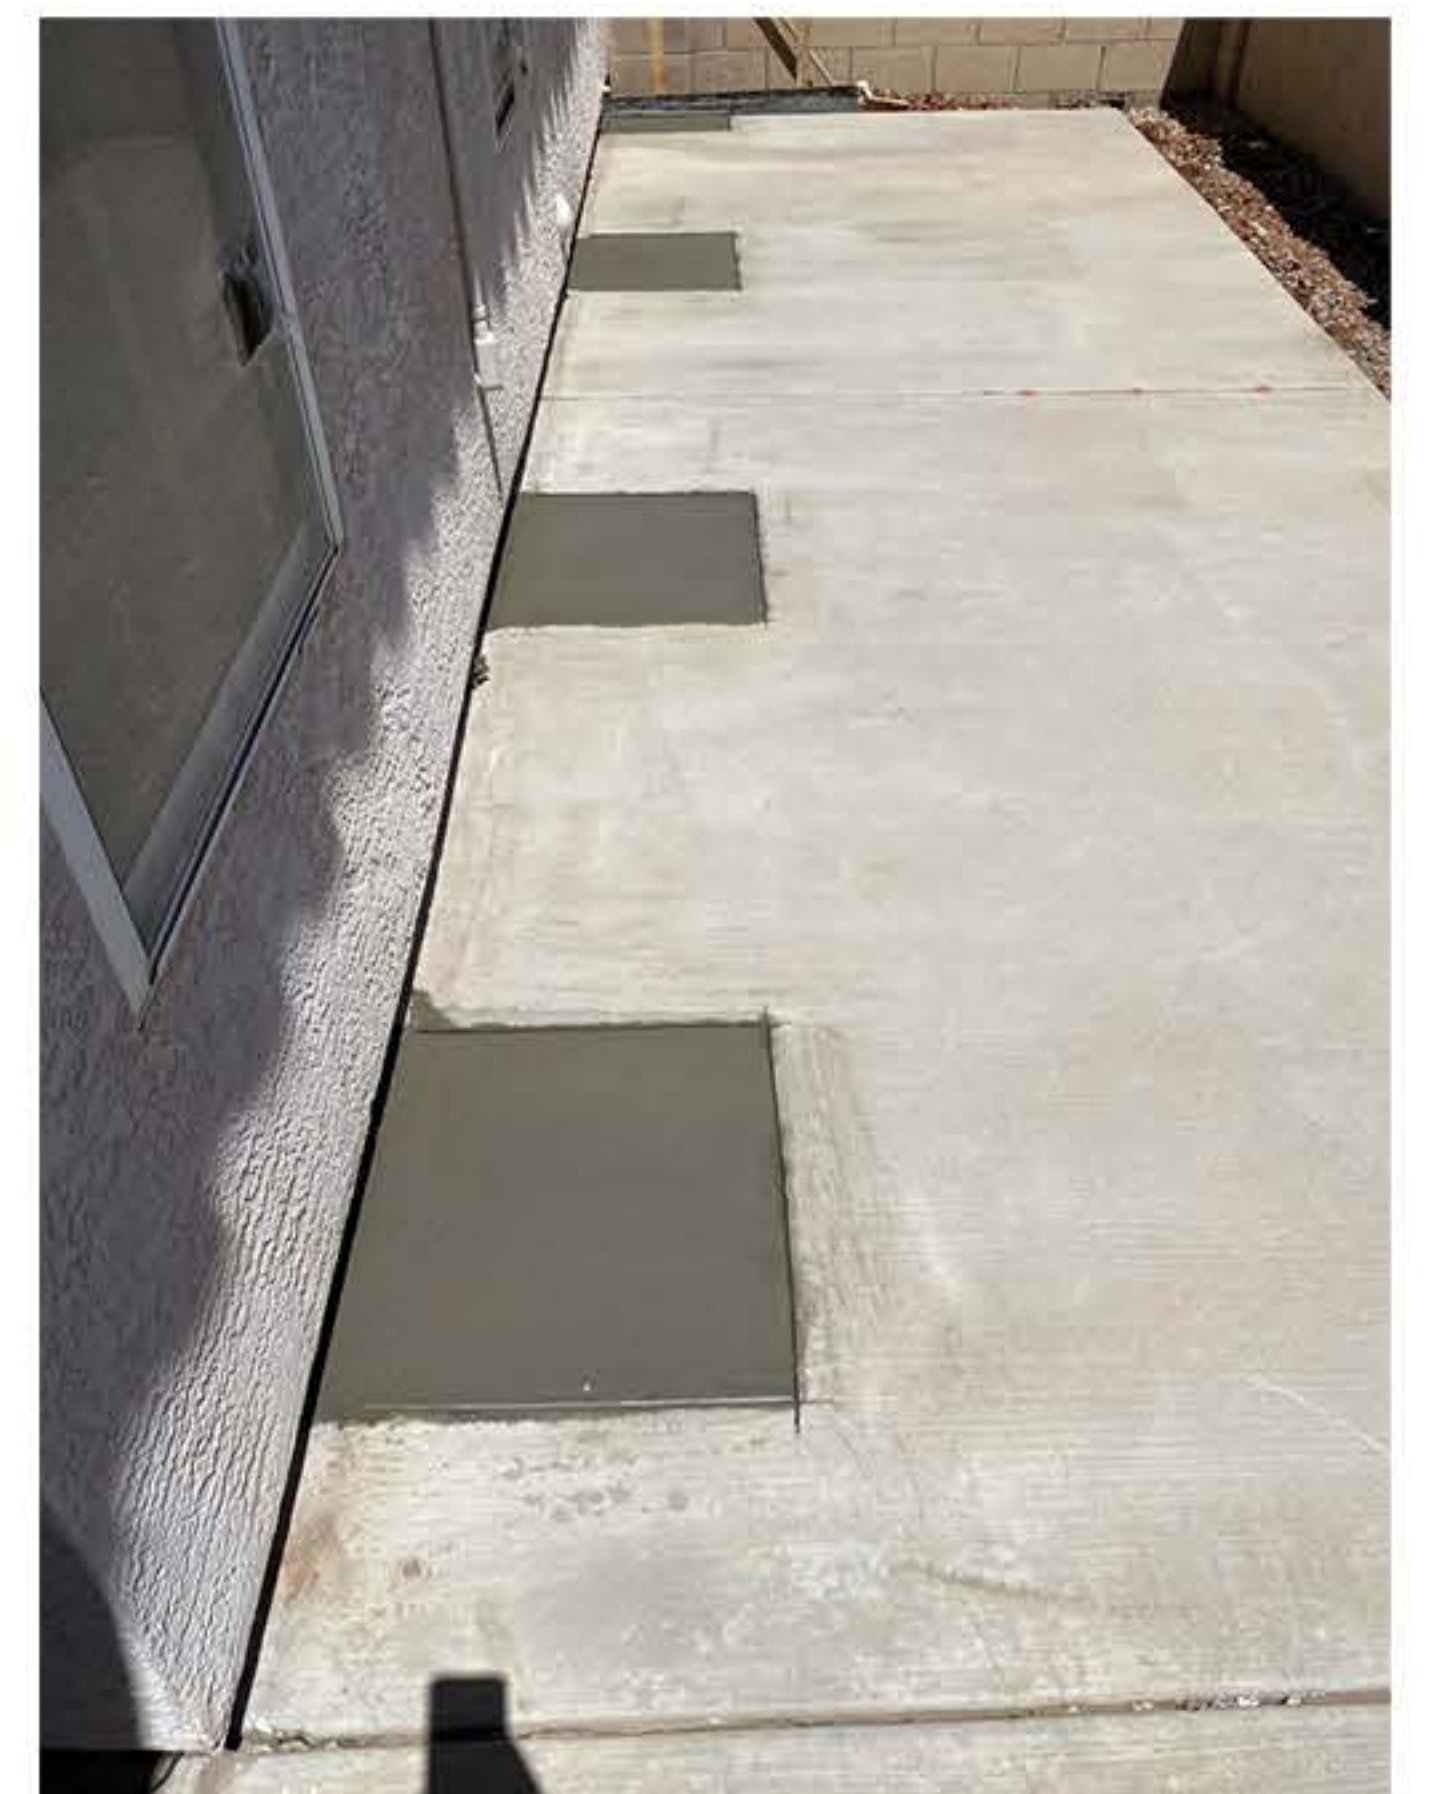
TOTAL HELICAL PILESS

19

HELICAL PILE PRODUCTS

**TAF-288
BY ECP**
