HELICAL PILES SAVE HILLSIDE HOME IN DANA POINT WITH OVER 7" OF SETTLEMENT FIND MORE CASE STUDIES AT:

1960S DAN POINT HILLSIDE HOME SETTLES 7 INCHES WITH SIGNS OF LATERAL MOVEMENT TOWARDS SLOPE

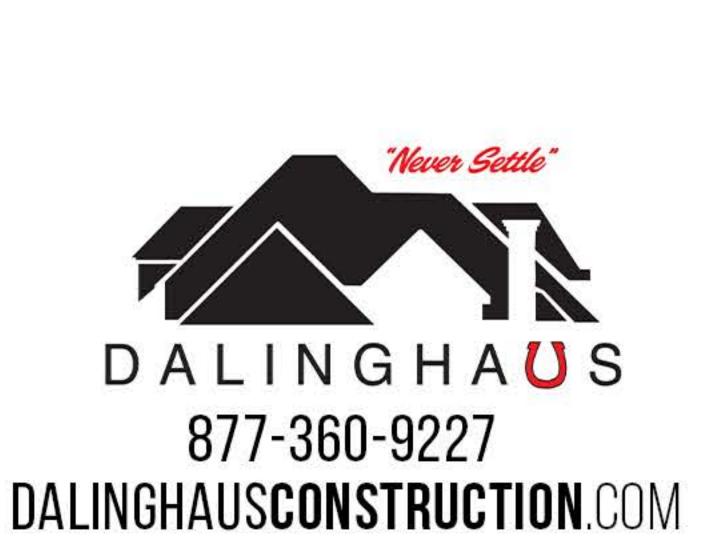
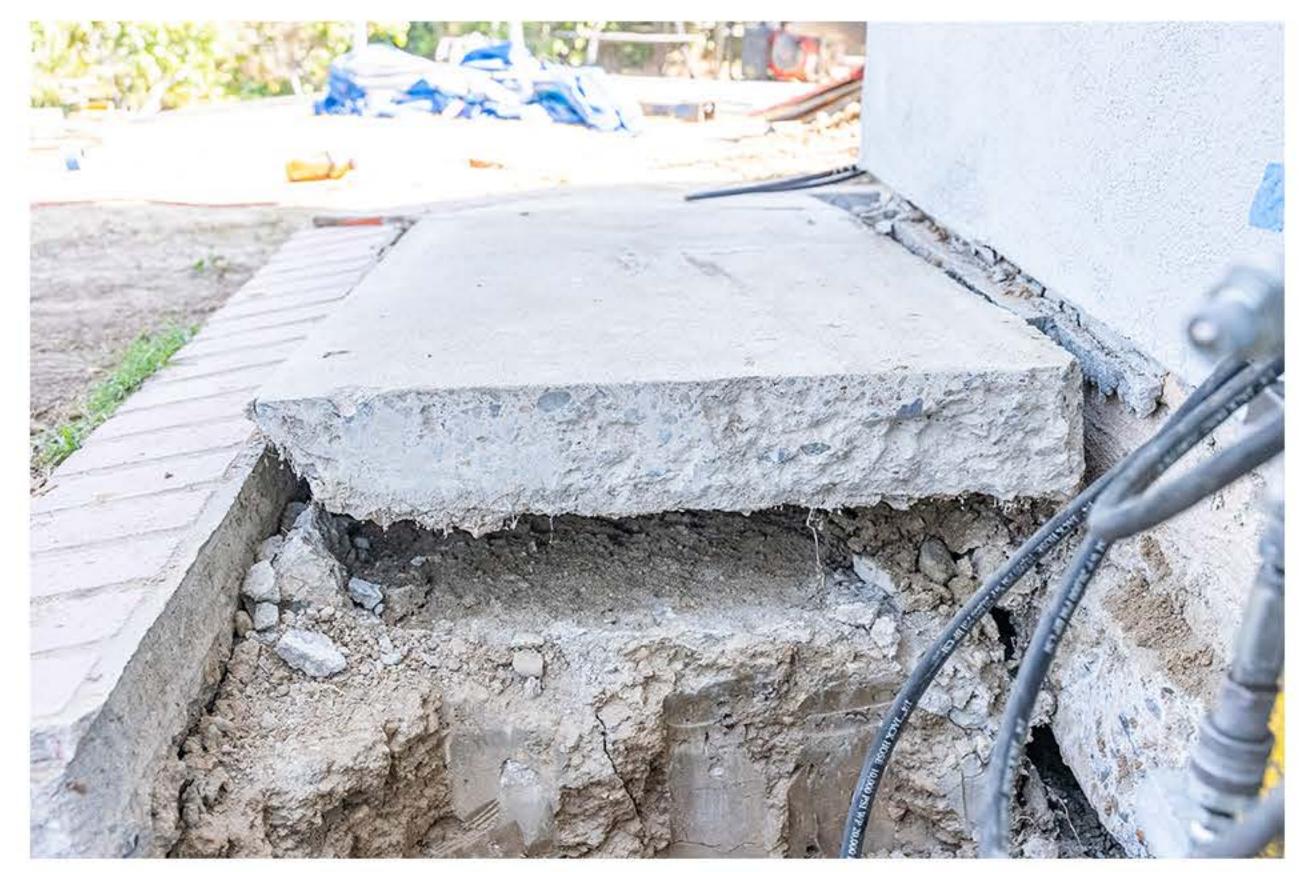
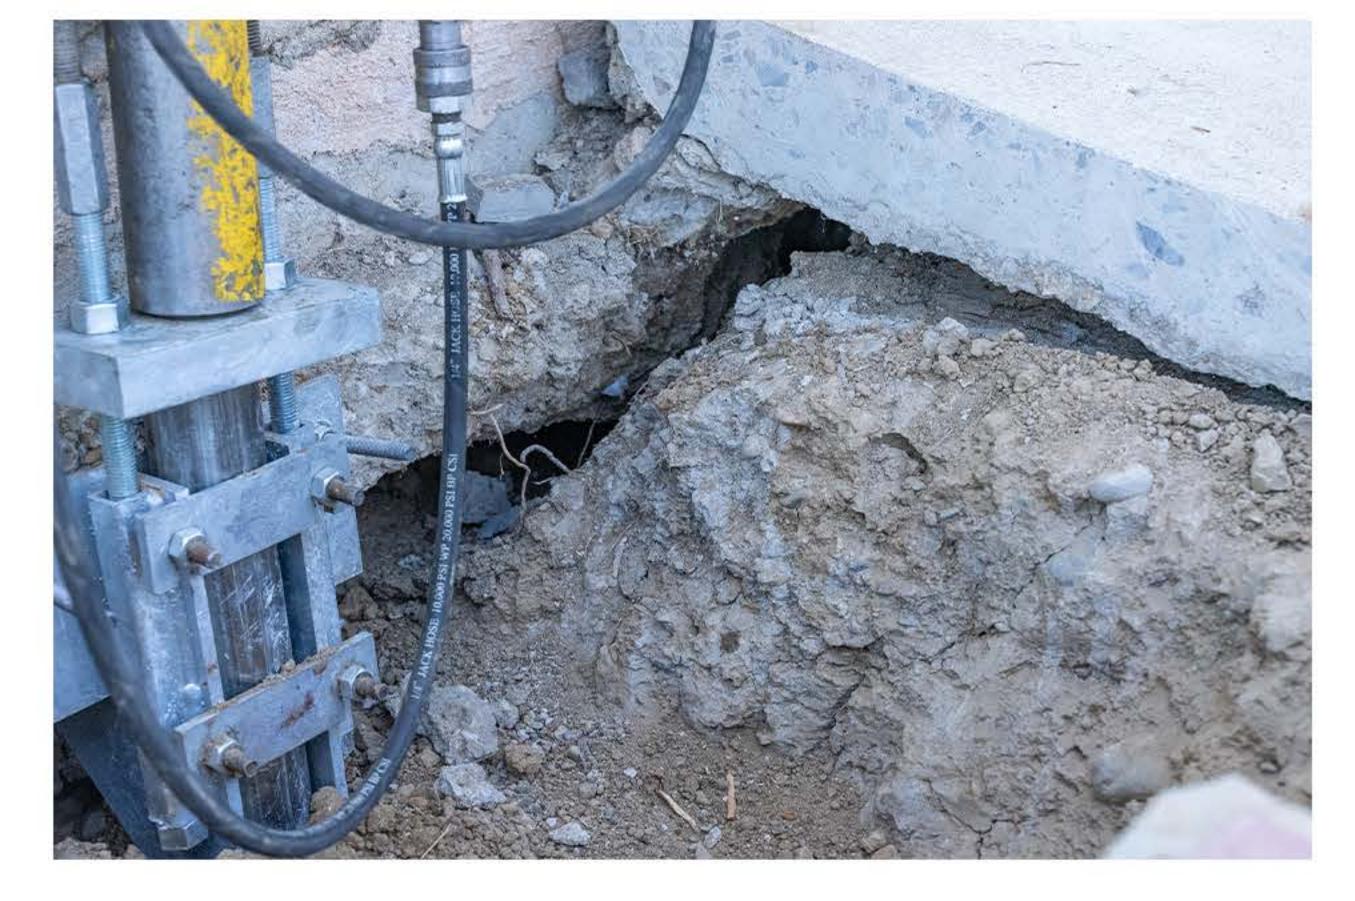
The repair plan would consist of the installation of 21 vertical helical piles around the back half of the home to stabilize the home fro future settling while attempting to lift and recover the 7". Isaac, Ethan, Dillon, Ben, and Jez made quick work of the project, finding competent load-bearing soils at depths between 32 and 36 feet. Once the helical piles were installed the crew was able to hydraullically transfer the load of the home to these piles and recover 6 of the 7 inches of settlement. After the lift was completed the crew moved to installing 2 helical tiebacks to properly address the lateral movement seen closest to the home.
