Type: Residential | Issue: NV201601

**Ram Jack  
Reinforces  
Basement in  
Structural  
Jeopardy**

## BASEMENT WALL RECOVERY

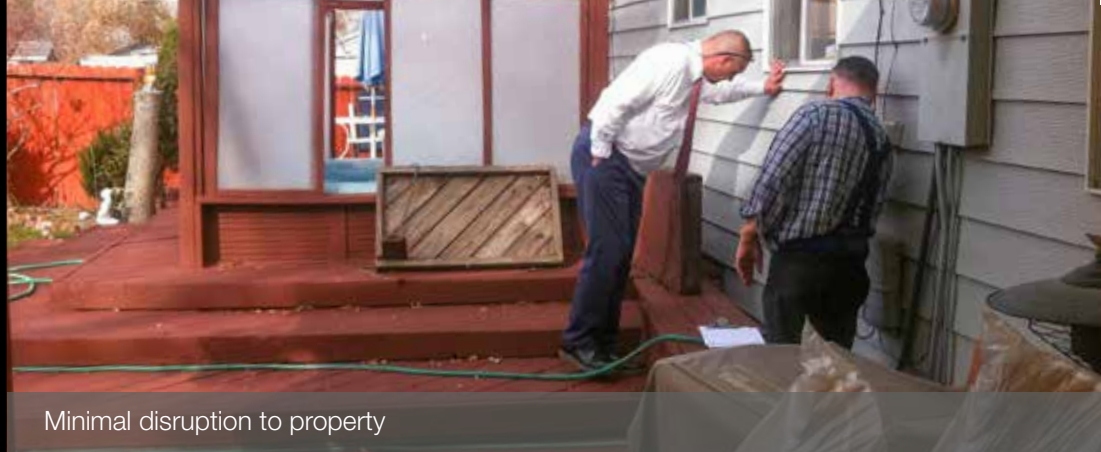
Minimal disruption to property

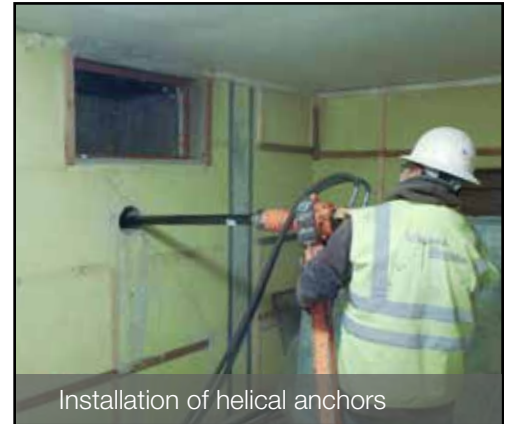
Installation of helical anchors

Without reinforcing steel present, it was determined that a whaler system was needed to distribute the lateral forces on the rear wall. Prior to installation of the whaler system, VersaGrade installed 1.5 in. Round Corner Stock (RCS) steel helical anchors through the wall using a handheld torque drive motor. Fortress Stabilization Carbon Fiber support straps were used at the midpoints between helical anchors to provide vertical support. Each strap was epoxied to the concrete wall with embedded Kevlar straps that attached to the structure (to prevent overturning to the wall). Finally, a 10 in. wide continuous steel channel was bolted to the wall as the whaler, tying the entire support system together.

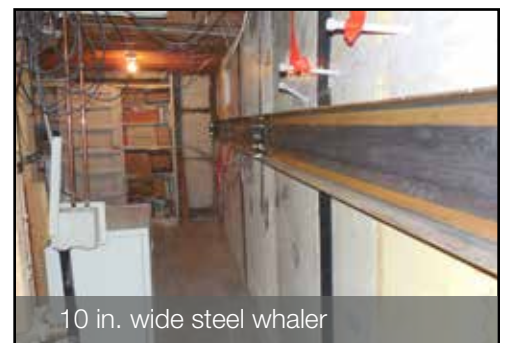
10 in. wide steel whaler
