## The First Law of Foundation Stability: Buildings Built on

Land Fill will Settle

Jackson County, Florida

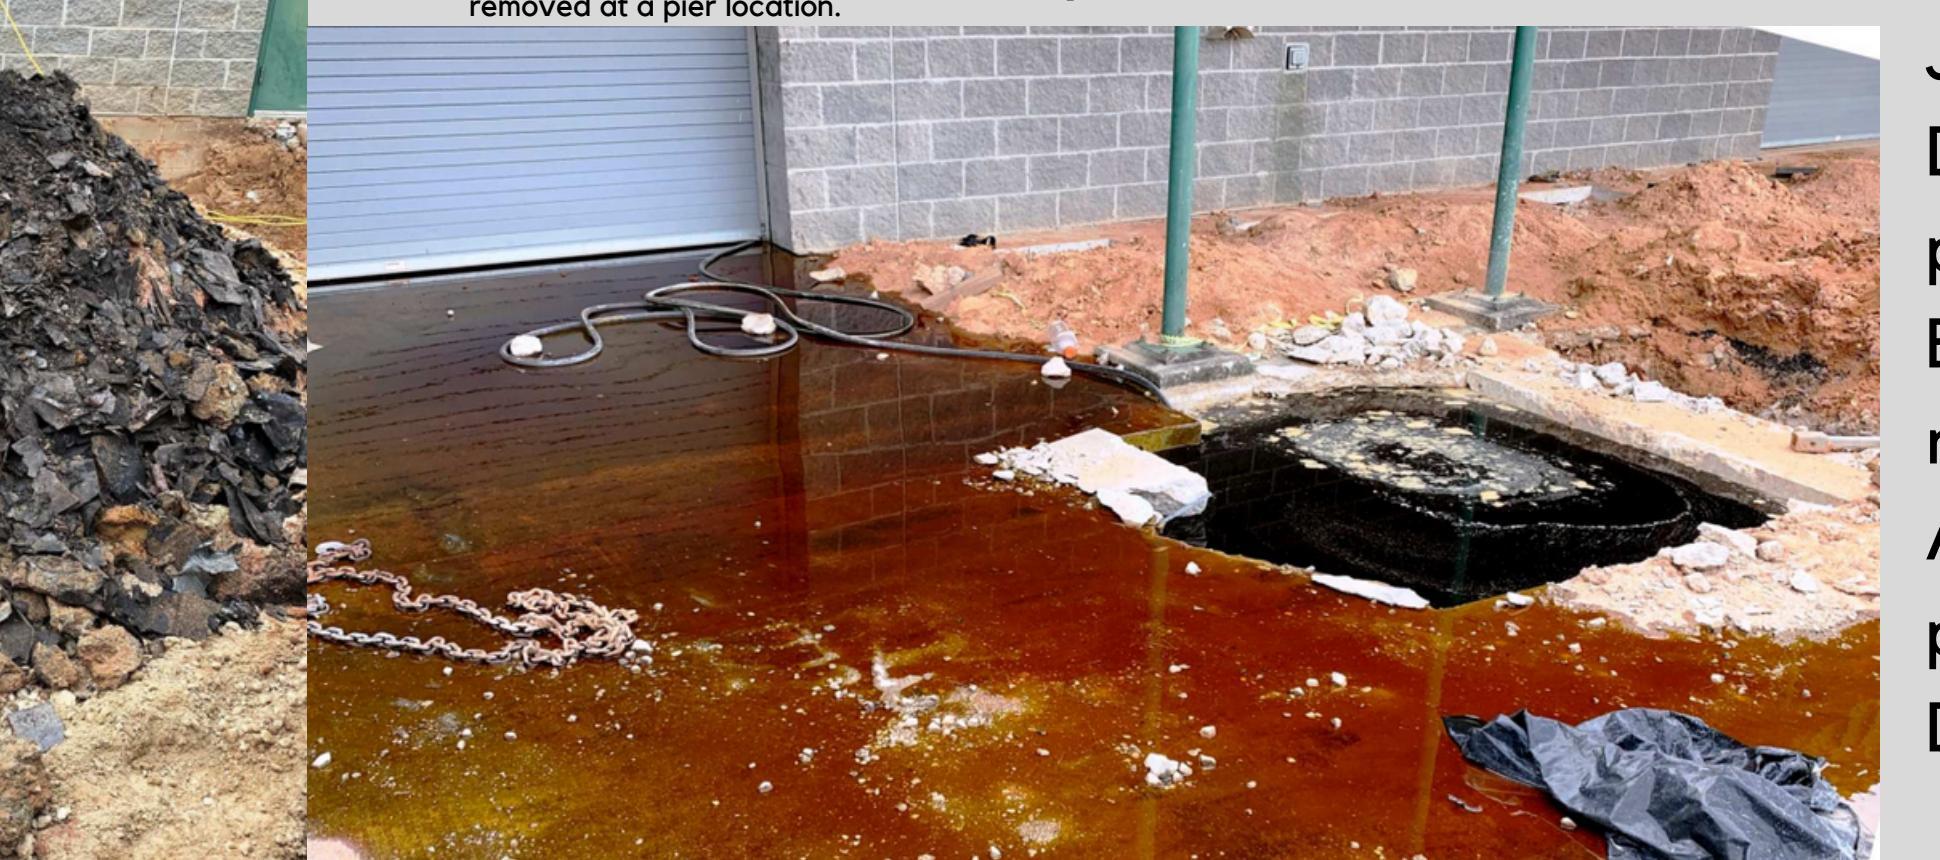
In 2011 a local competing foundation repair company installed 75 push piers under parts of the east wall and floor slab on the south half of the building. There were areas of the concrete slab showing evidence where previous foundation work had been installed. Patches were visible on the interior and exterior masonry and on the slab. No foundation repairs were made on the north end of the building. The plant manager stated that after the previous foundation underpinning and repair was complete, some parts of the building were better than before and some parts were worse. The building continued to move both in the area of previous foundation work and in other portions of the building. The owner hired Larry M.

The remediation procedure was designed to vertically and laterally stabilize the foundation of the structure. Recovering the lost floor elevation and vertically stabilizing it was accomplished by installing ECP Steel Piers that provide end bearing resistance against a verified and proof loaded tested stratum deep below the surface.

The lateral movement of the concrete footings required ECP Tieback Anchors attached to the ECP steel piers. There was also need for 20 slab piers to support, lift and stabilize the settlement and slab misalignments. At the locations of differential slab movement, the defects were corrected using ECP Torque Anchor compression piles connected to slab brackets. Steel angle supports were installed at the ends of 34 roof trusses to provide load bearing. Foundation Professionals of Florida had to overcome several obstacles to complete the project. Many massive concrete bollard foundations were encountered and had to be removed to gain access for the installation machinery. The original underpinning placement plan had to be modified several times due to conflicts with the 75 previously installed piers from 2011. There were serious amounts of garbage and debris excavated from under the structure. Even though over-excavation of areas with land fill were specified originally, the building contractor failed to remove the debris and replace it with control fill. The existence of sub-surface garbage, liquids, and major debris caused major time delays. Over excavated foundations under canopy support were encountered and some footings were larger than specified on plans causing extra time and work to remove and replace.
