CASE HISTORY

ECP HELICAL
TORQUE ANCHORS™

Tieback Anchors Repair Tilting Foundation Walls Denver, Colorado

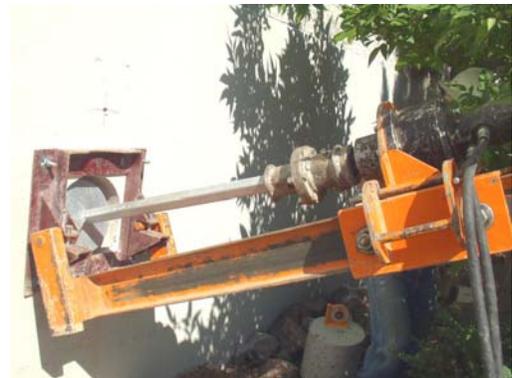
From the top: Soil removal was accomplished by conveyor as workers dug behind the stem walls. A helical tieback is installed at the specified angle.
