# CASE HISTORY

## ECP HELICAL TORQUE ANCHORS™

### Tieback Anchors Repair Tilting Foundation Walls Denver, Colorado

| Project Summary | |
|---|---|
| Project: | Rotated Wall Repairs, Denver, Colorado |

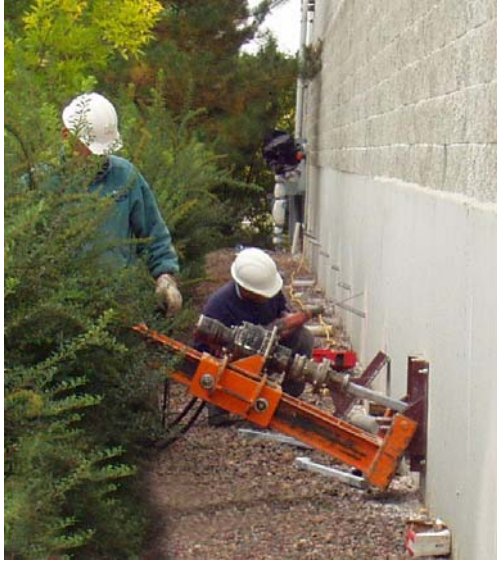
ECP Model TAF-150 solid square shaft Torque Anchor™ tiebacks were installed through the wall and into the soil below the structure. The tieback anchors were installed a distance of 25 to 35 feet under the building before reaching suitable shaft torsion to provide a working capacity of over 7,000 pounds at each placement.

Once the Torque Anchor™ tiebacks were installed, the wall was moved 3" to 4" back to plumb using a series of hydraulic jacks. The only evidence of the work is the row of wall plates, threaded bars and nuts that are visible along the exterior surfaces of the stem walls.
