<b>Type of Services</b>	<b>Geotechnical Investigation</b>
<b>Project Name</b>	<b>Fair Oaks West Apartments Seismic Upgrades</b>
<b>Location</b>	<b>655 South Fair Oaks Sunnyvale, California</b>
<b>Client</b>	<b>Prometheus Real Estate Group</b>
<b>Client Address</b>	<b>1900 S. Norfolk Street, Suite 150 San Mateo, CA</b>
<b>Project Number</b>	<b>307-10-1</b>
<b>Date</b>	<b>July 25, 2014</b>

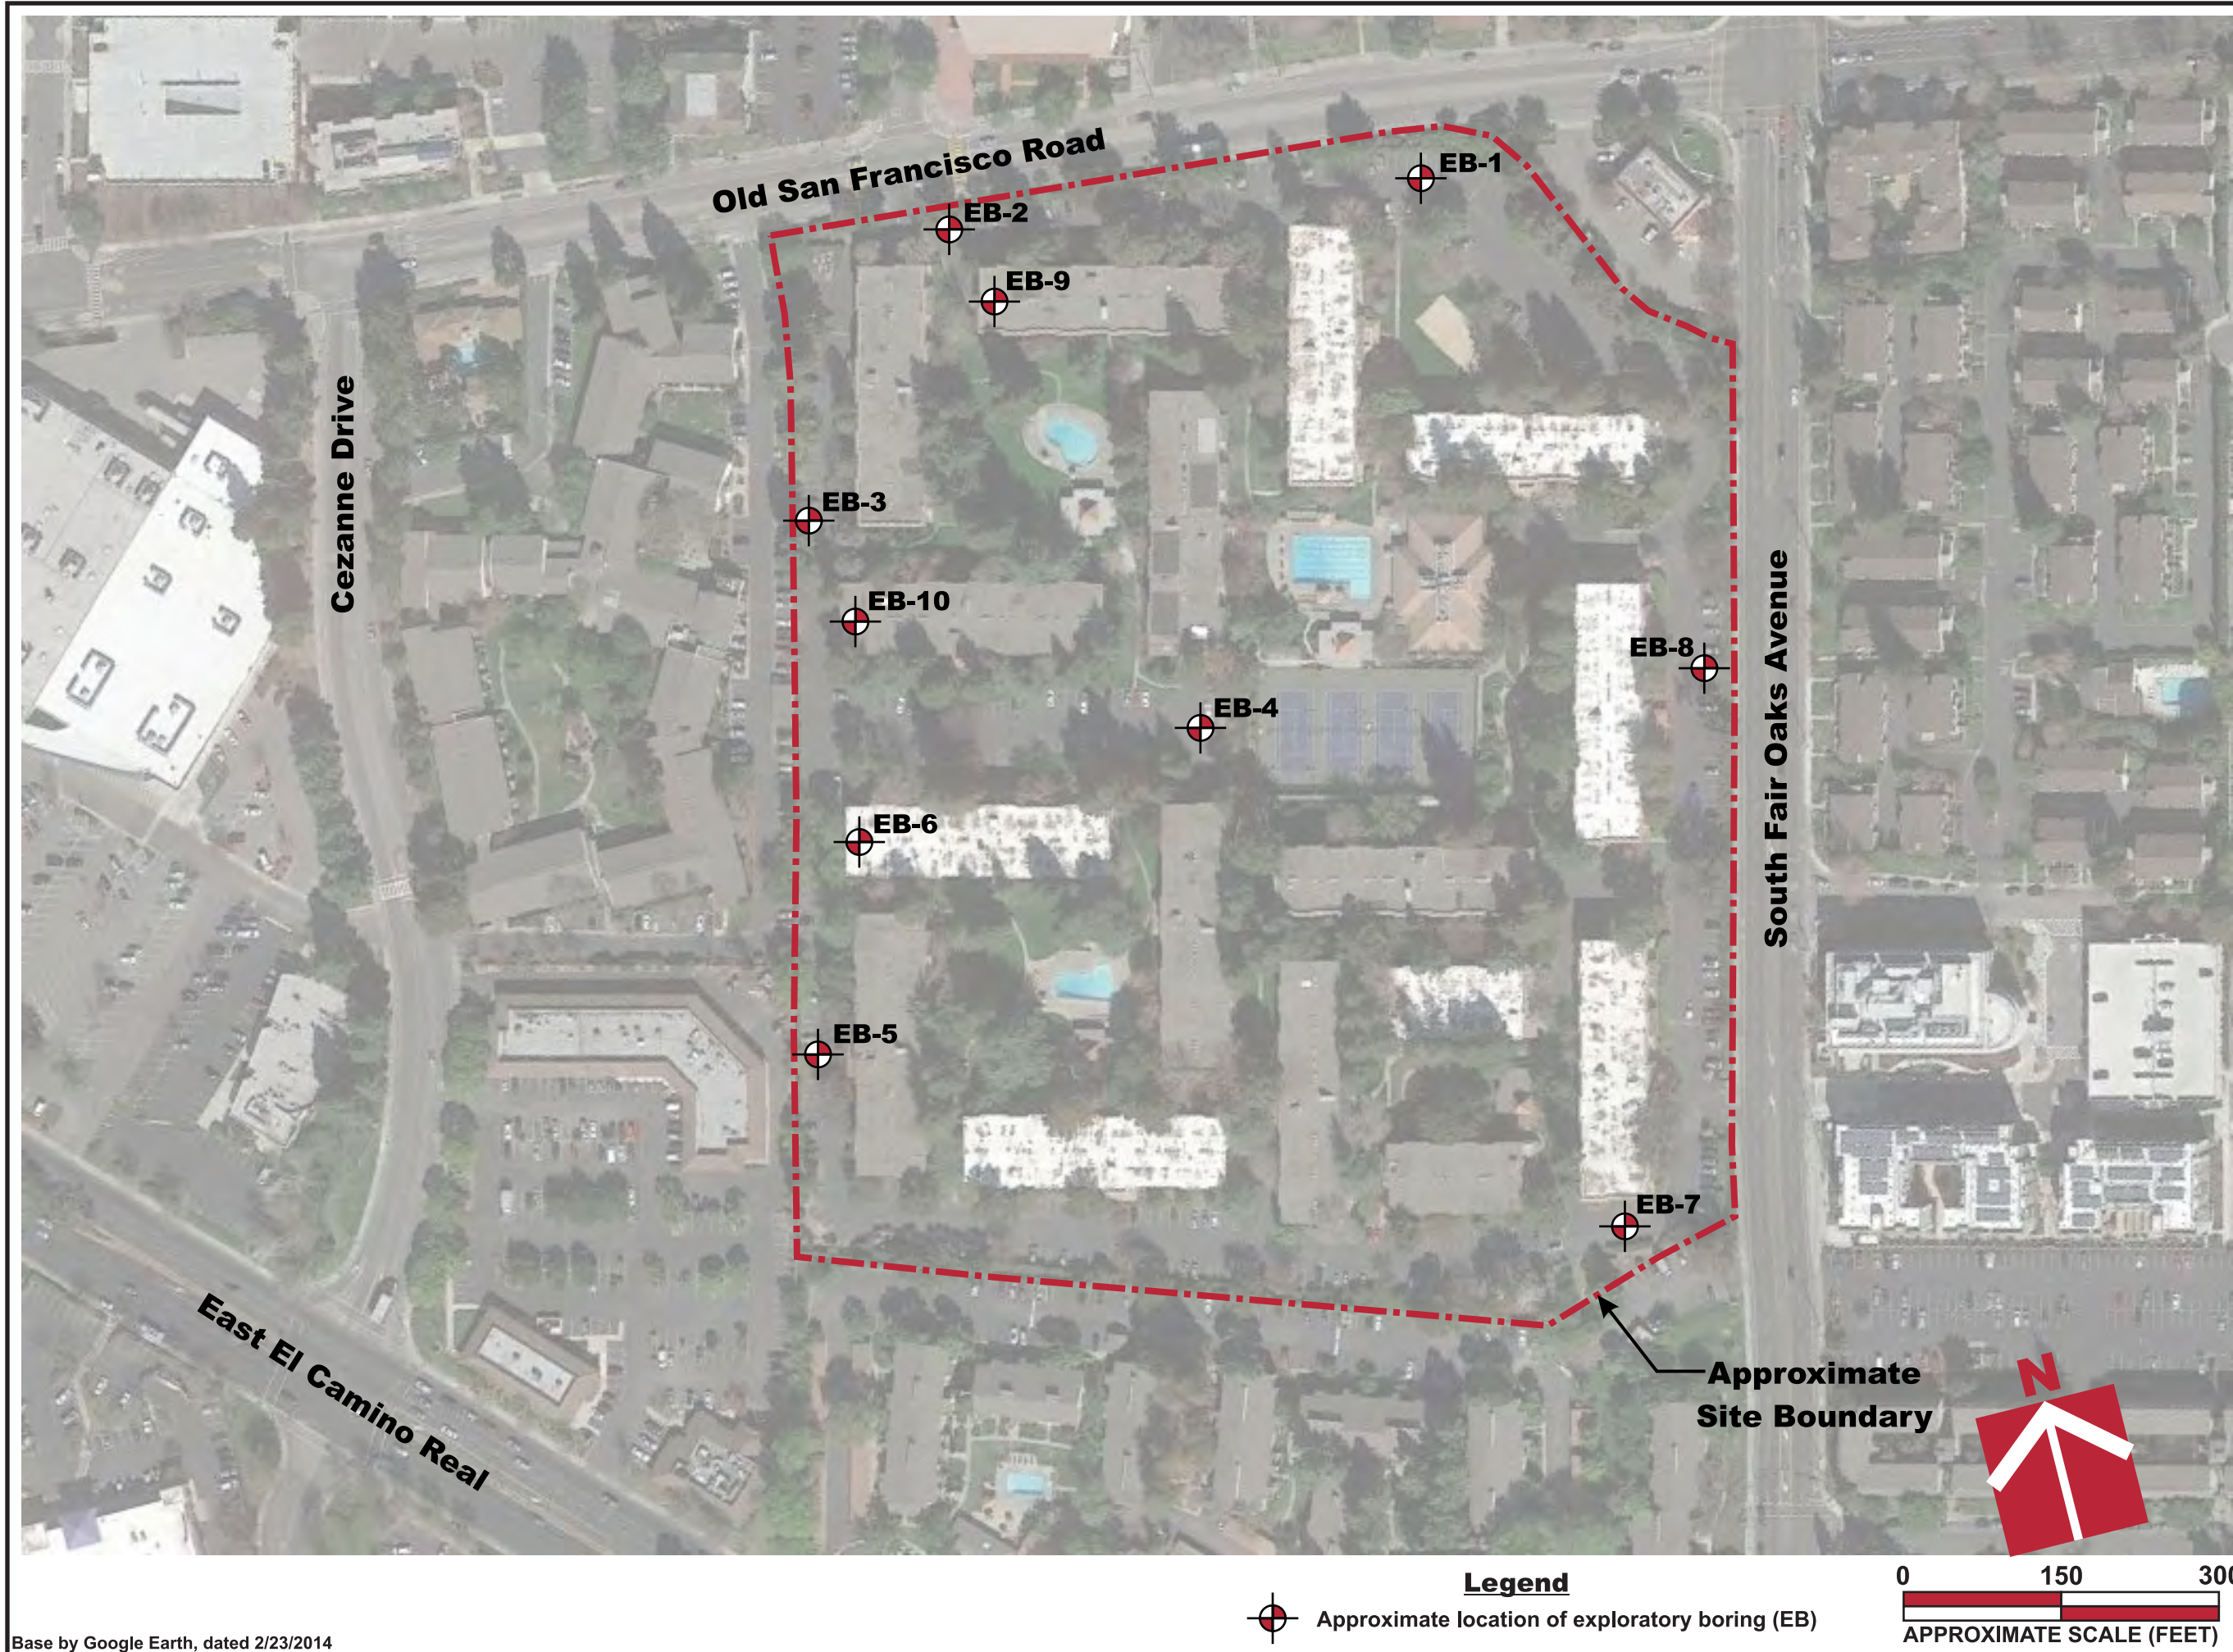
Project Number		307-10-1
Figure Number		Figure 2
Date	July 2014	Drawn By RRN
Site Plan		
Fair Oaks West Apartments Sunnyvale, CA		
<b>CORNERSTONE EARTH GROUP</b>

Base by Google Earth, dated 2/23/2014

The approximate locations of our exploratory borings are shown on the Site Plan, Figure 2. Details regarding our field program are included in Appendix A.

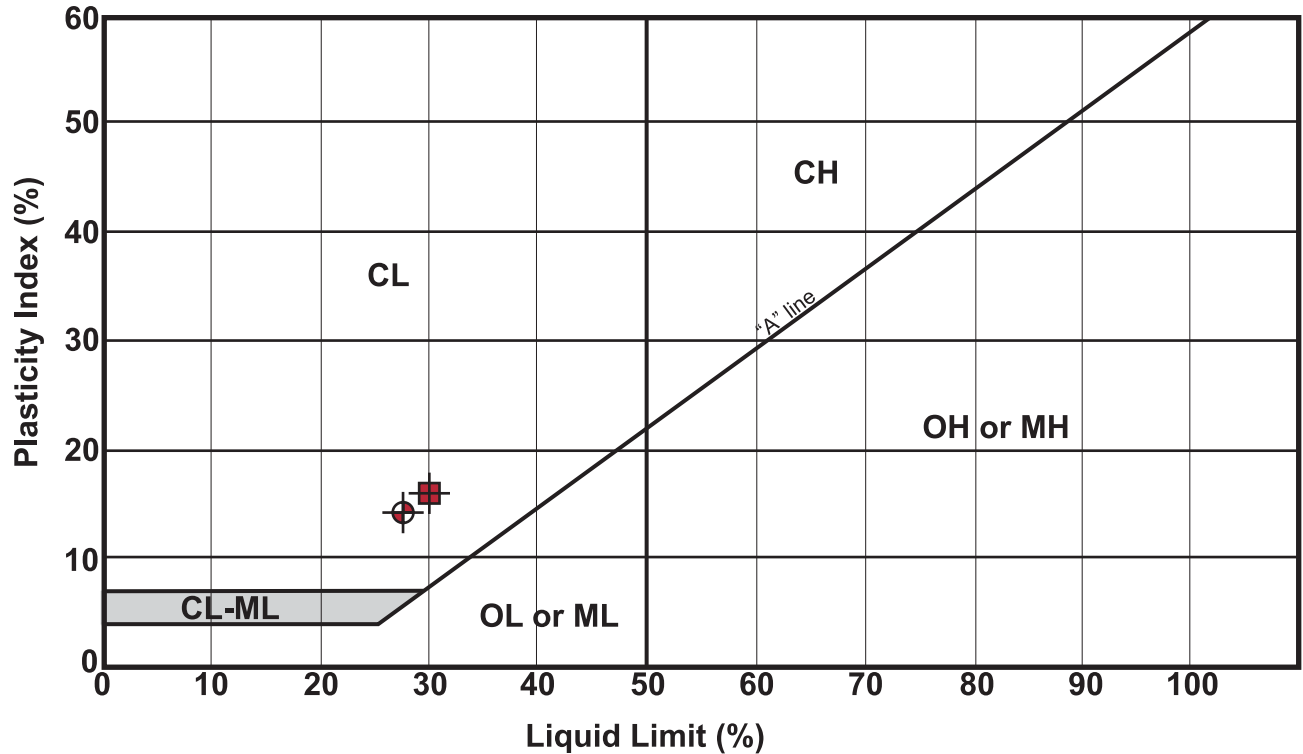
## Plasticity Index (ASTM D4318) Testing Summary

Symbol	Boring No.	Depth (ft)	Natural Water Content (%)	Liquid Limit (%)	Plastic Limit (%)	Plasticity Index	Passing No. 200 (%)	Group Name (USCS - ASTM D2487)
⊗	EB-5	2.0	8	28	14	14	—	Sandy Lean Clay (CL)
⊠	EB-9	2.0	12	30	14	16	—	Sandy Lean Clay (CL)

**Plasticity Index:** Two Plasticity Index determinations (ASTM D4318) were performed on samples of the subsurface soils to measure the range of water contents over which this material exhibits plasticity. The Plasticity Index was used to classify the soil in accordance with the Unified Soil Classification System and to evaluate the soil expansion potential. Results of these tests are shown on the boring logs at the appropriate sample depths.
