NELSON ENGINEERING CO.

Project: 188 OTTER ROCK DRIVE
GREENWICH, CONNECTICUT

Completed: OCTOBER 2011

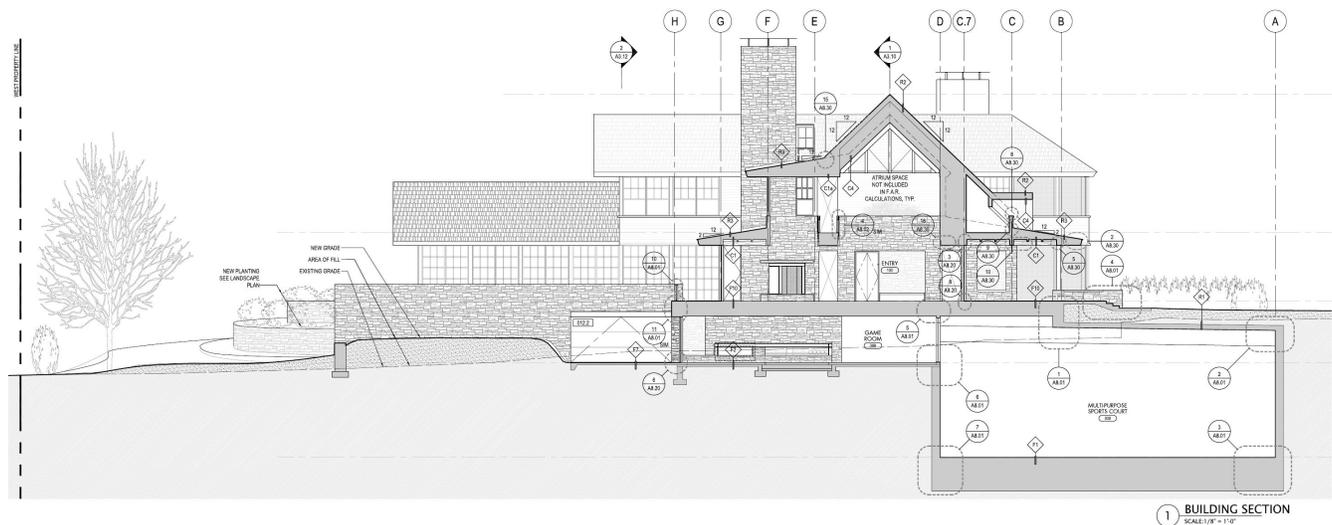
Illustration 1: Building cross section looking north. The large foundation component and subject of this history is to the lower right. The structure is a clear span box, 75' wide, 130' long, and 35' deep, and will enclose an indoor tennis court. There are no interior columns at all.

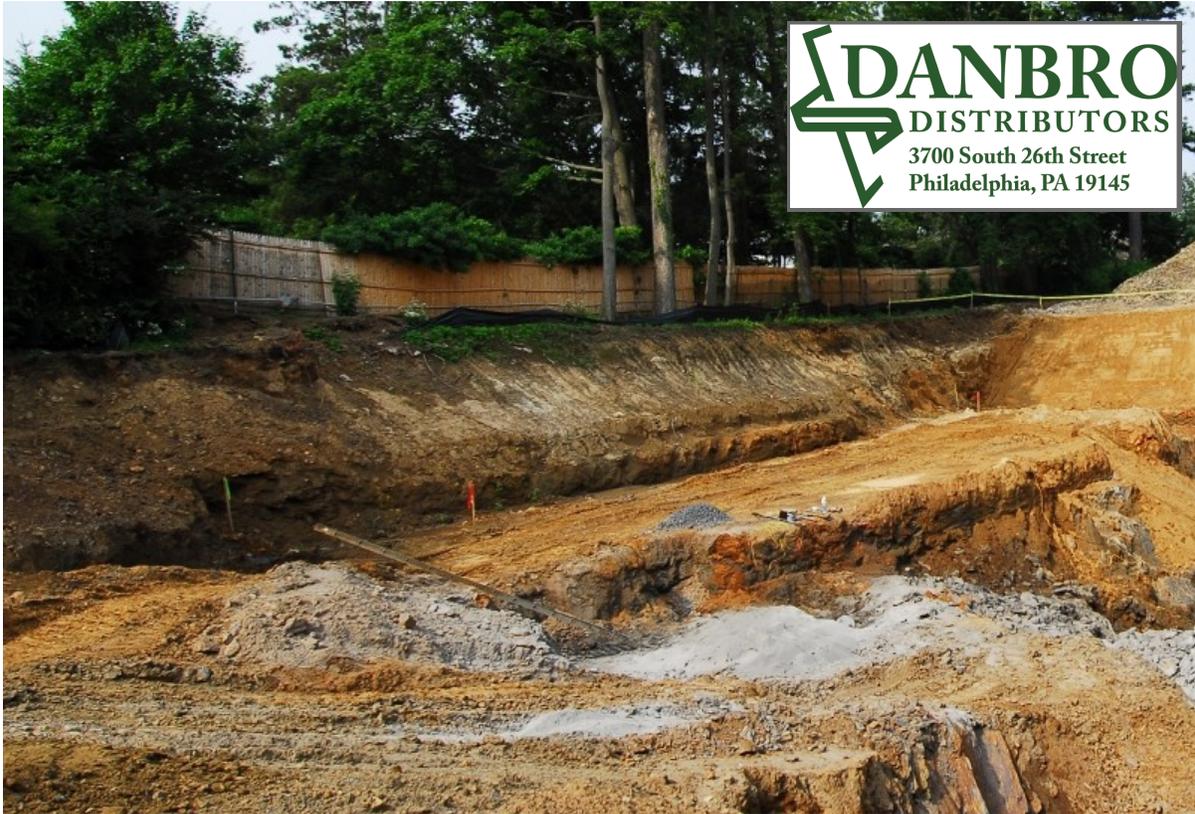
Illustration 2: The North Face of the hole. Shown here with the upper portion of the cut roughed out. The bench in front of it will remain until the Soil Nails and facing system are installed. The underlying rock can be seen at mid-right in the photo. The top of the finished slope face is only 3 ft. from the adjacent property line and wood fence.

The north face of the hole was to be excavated 35 feet deep. We broke the face into an upper and lower excavation, with the top tier consisting of 3 rows of Chance Helical Soil Nails, and the bottom with 4 rows of drilled and grouted tie-backs. The entire face was reinforced with a system of welded wire mesh and 20' re-bars, which are tied and hung on the anchor grid extensions. The two methods represent a very well matched combination and extension of these 2 very similar methods, used in difficult conditions found in soils with unpredictable obstructions and high ground water flows.

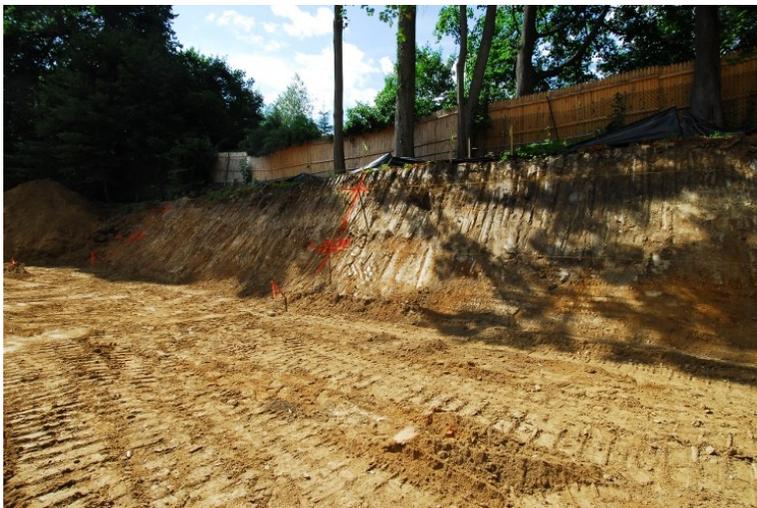
Illustration 3: North Face of the hole, cut back & staked out for Soil Nails.

Here, the layout work is visible a day prior to driving the Soil Nails. The accuracy and consistency of the anchor placement makes installation of the reinforcing system easier. The primary steel on this job was set in a diagonal pattern, made with double #4 bars and 6x6 welded wire mesh. The cleanly cut face also helps to cut down on excessive gunite thicknesses, keeps the job looking neat, and controls all those loose clods of soil and rock that tend to roll down the bank at the worst possible moment.

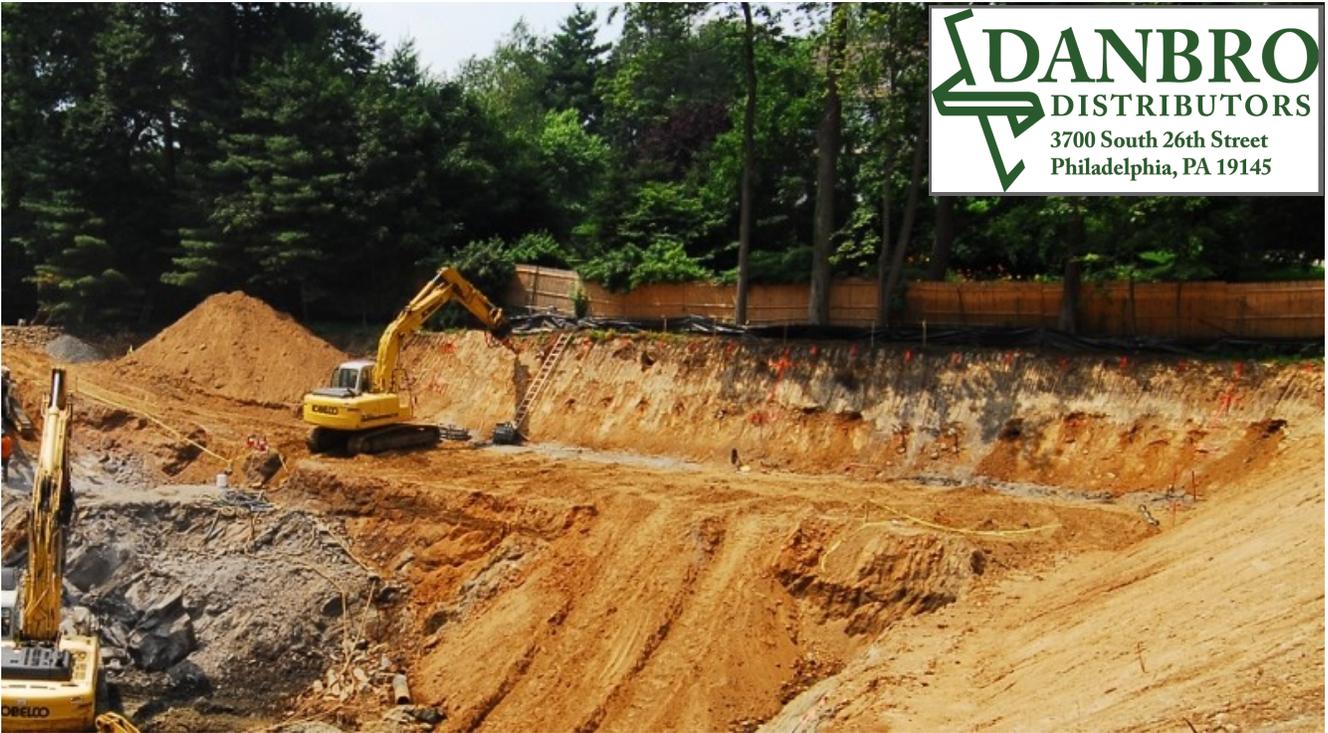
Illustration 4: Soil Nails being driven into the upper North Face. The drive took 2 days, with 2 men on the ground. The rows in this photo are spaced in a 5' x 5' grid, though some wander higher along the top of slope. These are a lead section and single extension going in to straddle the failure plane.

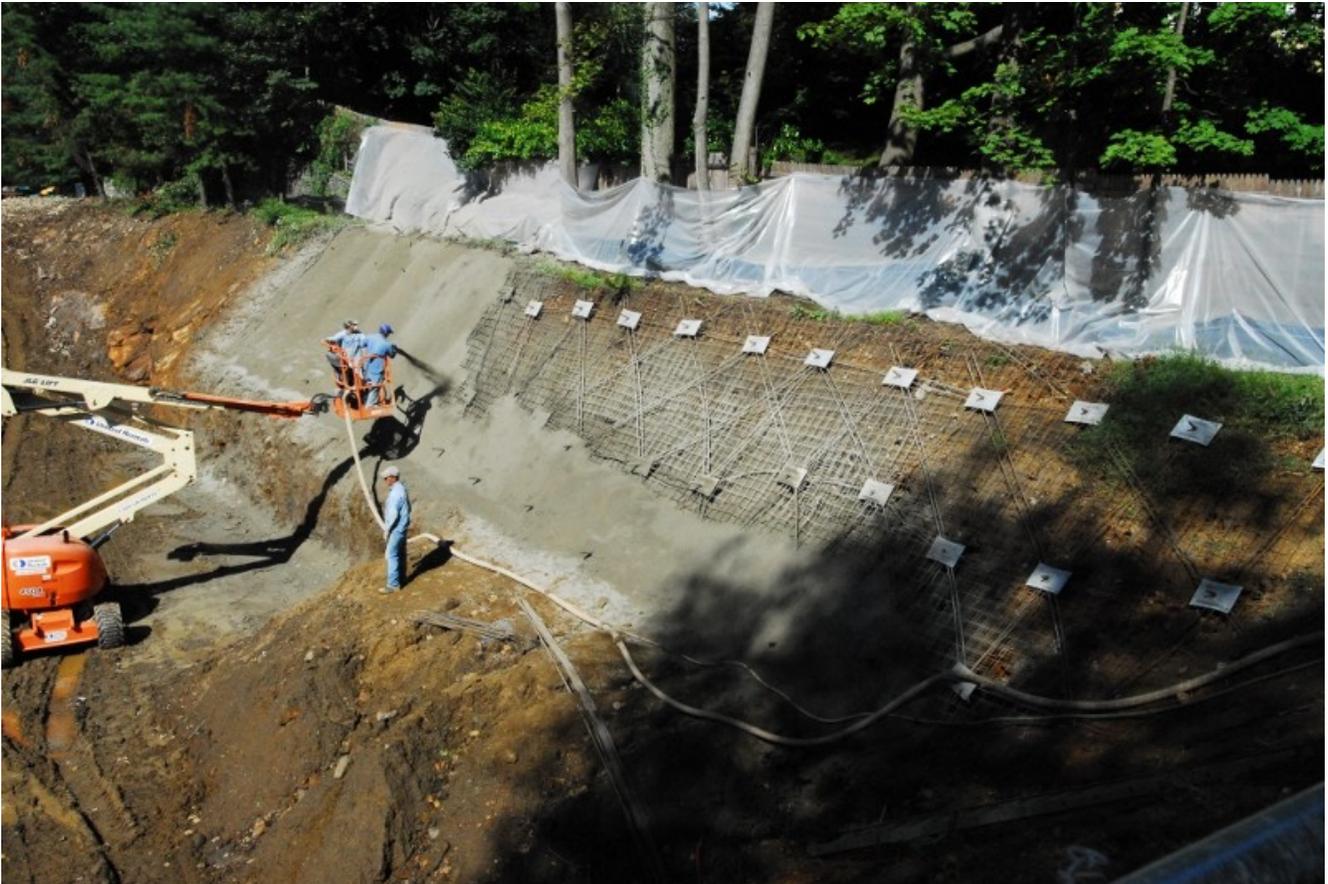
Illustration 5: Gunite operations. Some adjustment to the Nail pattern was necessary to avoid hidden rock formations in the embankment. The jump is visible in row 2, just right of center in the photo.

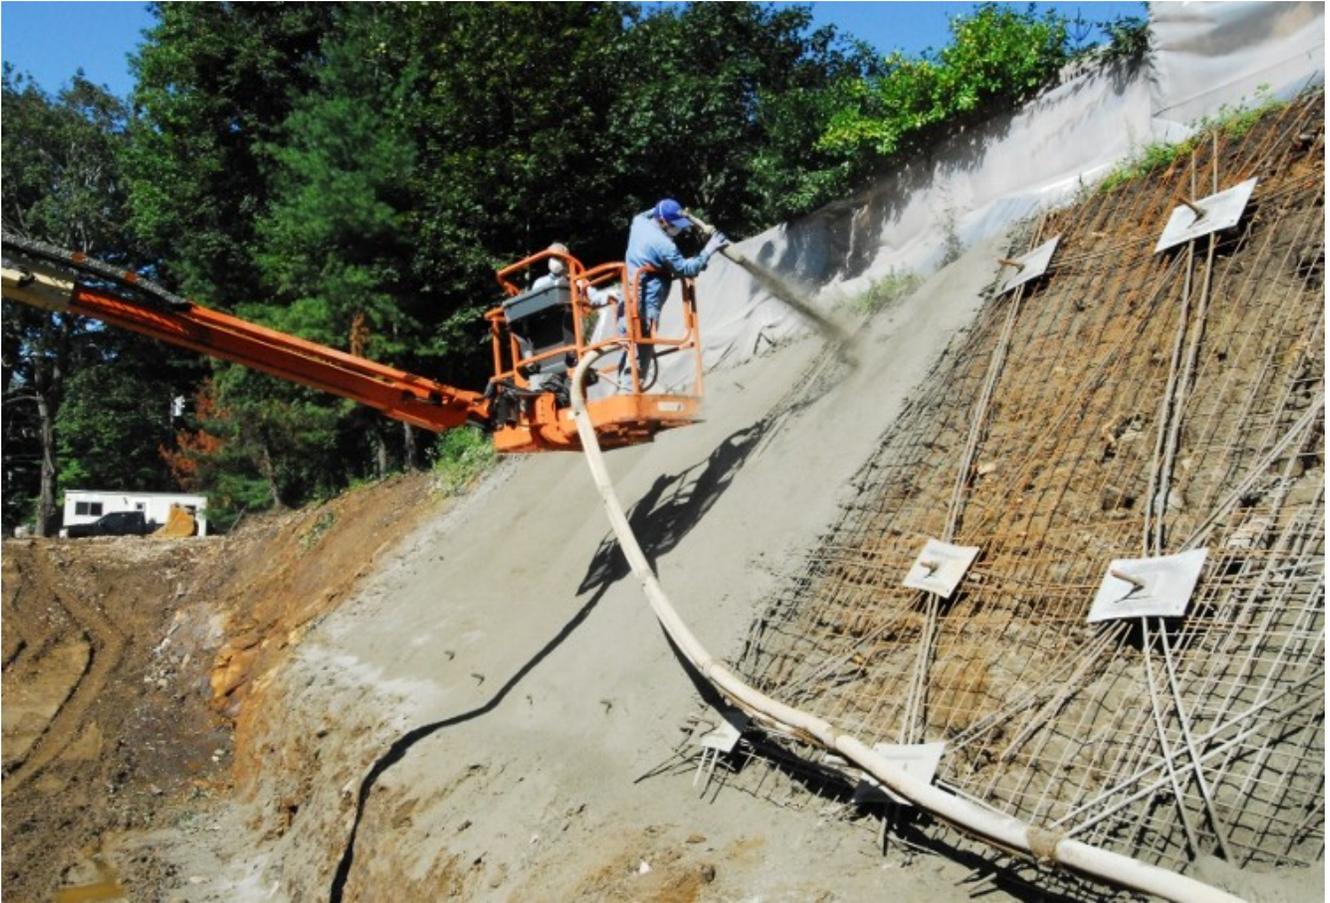
Illustration 4: Another photo of the gunite guys laying it on.

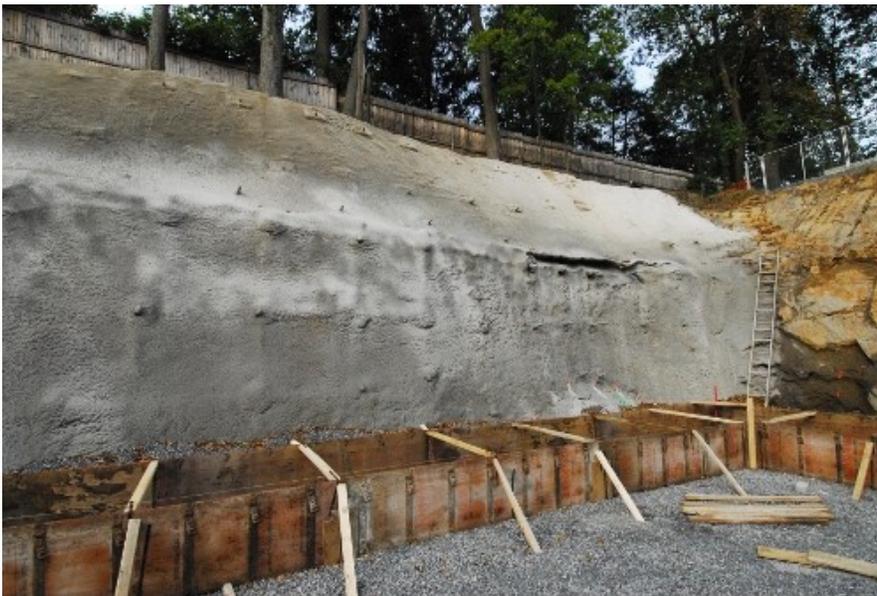
Illustration 5: The finished product.

At left, the finished job with footings just underway.

The lower gunite face is about 16' tall and was partially back-filled in front with a 3 ft. deep compacted bed of aggregate, as an interface between the foundation and the hard rock bottom of the hole.

For some better perspective, note the 16' ladder in the corner of the dig.

After the upper assembly was allowed to set for a few days, the lower portion of the dig was advanced, initially another 5', and then to full depth because of the soil conditions encountered. In general, it was anticipated that there were homogeneous ground conditions below, but when the lower reach was opened up, the highly decomposed layer of rock was inconsistent enough that drilled and grouted tie backs would work the best.

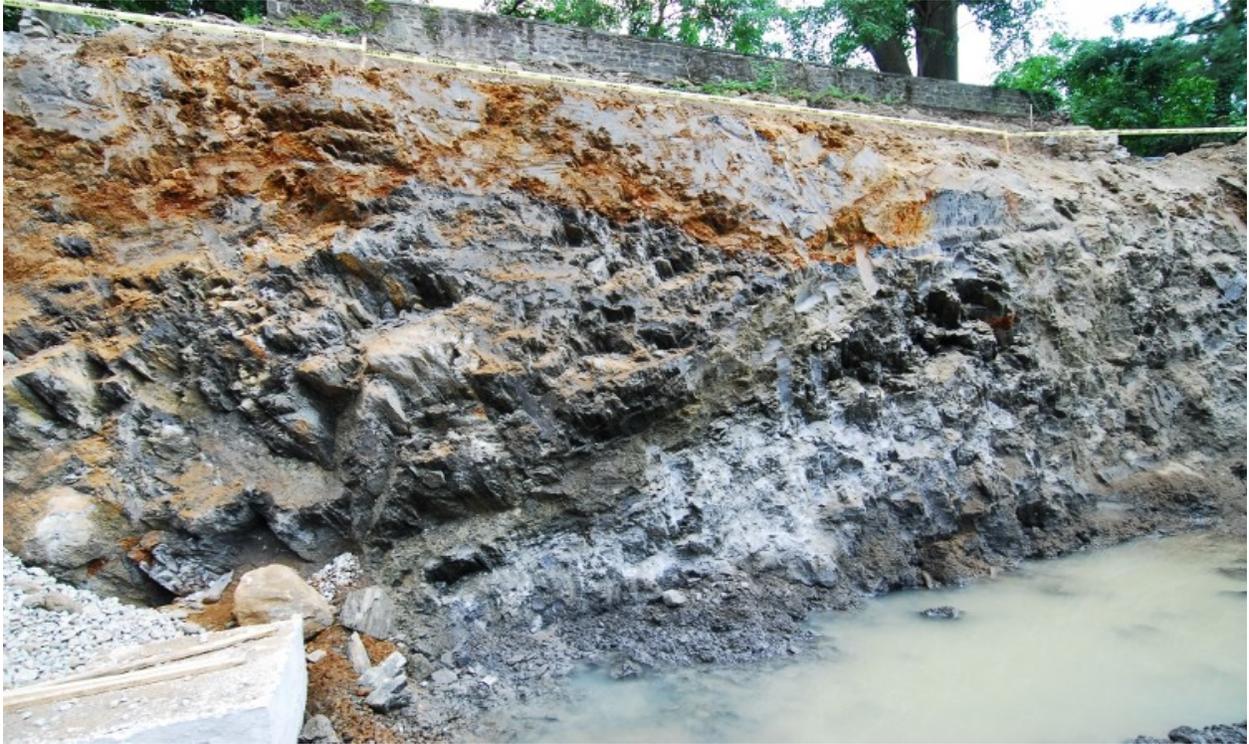
Illustration 6: Rough sledding down south. Note the density of the soil mass in the photo. The loping profile of the shist is seen clearly here. The semi-competent parts of it break in 6 different planes, and make each face (n-s-e-w) terminate uniquely. What works up north - does not work down south. The north and west sides of the hole were problematic in this way.

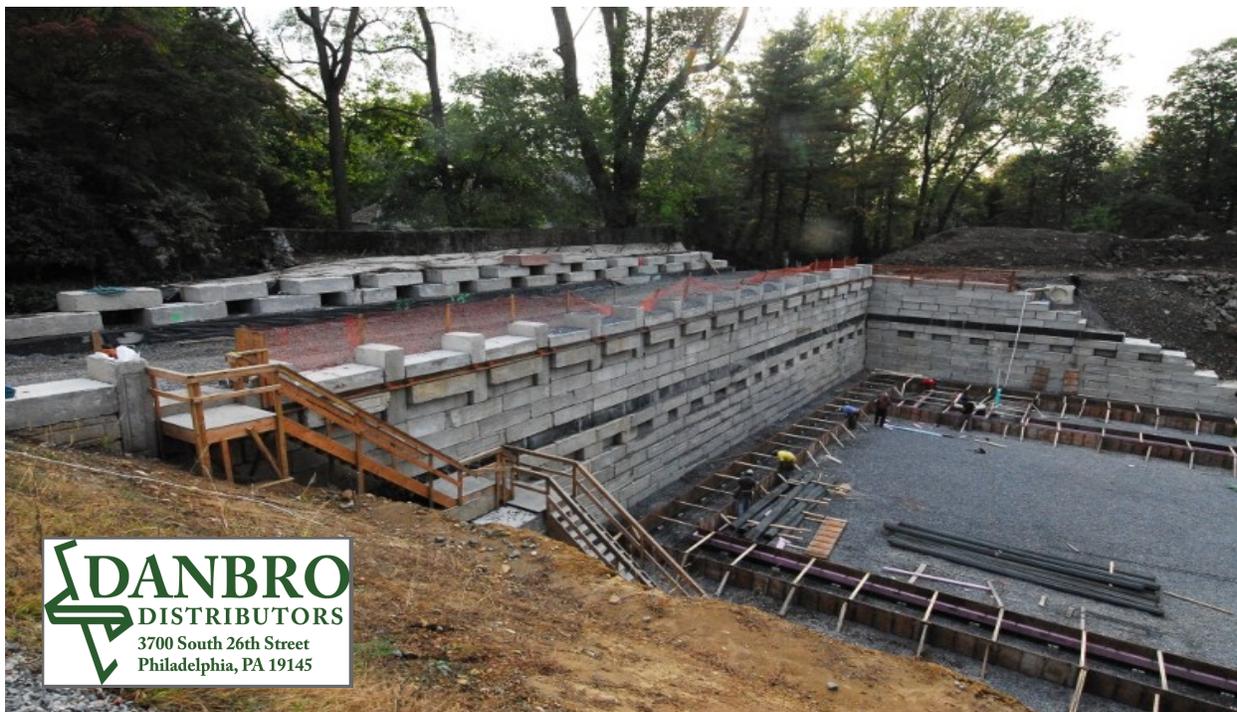
Illustration 7: Heavy Hybrid Structure. A nice use of classical proportions and robust balance. Includes a row of big plate anchors and tie rods for the "head set". The black band is the low-horizontal arm of it that also serves as a base. Its geometry is taken directly from the ancient.
