Retrofit Helical Piers Stabilize Wall

River Road Pump Station

Council Bluffs, IA

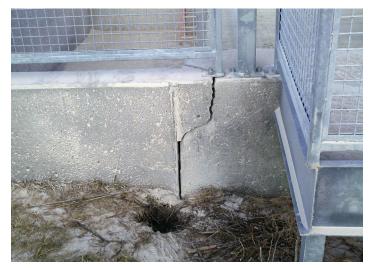
The River Road Pump Station, constructed in 2001, consists of a 2,700 square-foot, two-story building that pumps collected storm water into the Missouri River. Cracks in the poured concrete north foundation wall indicated that the structure was settling differentially. Initial underpinning recommendations to stabilize the building included either helical piers or hydraulically-driven push piers with a design working compression load of 35 kips per pier.

Fractured concrete

Helical piers, determined to be the better fit for the soil conditions, were ultimately selected to stabilize the north wall of the building. The underpinning design included nine retrofit helical piers, spaced 5.5 feet on center, with a design working load of 35 kips each. The helical pier configuration consisted of Model 288 (2.875-inch O.D. by 0.276-inch wall) hollow round shaft with a 10"-12"-14" triple-helix lead section followed by two 14-inch helix plates on the first extension.

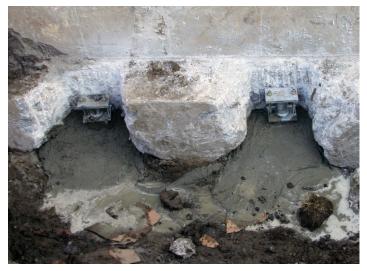
Completed pier with retrofit bracket; excavations filled with cement grout

to uniformly load the piers to the design working load. After the piers were loaded, the augered holes were backfilled with grout and the brackets were epoxy-anchored to the footing as specified by the project engineer. Despite longer than normal footing preparation due to the footing being much larger than anticipated and containing No. 8 rebar, the entire project was completed in just three days.

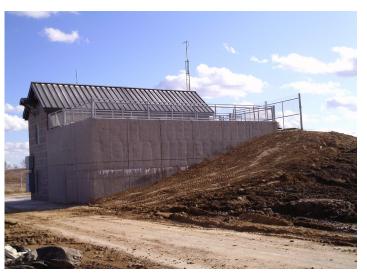
Completed project
