Genzyme Structural Slab Repair

**G. Donaldson
Construction, A
Division of
Hayward Baker**

**Jacobs
Conshohocken, PA**

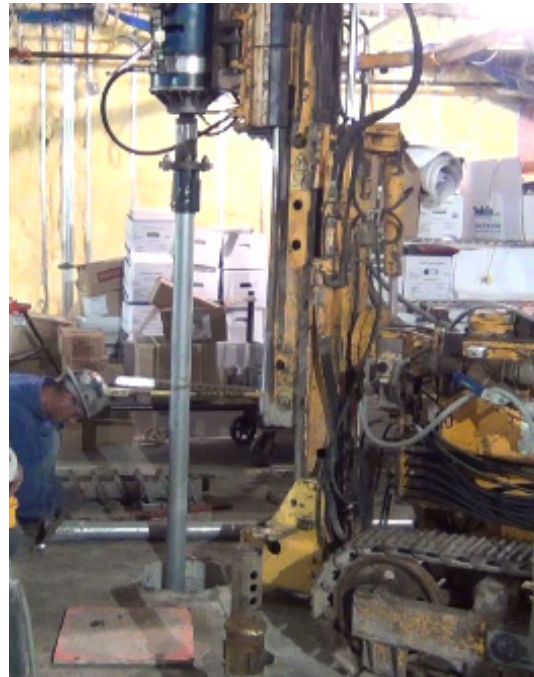
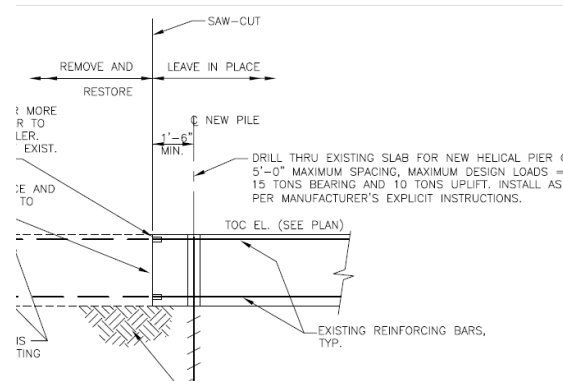
The bio firm has a facility that was slated for equipment upgrades for quality control laboratories. The underlining slab needed to be restored before it could be used. A FILL layer exists under the slab and extends 15 FEET below the surface. Therefore, the slab would require pile supports. Due to low headroom clearance issues and sensitive laboratory vibration concerns, CHANCE™ helical pile foundation system was the support of choice. Slab sections were removed and the helical piles were installed at 5' o/c spacing with construction caps.

- SS175 Solid Square Shafts with 10", 12", 14" helices
- The extensions were RS3500.300 Round Shaft that transitioned after the lead SS175 was installed. The extensions were 5' and 7' sections to accommodate the low head room restrictions.
- The piles were slated to go 25-30 FEET however, most of the piles reached the required torque around 15 FEET just below the FILL layer.
- Design Compression Load = 30 KIPS
- Design Uplift Load = 20 KIPS
- Required Torque = 6000 FT-LBS
