2 NEW CONSTRUCTION HELICAL
PILES AS ALTERNATIVE TO
CONCRETE CAISSONS

CONSTRUCTION HELICAL PILES INSTALLED AS PART OF MEDICAL PLAZA REMEDIAL FOUNDATION STABILIZATION

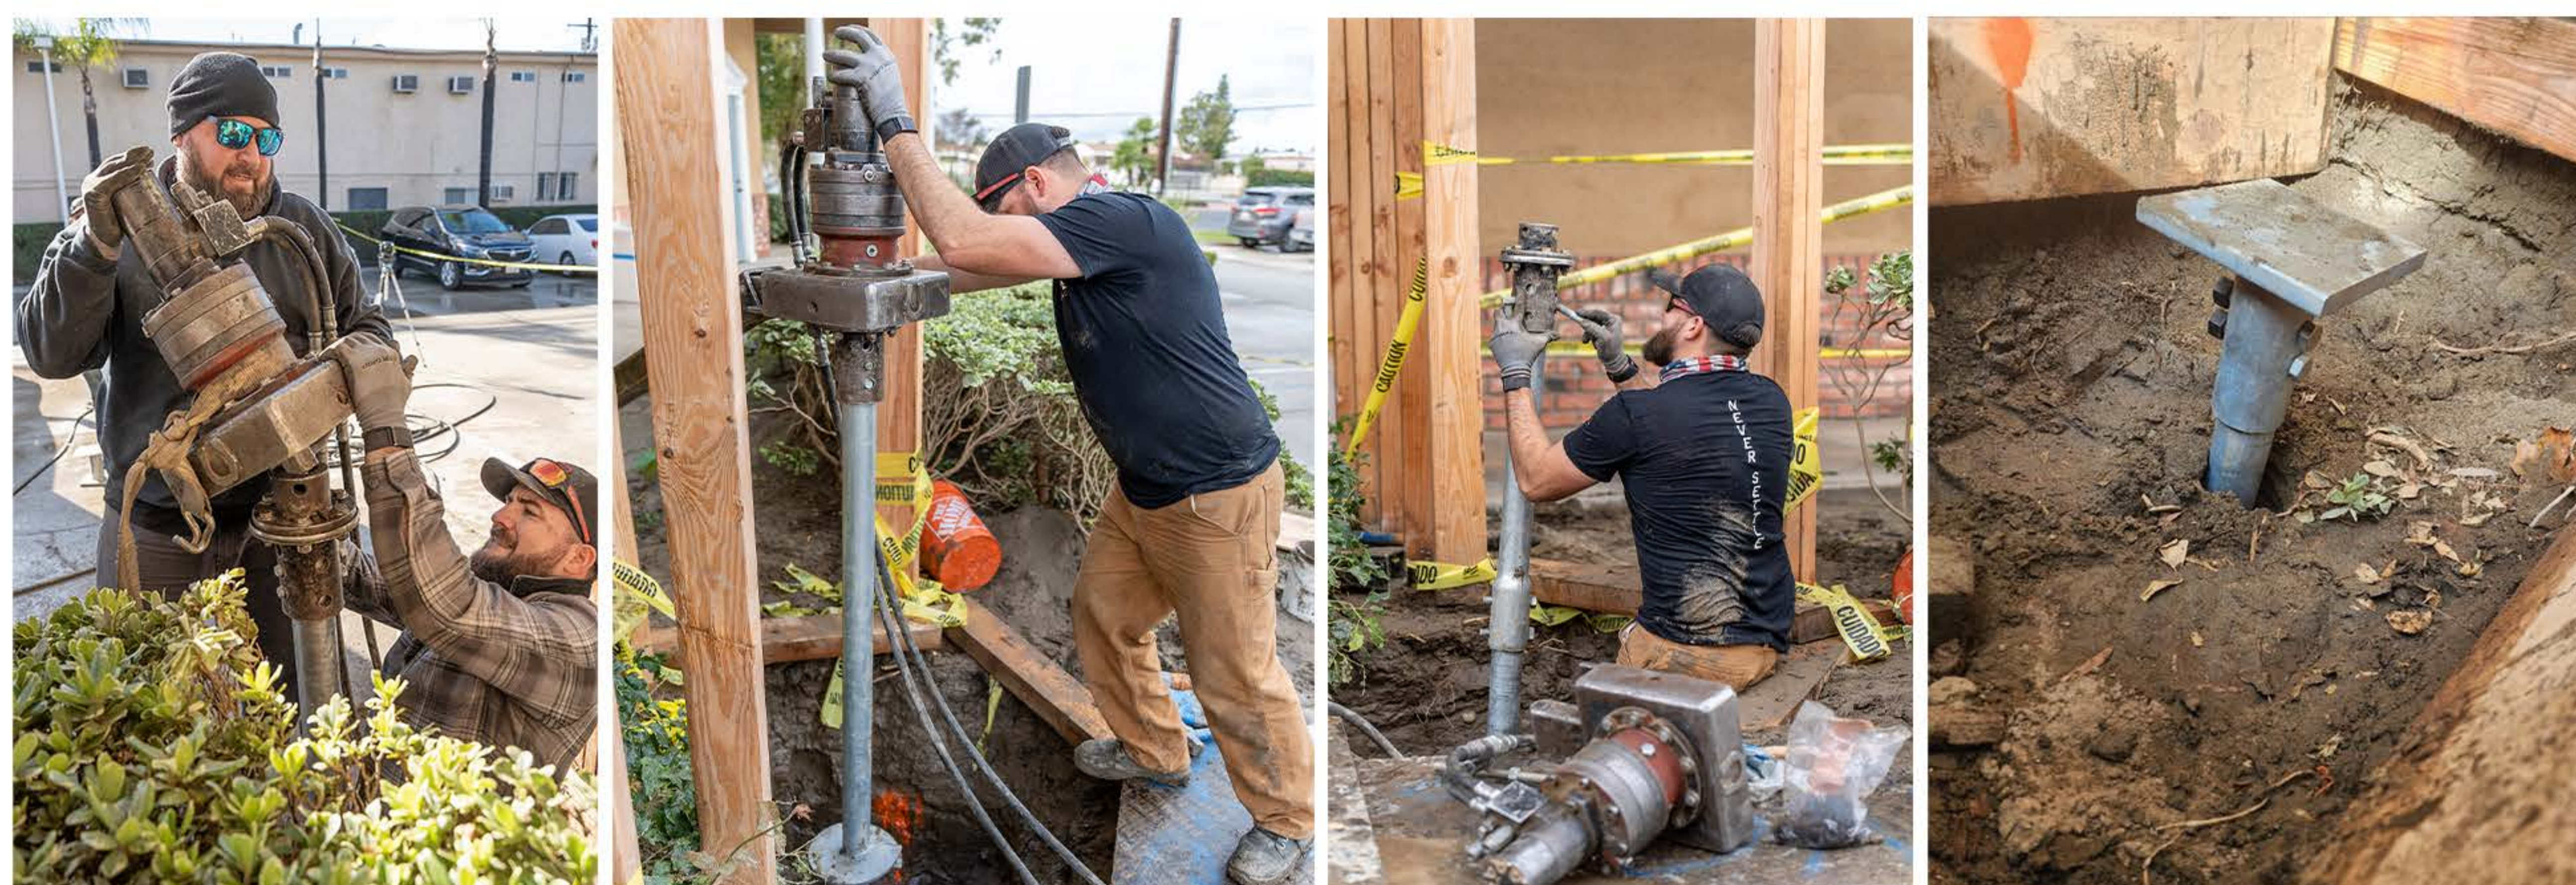
The GC on the project helped our crew make quick work of phase 2 of the project by excavating both of the pier locations prior to our team's arrival. After setting up their installation equipment and hydraulics the crew began driving the helical piles down to competent, load-bearing strata. They found competent soils at depths of around 28 feet beneath the soils surface. After driving the piles to competent soils they were able to install the new construction caps that would allow the piles to be tied into a concrete cage and encased in concrete.
