CASESTUDY

27 HELICALS INSTALLED TO
SAVE HILLSIDE BACKYARD IN
DIAMOND BAR

HELICAL PIERS & TIE-BACKS HYDRAULICALLY DRIVEN TO SUPPORT SLIDING BACKYARD & POOL

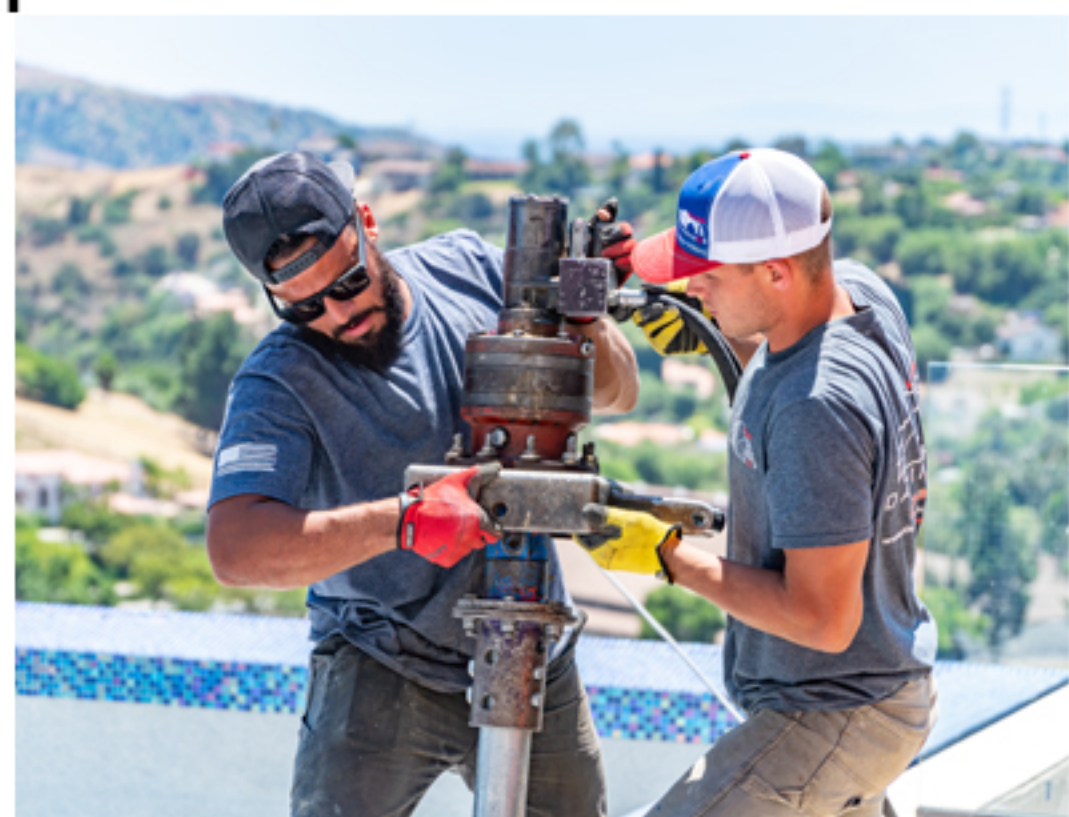
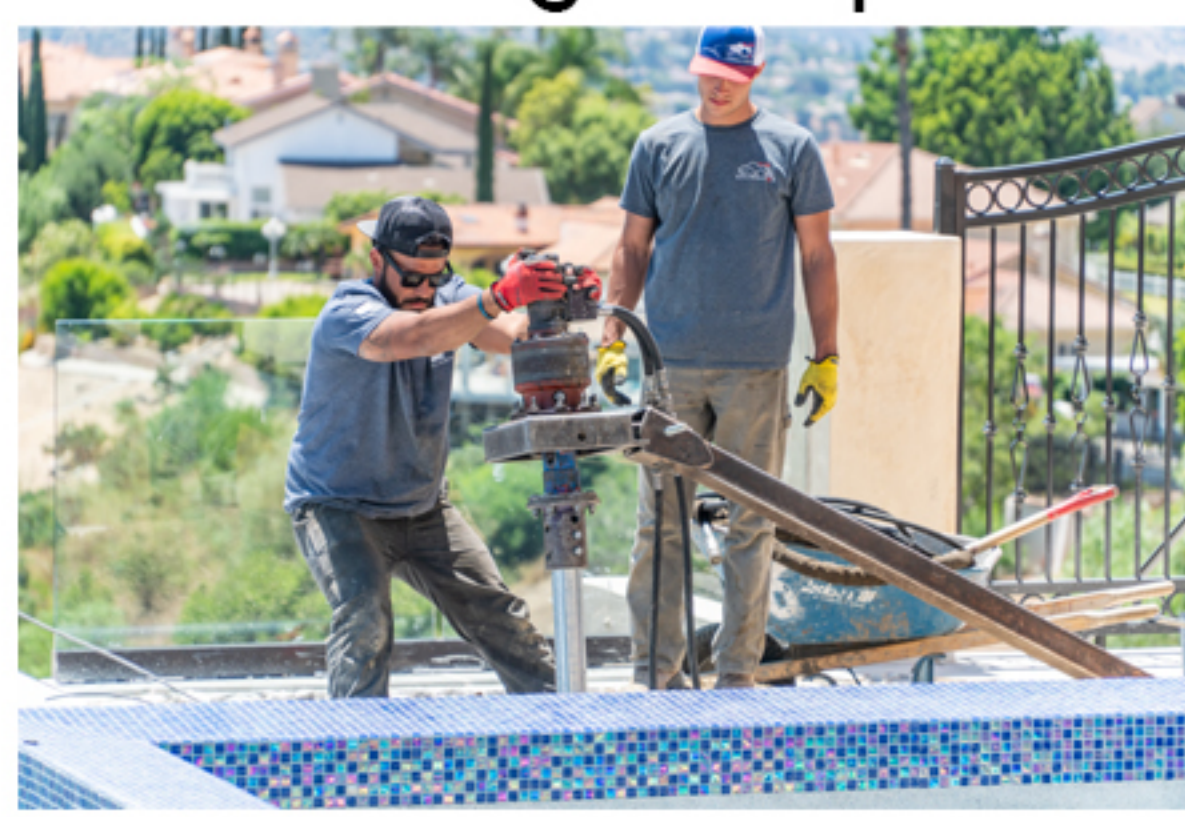
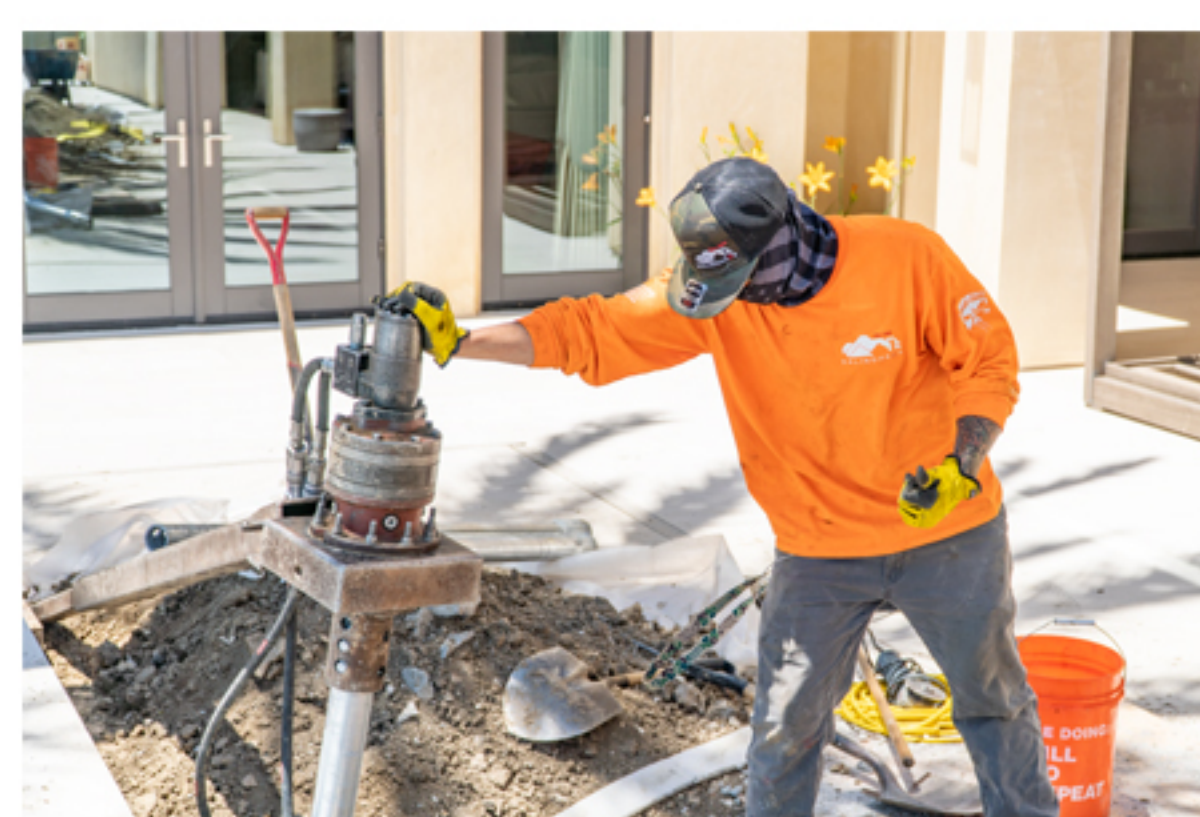
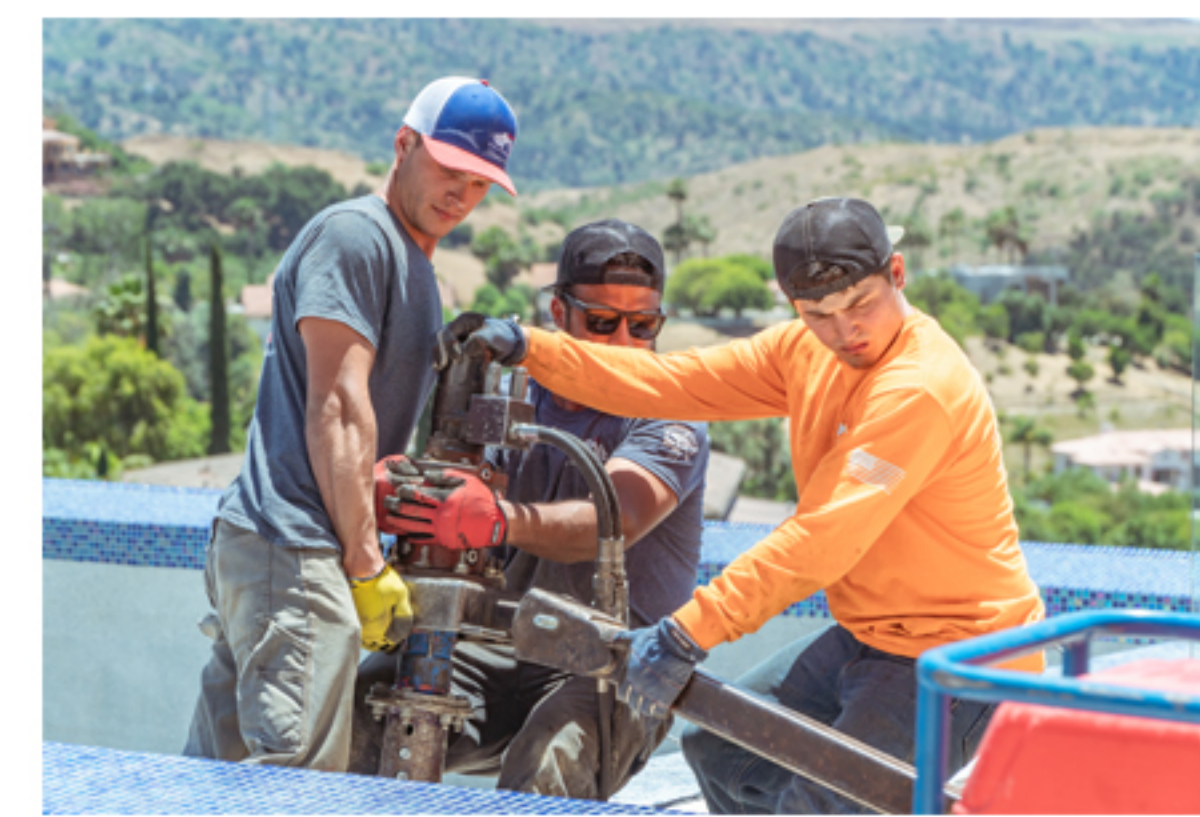
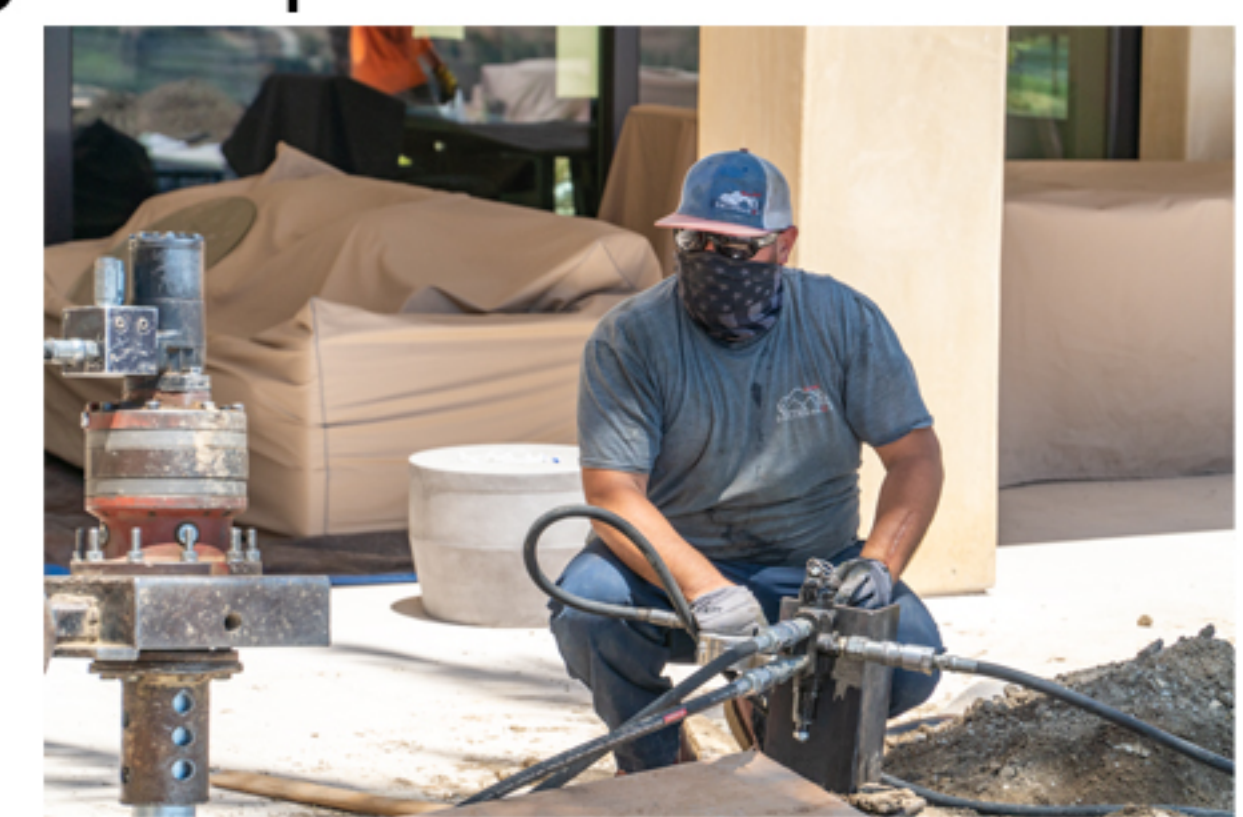
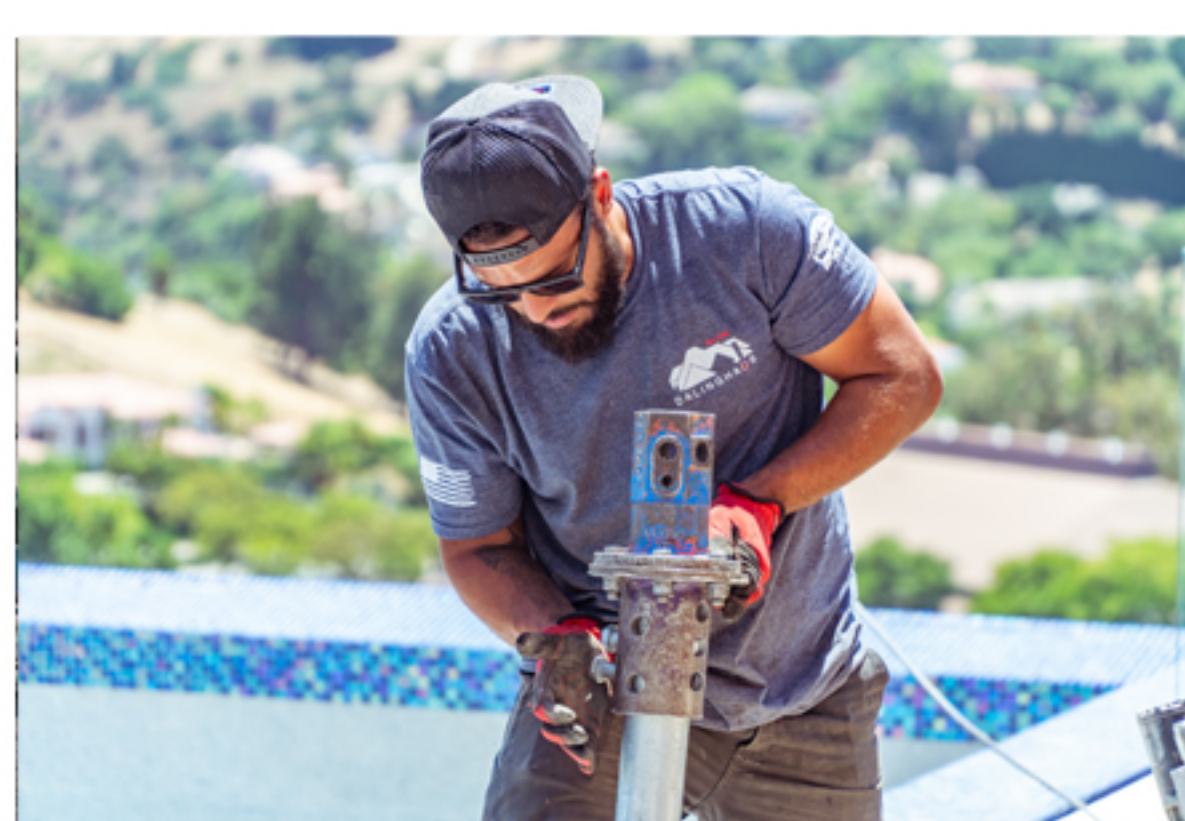
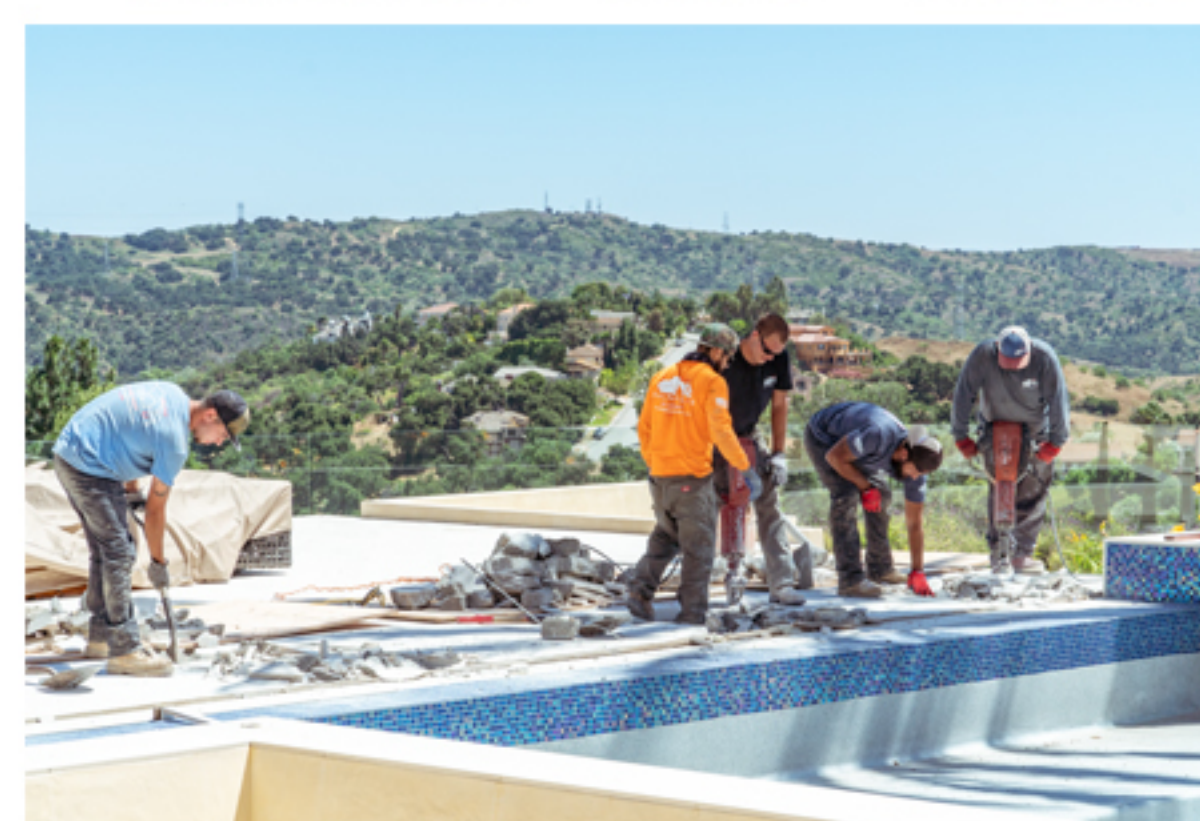
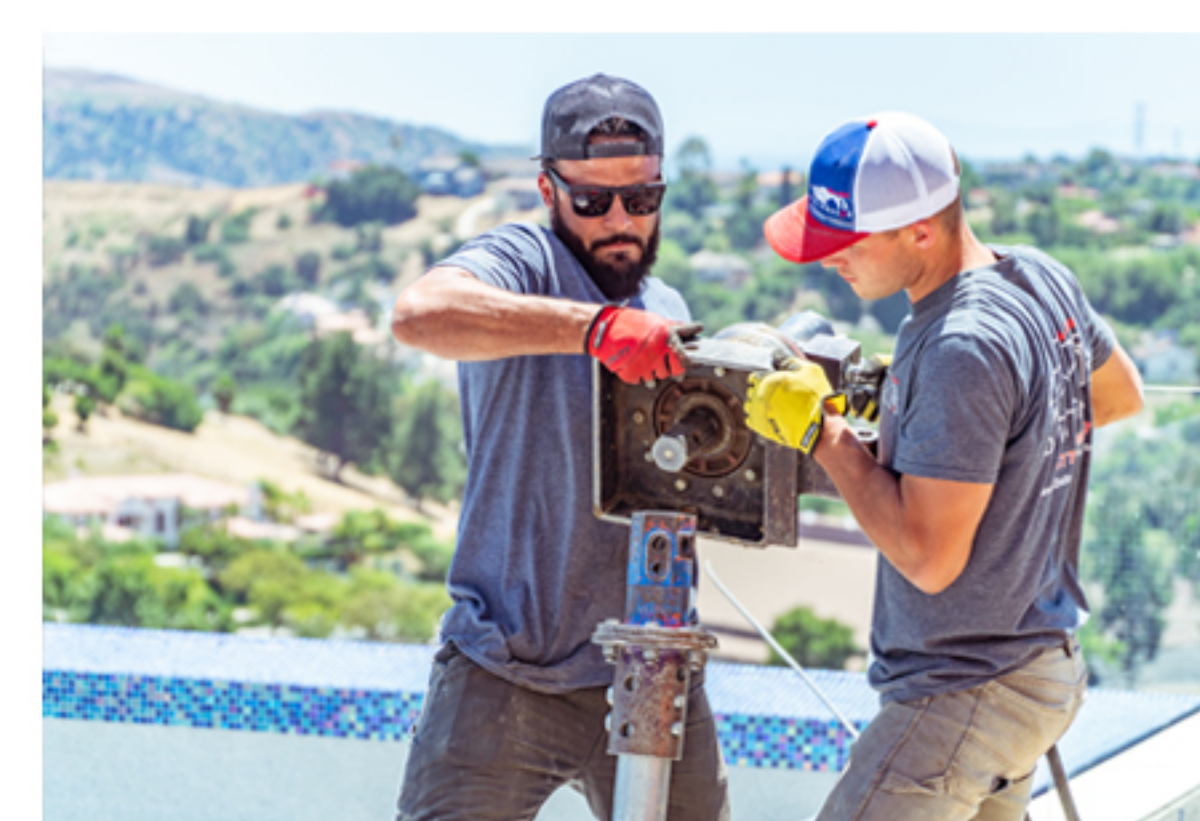
After purchasing this home in Diamond Bar, CA a new homeowner found himself looking at cracks all over his backyard with several large cracks running parallel with a massive slope that the home sits on. His first call was to an engineer who recommended he find a foundation repair contractor because there were only two options for this pool and backyard... either tear out and replace everything, or install piers to address the incompetent soils and lateral movement. With a soil report in hand the homeowner called the Dalinghaus Construction team to inspect the property and design a repair plan.

Having been familiar with several properties with similar slope conditions in this neighborhood, the owner called us to come out to the home and evaluate the site conditions. During the evaluation Joe and Phil found that the pool had settled over an inch on the side adjacent to the slope. They needed to design a repair plan that properly addressed the settling while also being sure to address the lateral movement the pool was experiencing towards the slope.

With the help of Helfrich and Associates Joe and Phil designed a repair plan consisting of the installation of 24 TAF288 vertical helical piles and 4 TAF150 helical tiebacks around the perimeter of the pool and along the hillside. The piles and tiebacks would be both embedded into new grade beams and mounted to the footings around the pool to lift the areas that had settled. The methodology for the design was to create a structurally sound solution to the slope's previously unsupported crepe characteristics.

Dalinghaus Construction was able to successfully install the 23 piles and 4 tiebacks with the help of two crews in one single phase to help solidify the hillside. The project was installed utilizing our hand held installation equipment. The piles were installed to an average depth of 28' and the tiebacks were installed to an average depth of 22'.
