TEMPORARY SHORING TO STABILIZE ADJACENT ROAD DURING CONSTRUCTION Aurora, Colorado

Project Summary	
Project:	Temporary Excavation Shoring, Aurora, Colorado
Engineer:	CTL Thompson, Inc., Denver, Colorado
Installing Contractor:	Park Range Construction, Inc. 2755 South Raritan Street, Englewood, Colorado
Products Installed:	TAF-288 Torque Anchor™ Piles – 2-7/8" Dia. Tube TAF-150 Torque Anchor™ Tiebacks – 1-1/2" Sq. Bar
Number of Placements:	10 Piles & 22 Tieback Anchors
Average Embedment:	15 ft
Ultimate Capacity:	30,000 lb
Average Working Load:	15,000 lb
Factor of Safety:	3.7 : 1 Ultimate To Working Load

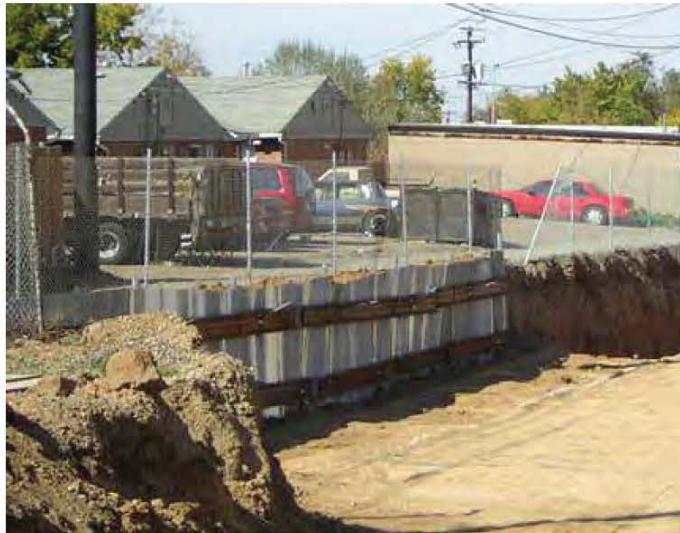
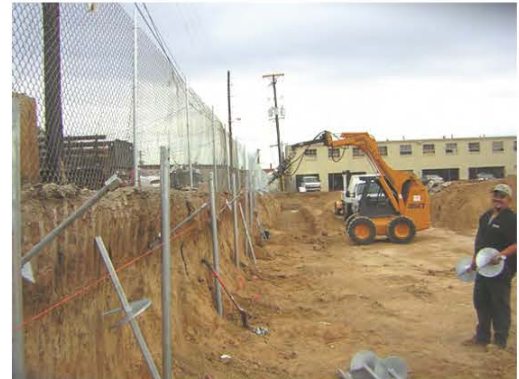
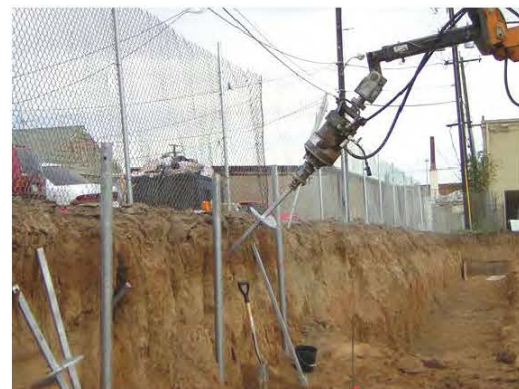
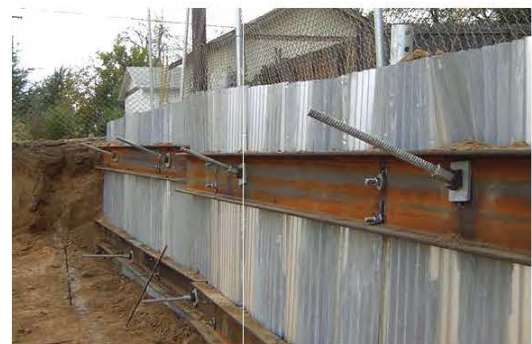
A new multi-housing unit was planned on this site. The plans called for an excavation for a new foundation to be adjacent to a public street. The engineer called for temporary shoring to stabilize the soil cut, and to support the road during construction. This project required installation of two different helical screw pile products. The Torque Anchor™ installations and shoring construction had to be accomplished in stages to prevent loss of soil support from beneath the road.

ECP Model TAF-288 Tubular Torque Anchors™ were installed first as vertical piles with spacing of ten feet on center along the edge of the proposed excavation. The piles were used to support Vulcraft CSV Steel Decking. As construction progressed, two rows of Model TAF-150 ECP Square Bar Tiebacks were installed with center to center spacing of ten feet. This spacing coincided with the tubular piles. Horizontal support for the steel decking was accomplished by installing C12x30 steel channel beams as a waler system for the two rows of tieback anchors.

Photographs from Top: Site and finished shoring; Installation of tiebacks; Close up view of shoring construction.

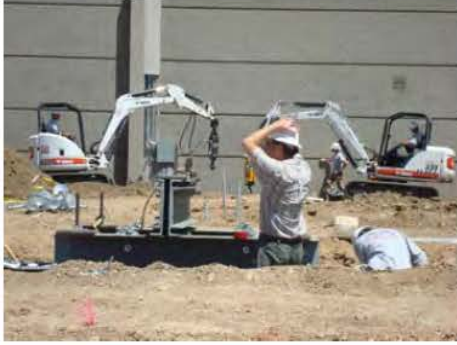
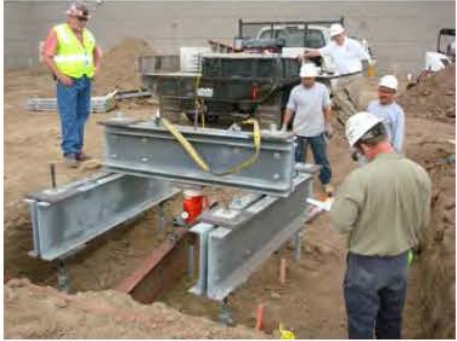
Load Testing

The ECP Model TAF-175 Torque Anchor™ solid square shaft helical pile was installed at each placement to a minimum depth requirement of 45 feet below grade. The pile configurations varied due to soil borings encountering very dense soils at 10 to 15 feet deep on a portion of the site. At these placement locations, the smaller plate configuration was used to allow the pile to reach the target depth before experiencing excessive shaft torsion. The target shaft torsion to provide the service load requirement of 43,500 pounds, plus a factor of safety of 2.0, was 8,700 foot-pounds.

As part of the verification process, two static load tests were performed prior to installing the piles and two load tests during production. These tests were directed and supervised by CTL Thompson Engineering and monitored by the USPS inspector. The test procedure was conducted in close conformance with ASTM D-1143. All of the load tests were successful.
