Helical Piles of New York Installs (22) Helical Piles for Underpinning and a New Foundation for an Elevated House in Lindenhurst, NY

December, 2015

Project Name & Location:	Elevated House Foundation - Lindenhurst, NY
Project Date:	December, 2015
Project Type:	Underpinning Existing Block Foundation and Installing Piles for New Foundation
Helical Pile Installation Contractor:	Helical Piles of New York - Div. of High-Rise Industries
Structural Engineer:	Jeffrey Havelin, P.E. - www.havelin-pe.com
General Contractor:	Sprint Enterprises - www.sprintenterprises.com
Helical Pile & Bracket Specifications:	SS5 1.5" RCS Piles with 8",10",12" Helix Bearing Plates, (10) Tons Ultimate, Galvanized
Soils & Embedment Depth:	Sand. Average Pile Embedment 20 ft.
Project Timeline:	Helical Pile Installation - 4 days
Helical Pile Manufacturer:	A.B. Chance - Centralia, MO

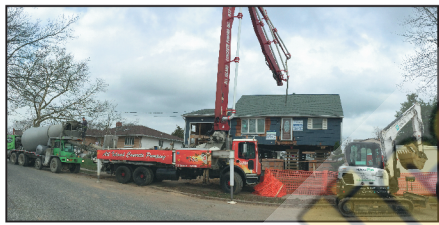
Helical Piles of NY, a division of High Rise Industries with headquarters located in Shirley, NY, recently completed a very challenging project on a house in Lindenhurst, NY on Long Island. The house and the block foundation were badly damaged by Super Storm Sandy. The engineer decided to have the block foundation underpinned so it could be used to help support the new poured wall foundation needed to elevate the house to the new BFE specification.

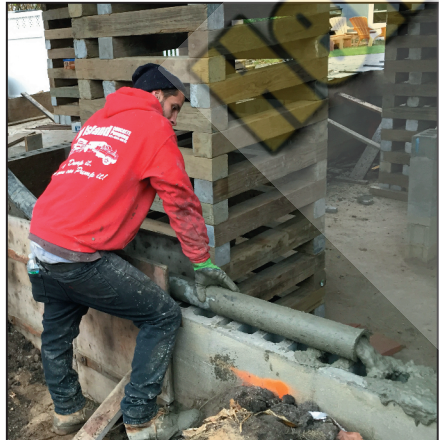
After the house was elevated, Helical Piles of NY began the process of underpinning the existing block foundation. Before the underpinning piles could be installed, a substantial amount of forming was done and a 3000 PSI 3/8" stone mix was pumped to fill all of the cinder blocks for leveling purposes and to increase the load capacity.

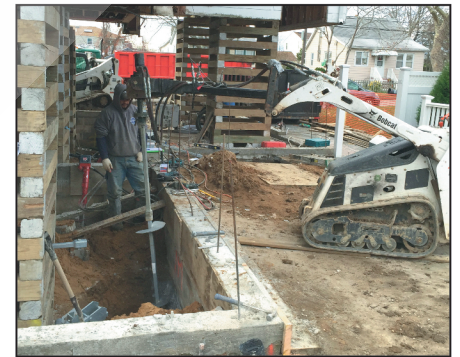
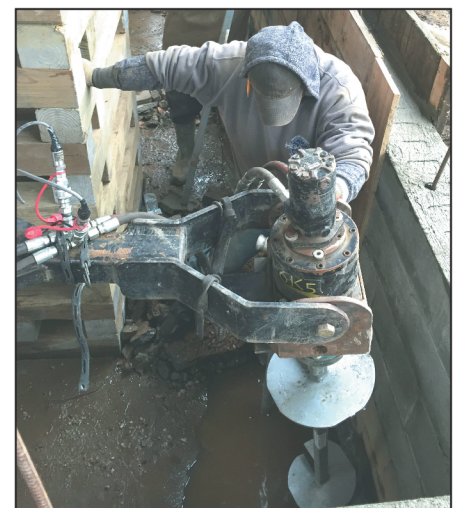
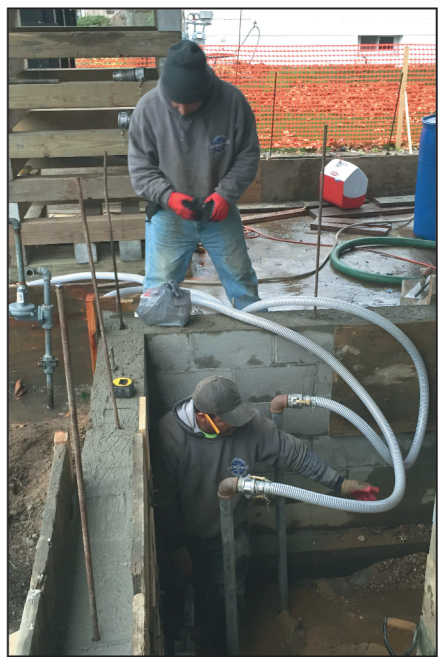
After the grouting was completed, the process of installing the underpinning piles began. This process was rather slow and tedious going due to some extremely tight space limitations. In addition to the tight space, the water table was extremely high on the site, and a good deal of time was spent dewatering. A total of (22) SS5 helical piles were installed on both the interior and exterior of the block walls due to space limitations and a collapsing swimming pool on one side of the house. The piles were secured to the walls with Chance underpinning brackets. Due to all the issues with the site, pile installation was completed in (4) days.

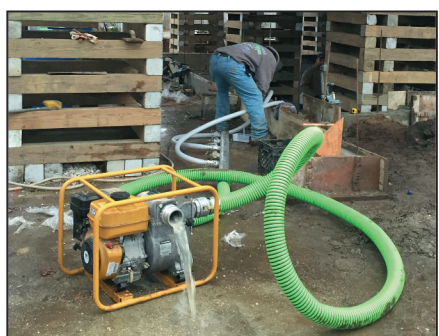
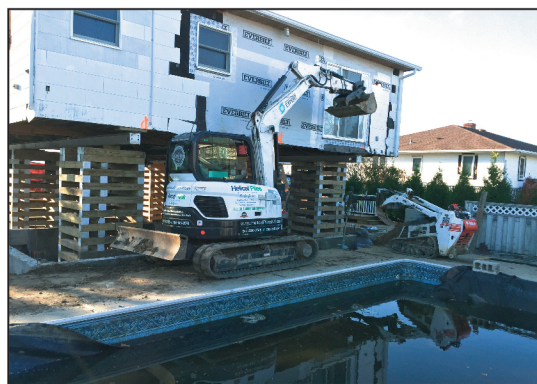
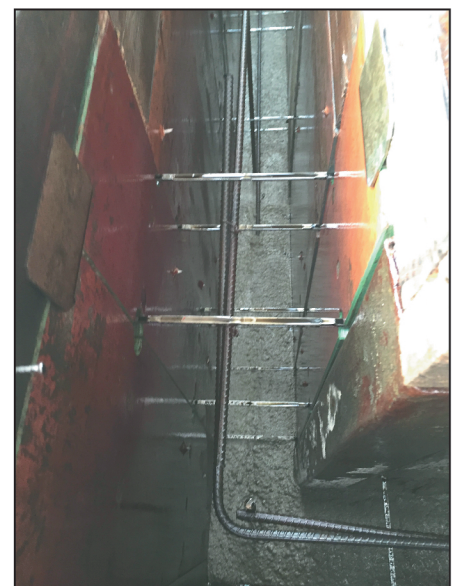
Helical Piles of NY also did all of the forming and pouring for the new foundation that is 4' high and 8" wide and is two feet above the new BFE code. The company also completed the demolition work on the swimming pool and decking.
