Helical Piles of New York Installs Helical Pile Deep Foundations for an Elevated House Project in Massapequa

Project Name & Location:	New Elevated House Foundation, Massapequa, NY
Project Date:	June 2014
Project Type:	Helical Piles Installed to Support New Elevated House Foundation
Helical Pile Installation Contractor:	Helical Piles of New York - Div. of High-Rise Industries
Architect:	SRF Architect, P.C. - Melville, NY
Helical Piles Specifications:	(23) Helical Piles; 1.5" SS5 with 8",10",12" Helix Bearing Plates; (21) Underpinning Brackets; 15 Ton Ultimate Capacity; Galvanized
Soils & Embedment Depth:	Sand and Clay. Average Pile Embedment 15 ft.
Project Timeline:	Helical Pile Installation - 3 days
Helical Pile Manufacturer:	A.B. Chance - Centralia, MO

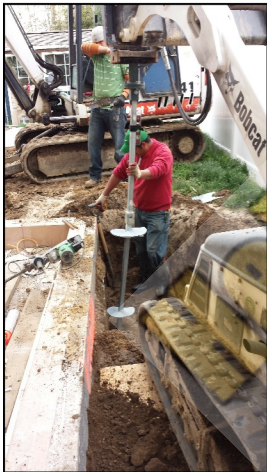
[Helical Piles of NY](#), a division of [High Rise Industries](#) with headquarters located in Shirley, NY, recently completed helical pile installations and new foundation work for a badly damaged house. The house is located between the canals in Massapequa on Long Island, and it suffered significant flood damage not only from Super Storm Sandy (5 feet of water) but also from Hurricane Irene (2 feet of water) a year earlier. The combined forces from both storms and the significant high water table eventually caused the slab-on-grade foundation to settle and to also shift laterally.

The project objective was to lift the house approximately (8) feet and place it on a new poured wall foundation supported by helical piles. But once the house was lifted, it became apparent just how bad the existing foundation was out of level. Although the original plan of work specified to use the existing foundation to support the new walls, it was obvious that plan would not work with the compromised slab that had settled (6) inches and had significant bowing in or out at the corners.

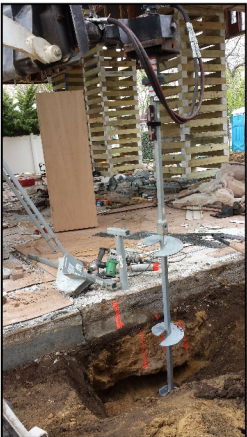
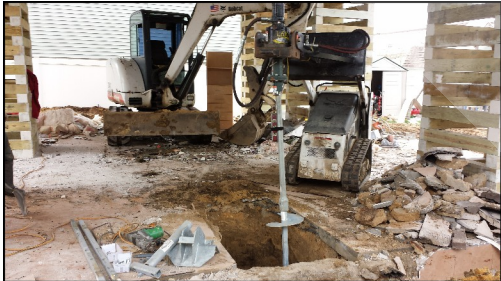
The revised plan called for underpinning the existing foundation with helical piles and to install underpinning brackets on (21) of the piles to support the new poured foundation above. After the helical pile locations were marked, excavation to expose the footings began. Right away the crew experienced very strong hydrostatic pressure from the high ground water table that caused caving and dewatering challenges. The crew had to use two excavators working in tandem – one to keep the hole open and the other one to install the helical piles. This made the installation process slow and tedious to put it mildly. In addition, once the crew exposed the old footings, installed the helical piles and began mounting the underpinning brackets, it became apparent that the original footings were not poured level and were also out of plumb.

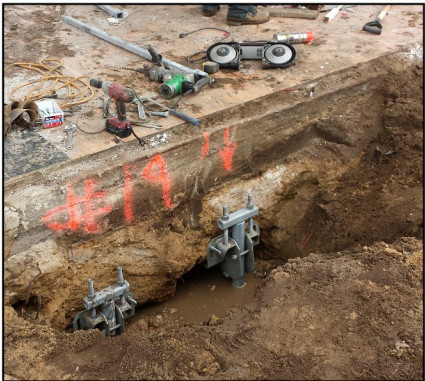
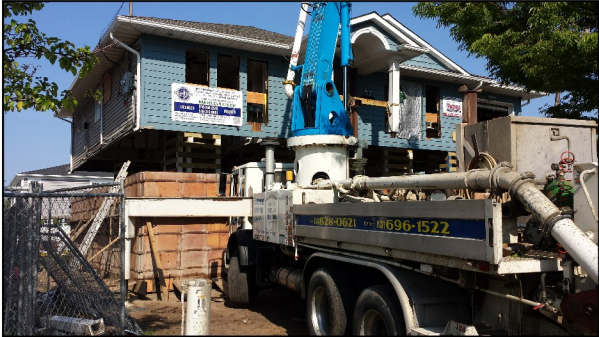
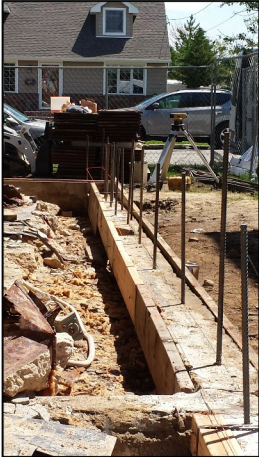
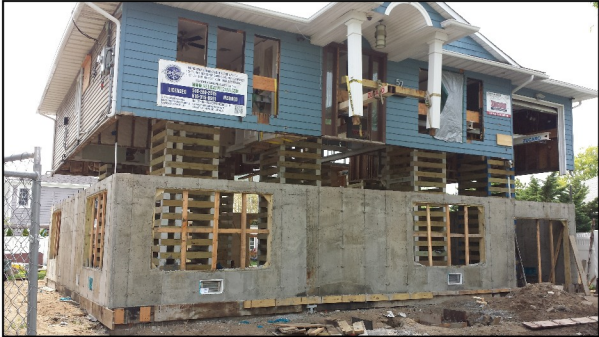
In addition to the (21) helical piles with underpinning brackets, (2) additional helical piles were installed with concrete pile caps to support the front concrete stair case walls. The new foundation has a height of (8) feet, and the walls are (8) inches thick with (2) #5 rebar horizontally on the top and bottom and vertically (3) feet on center. (11) Smart Flood Foundation Vents were installed to alleviate future hydrostatic water pressures.
