Helical Piles of New York Installs Chance Transitional Helical Piles for a New House Foundation in Island Park, NY on a Site with Very High Water Table

Project Name & Location:	New House Foundation, Island Park, NY
Project Date:	March 2014
Project Type:	House was Destroyed by Super Storm Sandy. Helical Piles Installed to Support New House Foundation
Helical Pile Installation Contractor:	Helical Piles of New York - Div. of High-Rise Industries
Structural Engineer:	R Shatarah Consulting Engineers, P.C. - Syosset, NY
Helical Piles Specifications:	(44) Transition Helical Piles; 1.5" SS5 Leads with 8",10",12" Helix Bearing Plates with 2.88" RS Extensions; 15 Ton Ultimate Capacity; Galvanized
Soils & Embedment Depth:	Sand and Clay. Average Pile Embedment 22 ft.
Project Timeline:	Helical Pile Installation - 2.5 days
Helical Pile Manufacturer:	A.B. Chance - Centralia, MO

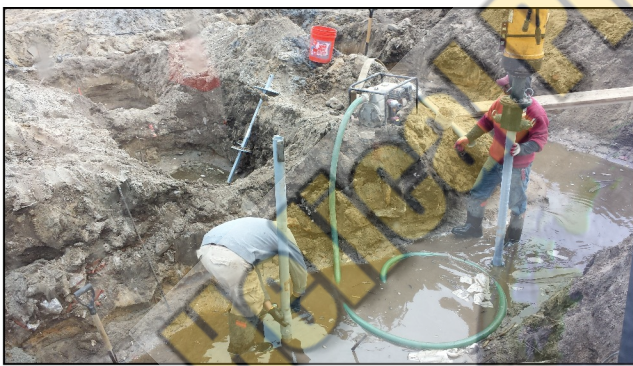
As soon as the crew began excavating, company owners Silvio and Danny Rebelo realized there were some real challenges ahead as ground water was present at just 18 inches below grade. Local code specifies that foundation footings must be 48 inches below grade. While dewatering excavations is normal business for foundation contractors, this situation presented a special challenge because local code stipulates that water cannot be pumped to the street, and the adjacent lot had a punctured oil tank on it. Silvio realized the company had a special situation on its hands, and he immediately reached out to the project architect, the engineer of record and the building department to ask for advice.

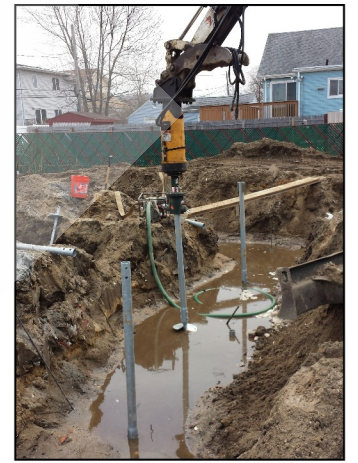
"I knew installing the helical piles through the ground water was not going to be a problem, as the soils report revealed competent soil at around 20-25 feet," Rebelo explained. "What we were most concerned about was the amount of water we would have to remove in order to pour the foundation footings. After meeting with the architect, engineer of record and the building official, it was determined that the 48 inch depth requirement for the footings would be changed to 36 inches in an attempt to reduce the water management challenge," Rebelo added.

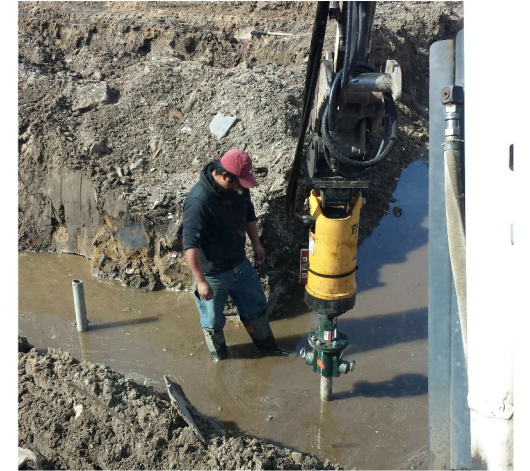
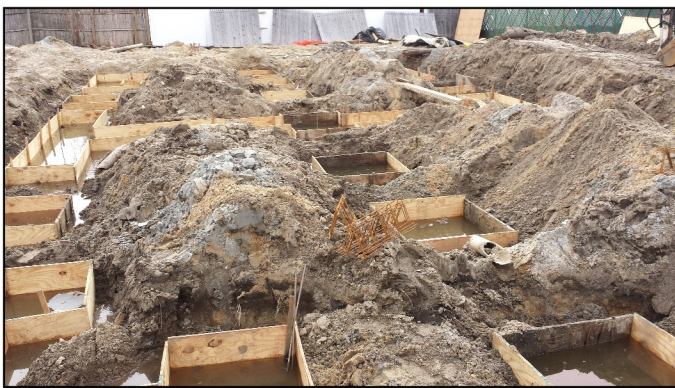
The engineer of record, Rudolph Shatarah of R. Shatarah Consulting Engineers, P.C., was concerned about the extremely high water table and the potential for frost heave that could potentially compromise the foundation. Part of his solution to help mitigate potential heave was a change in the grade beam design from a traditional continuous footer to a design calling for sections or points. He also specified A.B. Chance transitional helical piles with 1.5 inch square bar lead sections followed by 2.875 inch round shaft extensions connected to an uplift resistant pile cap. Shatarah has significant knowledge and experience specifying helical piles, and he is well aware of the product's ability to perform in both compression and tension – the latter of which was very important to him for this project. (44) Chance transitional helical piles were installed to an average depth of 22 feet and a 15 ton ultimate bearing capacity.

Engineer Shatarah's creative design change enabled Silvio's team to basically divide the foundation in half by using excess fill, and this enabled the crews to dewater one side at a time and pour the concrete. Once the concrete for side one cured, the second side was dewatered and pouring was completed for that side. "It was a challenging project to put it mildly, but with the knowledge and creativity of our team members we were able to successfully complete the project with minimal time delays and cost overruns," Rebelo added.
