## Model 150 Helical Tiebacks

**Project:** Historic Home Tiebacks

**Location:** Davenport, IA

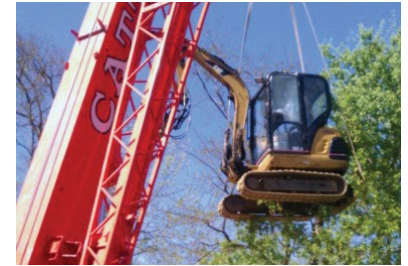
Lowering mini-excavator onto working surface below wall

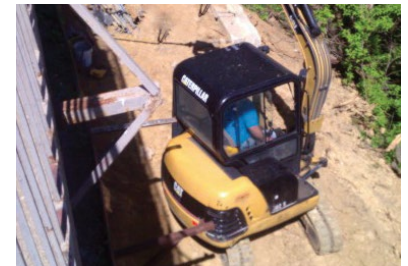
Maneuvering for tieback installation

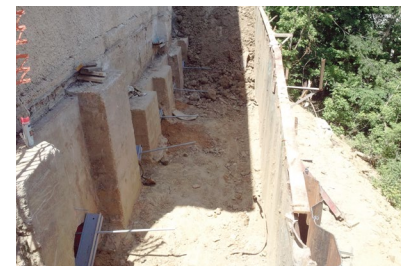
Tiebacks advanced through core holes of concrete underpinning

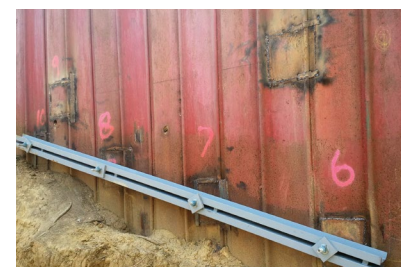
Waler detail

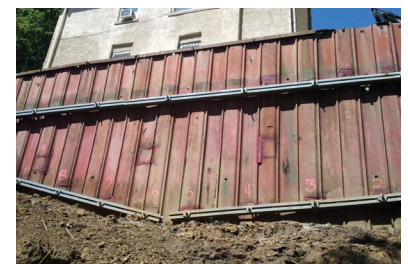
Tieback and waler installation complete
