Helical Piles used to Restore Historic Building

Great Falls, Montana

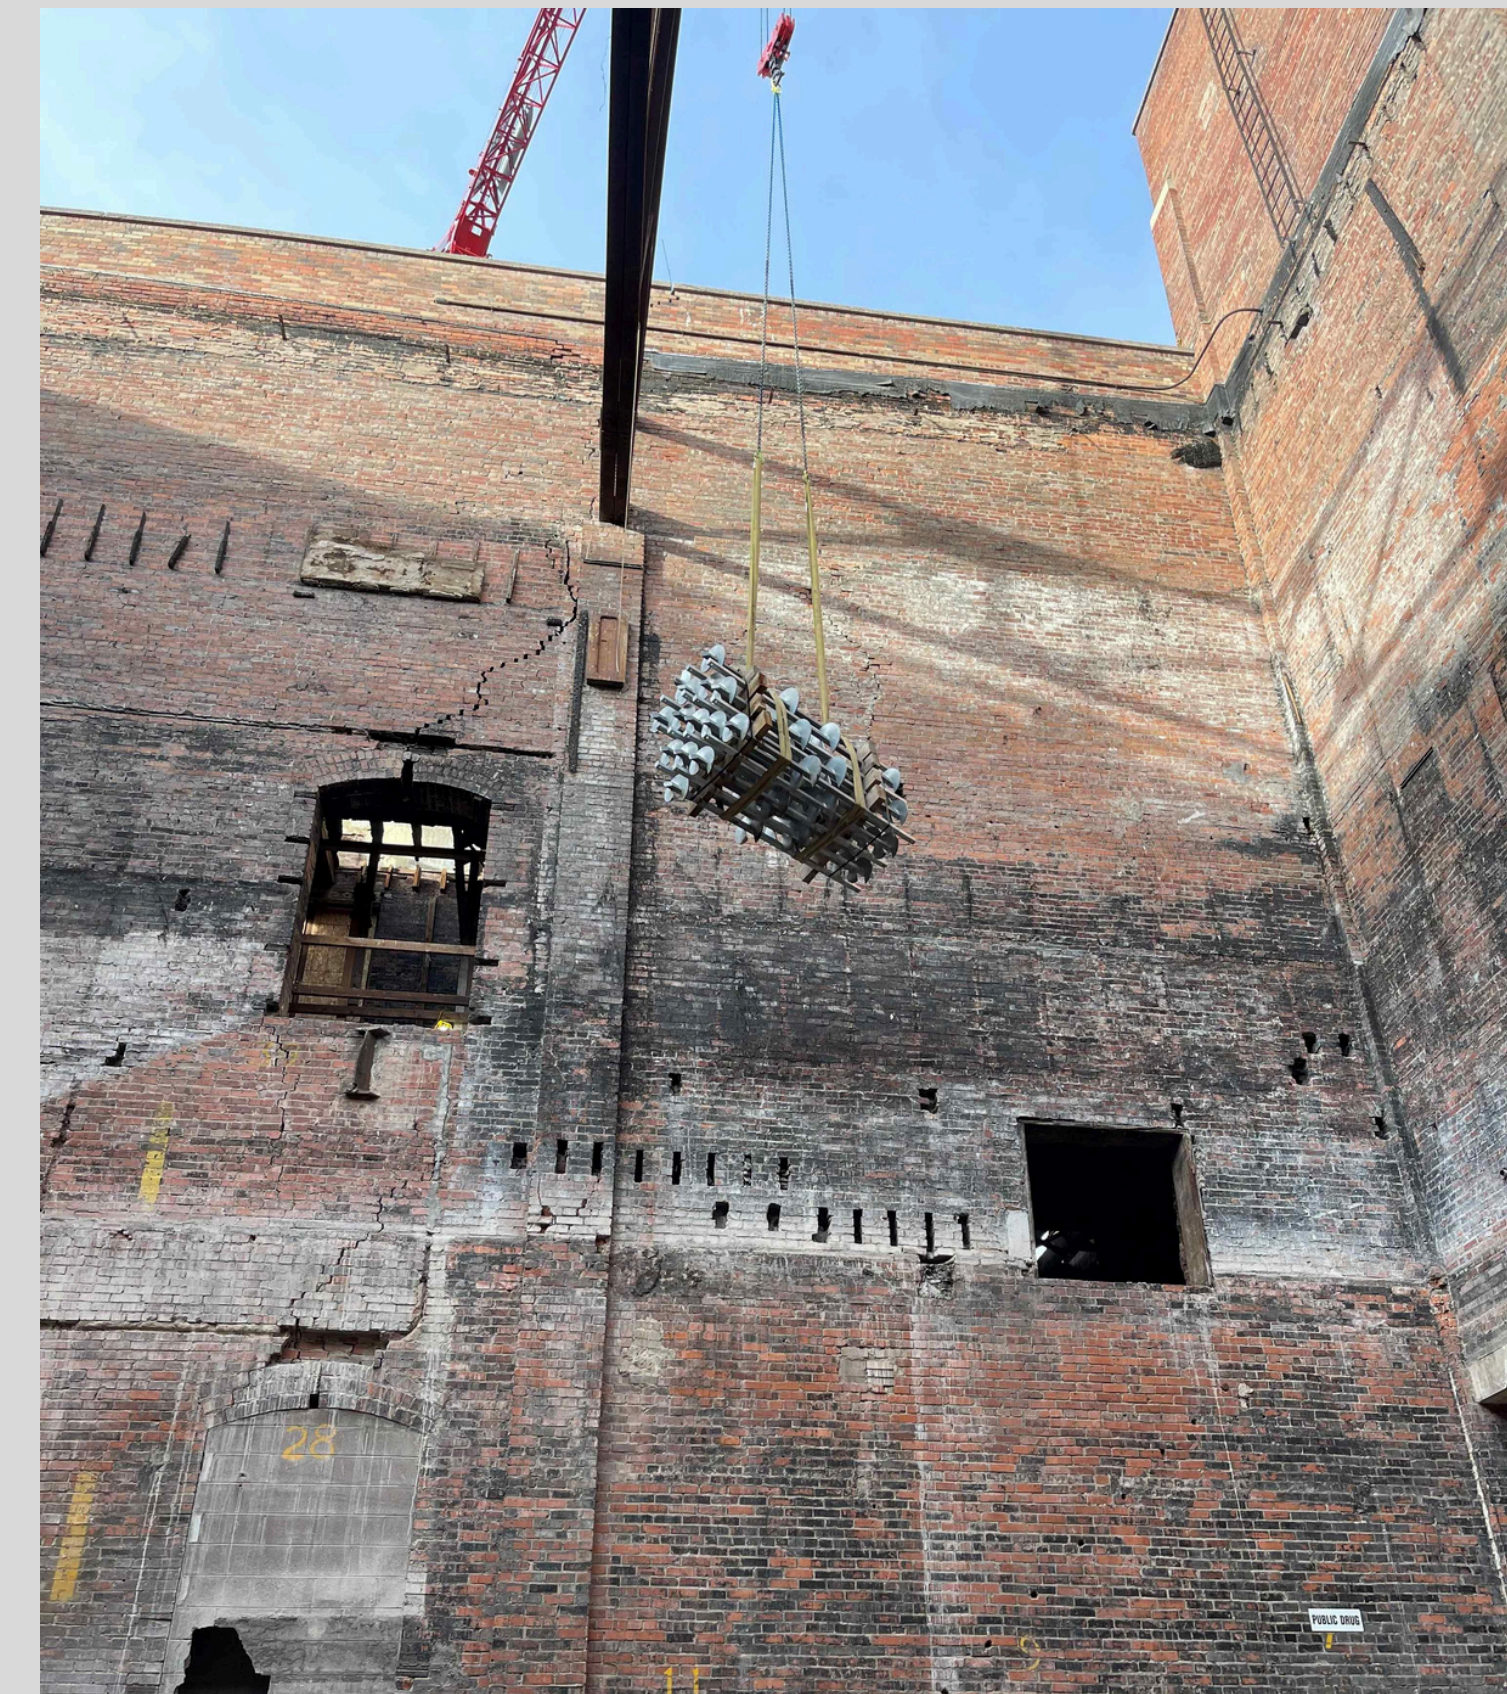
The teams faced very limited access to the charred building site. All equipment and products had to be craned into the basement of the four-story building. On top of that, there was limited headroom for installation of deep foundation elements. The Geotechnical investigation revealed that the soils encountered at bearing elevation are very weak and compressible yet expansive. This, coupled with the magnitude of the anticipated foundation loads for the project, lead the Structural Engineer, Geotechnical Engineer, and General Contractor to the use of grouted helical piers.

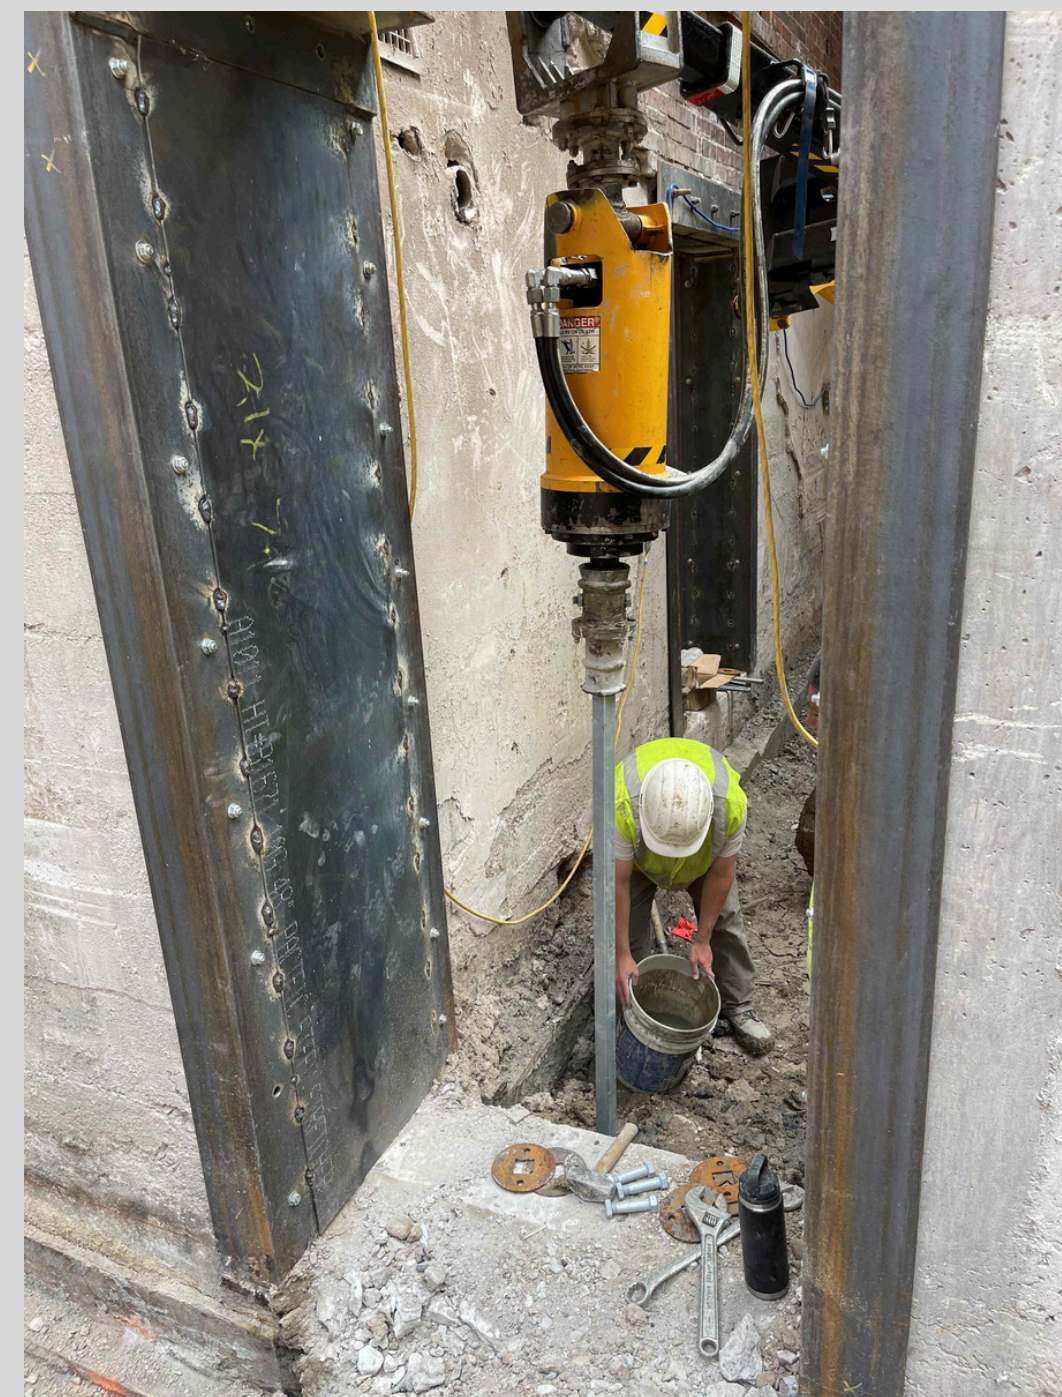
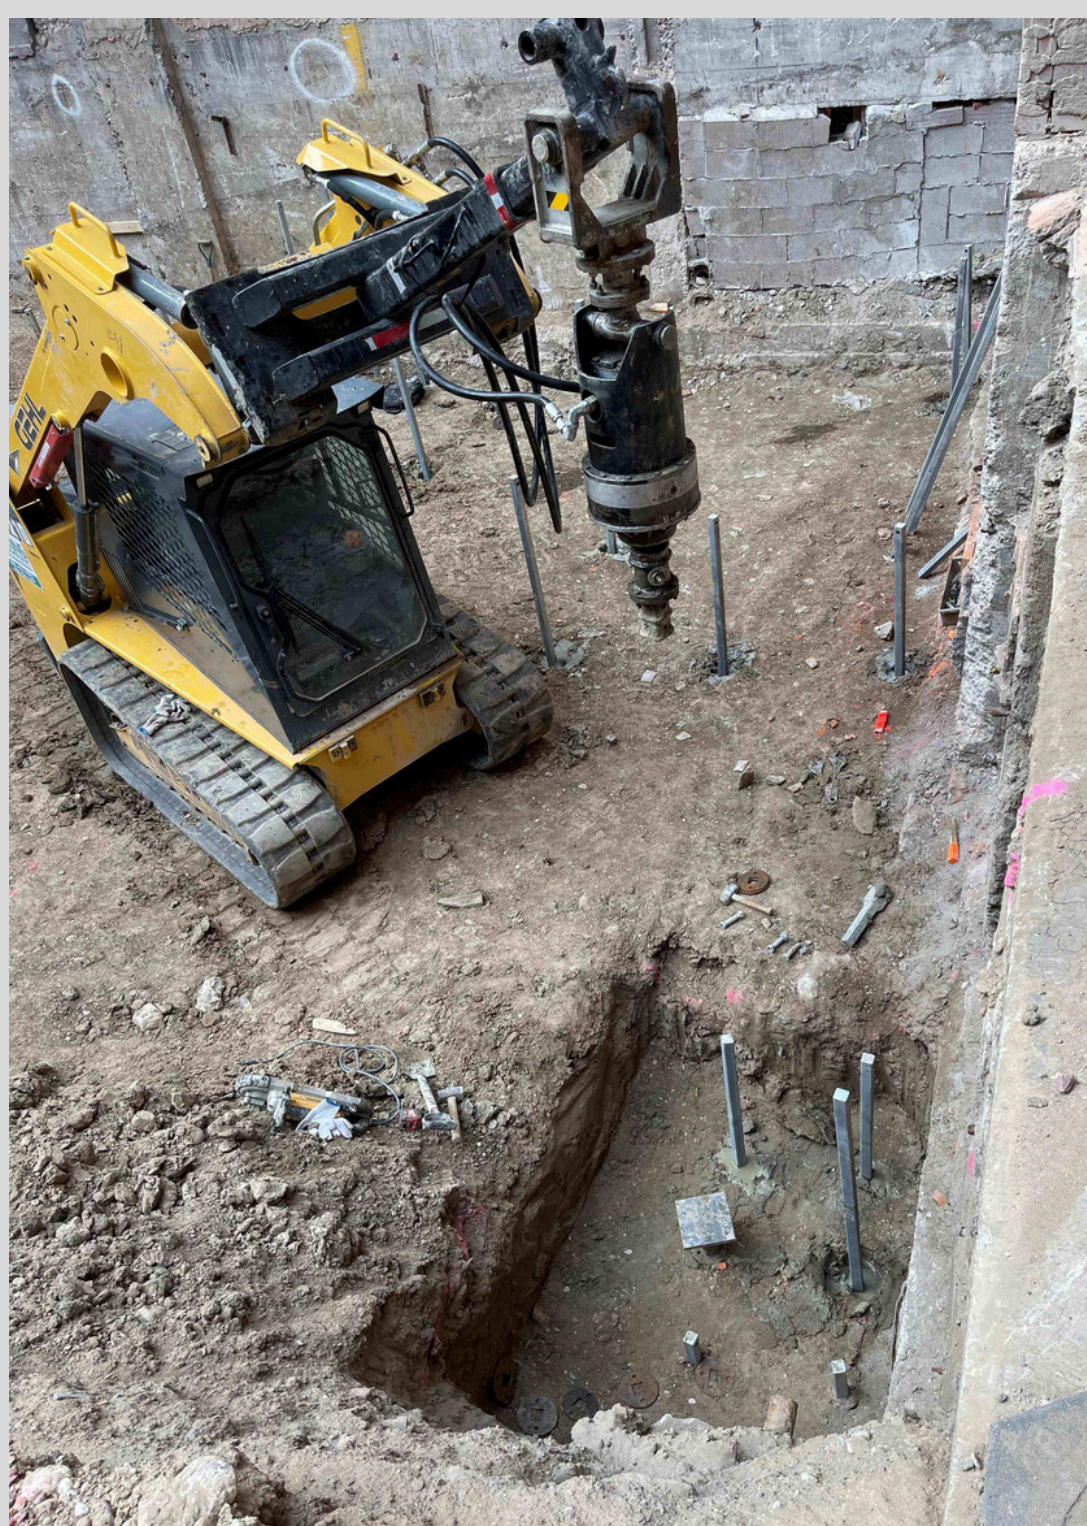
The design team, comprised of Thomas Dean & Hoskins Engineering & Geotech, along with consultation from Gittins Foundation Specialist Inc., proceeded with installing ECP TAF-175-84 helical piers with a 10/12 helical flight configuration and a 6" diameter grout ring. The grout ring, made of steel, was placed just below the coupler, allowing the grouted columns to continue to a load bearing strata.
