Structural Systems Repair Group (SSRG) Installs (212) Helical Piles for Modular Buildings in Little Ferry, NJ - Despite the Flooding Rains

Summer 2018

Project Name & Location:	Little Ferry Board of Education – Little Ferry, New Jersey
Project Date:	Summer, 2018
Project Type:	Helical Pile Deep Foundation for Modular Buildings
Helical Pile Installation Contractor:	Structural Systems Repair Group , Cincinnati, OH
Structural Engineer:	TR Arnold & Associates , Elkhart, IN - www.trarnold.com
General Contractor:	Hunter Modular Construction, Inc. - http://www.huntermodular.com/
Helical Pile Specifications:	(212) 2.875" O.D. Round Shaft Helical Piles with 8", 10" Helix Bearing Plates; 28 Kip Ultimate Compression Capacity; 10"x10"x.5" Pile Caps; 6"x6"x.5" Pile Caps for (32) Battered Piles; All Galvanized
Soils & Embedment Depth:	Fine to Coarse Sand & Gravel (Wet). Average Pile Embedment 35 ft.
Project Timeline:	(15) Days
Helical Pile Manufacturer:	Helical Anchors Inc. - Minneapolis, MN

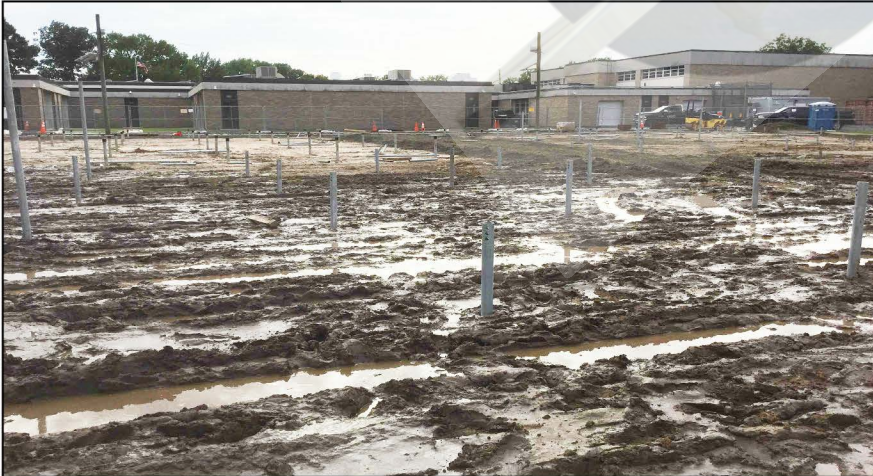
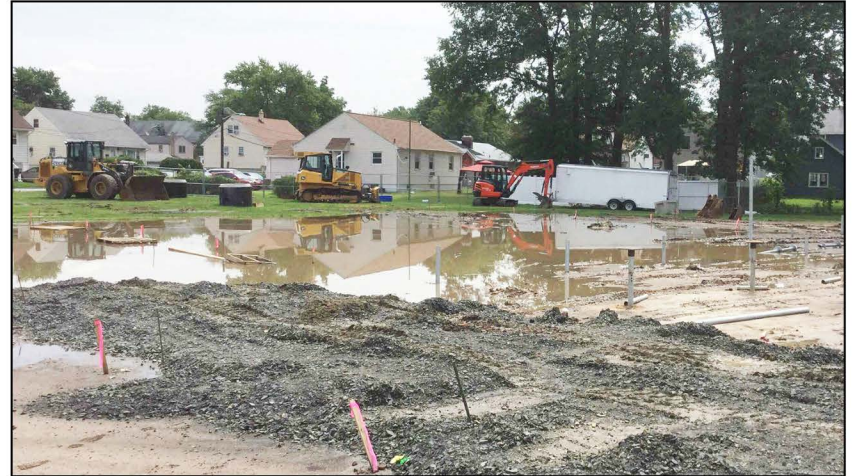
Weather Be Damned - Helical Piles were the Perfect Choice for this Above-Ground Structure Project. Kudos to the Crew for Completing the Project on Time and on Budget.

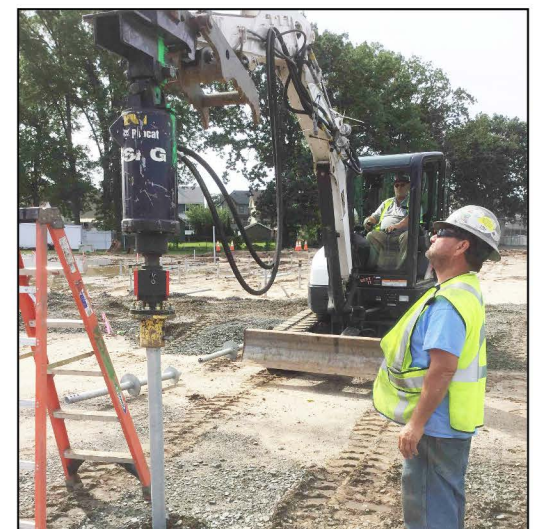
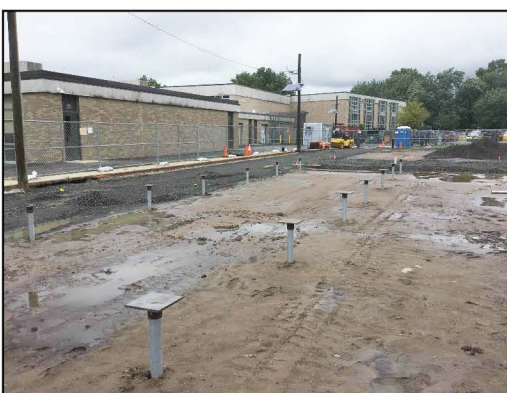
The soils on site were designated as poor (WH at some locations) through 28' to 30'. The average pile embedment to bear on the fine sand ended up being 35'.

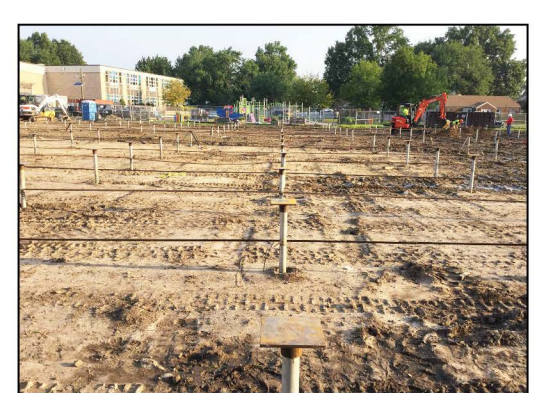
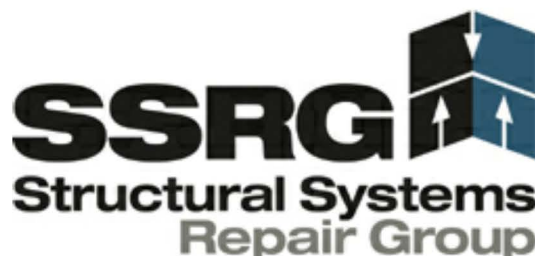
During installation of piles, the crew had challenges working in heavy rains for a couple of days. However, the rains did not stall the work schedule thus affirming the use of helical piles as a better solution in adverse weather conditions.
