Push Piers, Helical Anchors and PolyLevel Lift and Stabilize Office Building

Office Building Underpinning

Aliso Viejo, CA

November 2021

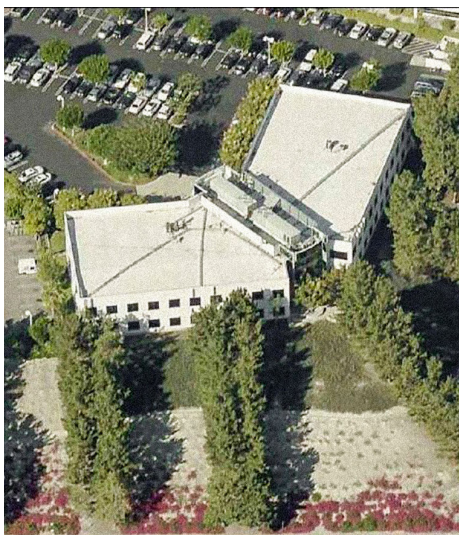
Arial view of the office building showing the slope behind the center patio and south and southeast wall areas

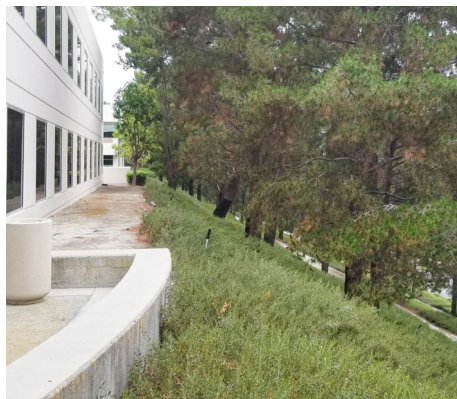
Access conditions along the southeast wall

tilt-up panels, the ideal remedial method would first stabilize the structure and then potentially lift the walls back toward the original elevation. After the lift operations, void space created under the interior floor slab and wall footings would require filling. The site grade near the south and southeast exterior walls generally consisted of about 10 feet of level ground until an approximate 2:1 (horizontal to vertical) slope extended downward for about 60 to 70 feet. With the site grading conditions, construction equipment access was limited at the wall areas requiring underpinning.

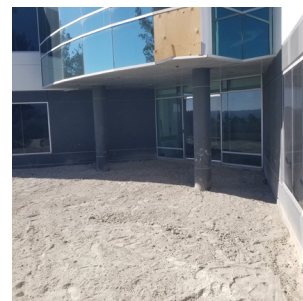
Pier locations backfilled and compacted at center patio area
