## Scobbo Foundation Systems (a Preferred Seawall Repair Network Contractor) Installs (15) Helical Piles to Underpin the Historic Cleggs Hotel in Ocean Beach New York

<b>Project Name &amp; Location:</b>	Cleggs Hotel Underpinning - Ocean Beach NY
<b>Project Date:</b>	January 2024
<b>Project Type:</b>	Underpinning
<b>Helical Pile Installation Contractor:</b>	<a href="#">Scobbo Foundation Systems</a> - Long Island & Piscataway
<b>General Contractor:</b>	<a href="#">Galvin Bros.</a> - Great Neck, NY
<b>Sub Contractor:</b>	<a href="#">Soil Solutions</a> - Hempstead, NY
<b>Engineering Company:</b>	<a href="#">Newport Engineering</a> - Oyster Bay, NY
<b>Helical Pile Specifications:</b>	(15) 3.00" Diameter Helical Piles with 10-12 Inch Helix Bearing Plates (15) 24" Angle Brackets & Lifting Brackets; Piles & Brackets Loaded to (15) Tons
<b>Soils &amp; Embedment Depth:</b>	Sands, Silts, Mild Organics, Ground Water at 1.5 ft. from Grade; with Average Pile Embedment Depth of 36 ft.
<b>Project Timeline:</b>	(18) Days for Piles; (6) Days for Urethane Grout
<b>Helical Pile Manufacturer:</b>	Round Shaft Piles & Angle Brackets- Magnum Piering

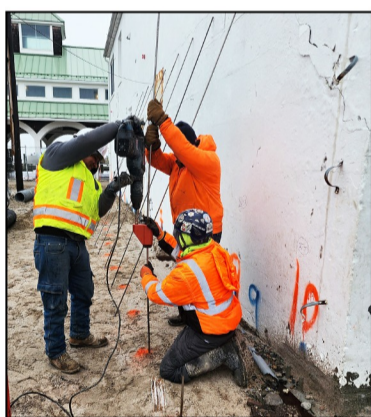
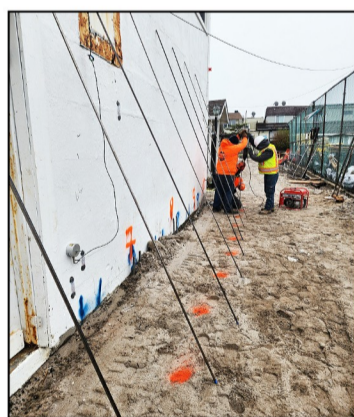
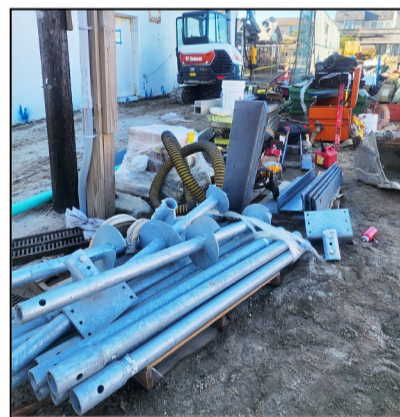
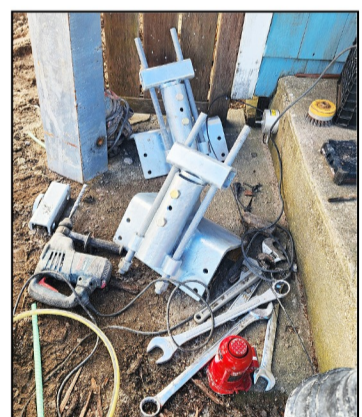
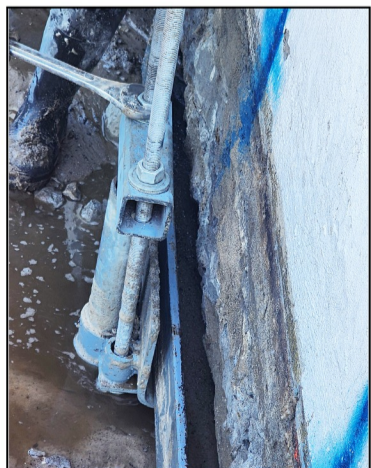
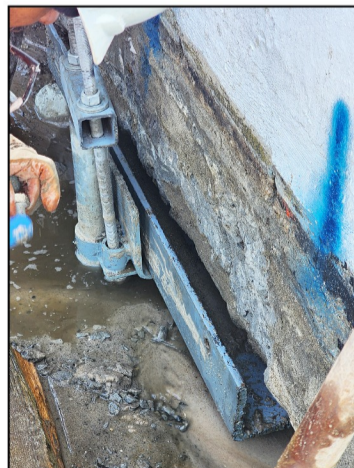
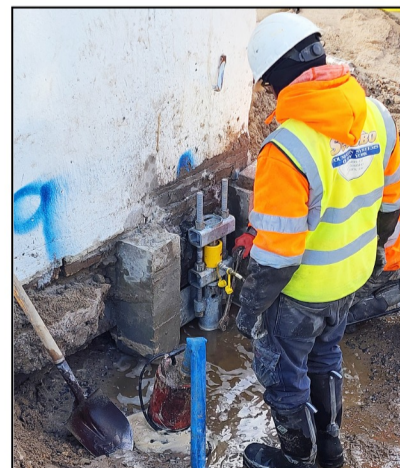
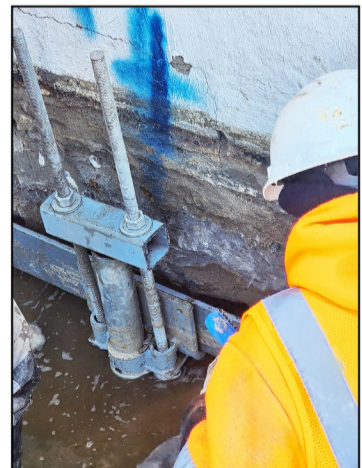
The historic Cleggs Hotel located on Fire Island settled 1.04" due to flooding conditions from dislodged drainage.

After excavating the crew installed over-sized 36' long x .75" angle brackets followed by the installation of the helical piles and lifting brackets. The piles were installed to an average depth of 30 ft. The crew was successful recovering .90 of the settlement. The crew injected grout in all voids to complete the project.
