CASE STUDY

Chick-Fil-A Lodge

NEW SMYRNA BEACH, FL

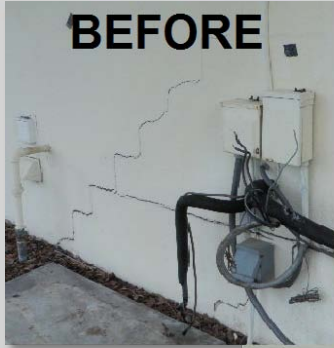
BEFORE

Situation: The Chick-Fil-A lodge overlooking the Sugar Mill Golf Course in New Smyrna Beach, FL was experiencing signs of foundation settlement. There were stair-step cracks and wall separation along the entire exterior of the building facing the lake. The property management company reached out to Ram Jack for a minimally-invasive solution to their settlement problem.

Solution: With an ultimate load of 40 kips and allowable of 20 kips, S.T.C. Properties requested that Ram Jack provide a solution to meet load requirements. (44) Ram Jack 2 ⁷/₈ Helical pilings with a 10"-12" helix configuration were installed at the Chick-Fil-A Lodge by Florida Foundation Repair.

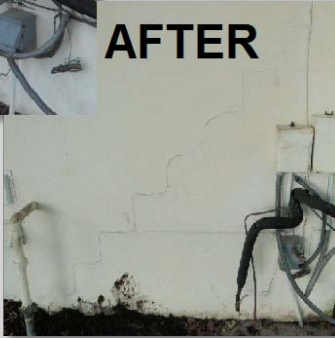
AFTER

Conclusion: Remedial helical pilings with standard brackets installed along the exterior of the lodge succeeded in almost completely closing the existing cracks. Ram Jack's minimally invasive and quick installation helped stabilize the Chick-Fil-A Lodge, allowing them to re-paint and then making existing cracks virtually invisible.
