Huge landslides are devastating the entire community of Rancho Palos Verdes. Particularly, the Portuguese Bend neighborhood got obliterated. Dalinghaus was brought in to address a home with several inches of settlement with a crack so massive pure daylight shines inside the home. With both the structure and hillside continuing to move, they needed to tie it all into more competent soils and completely stabilize it.

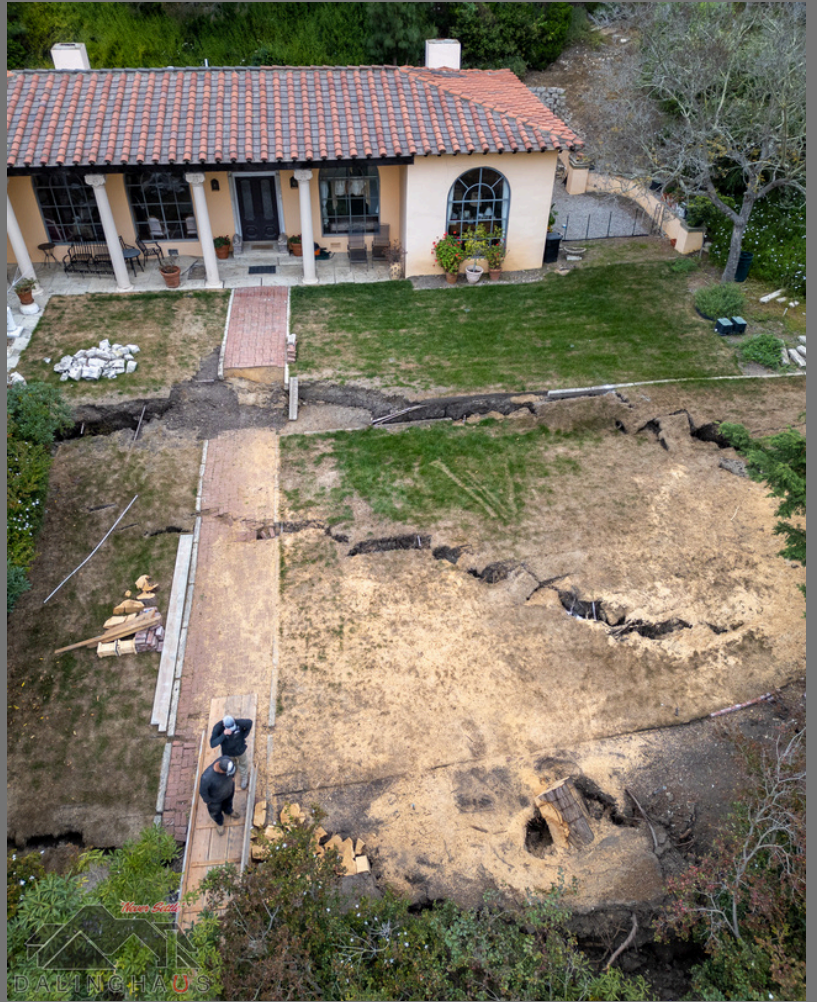
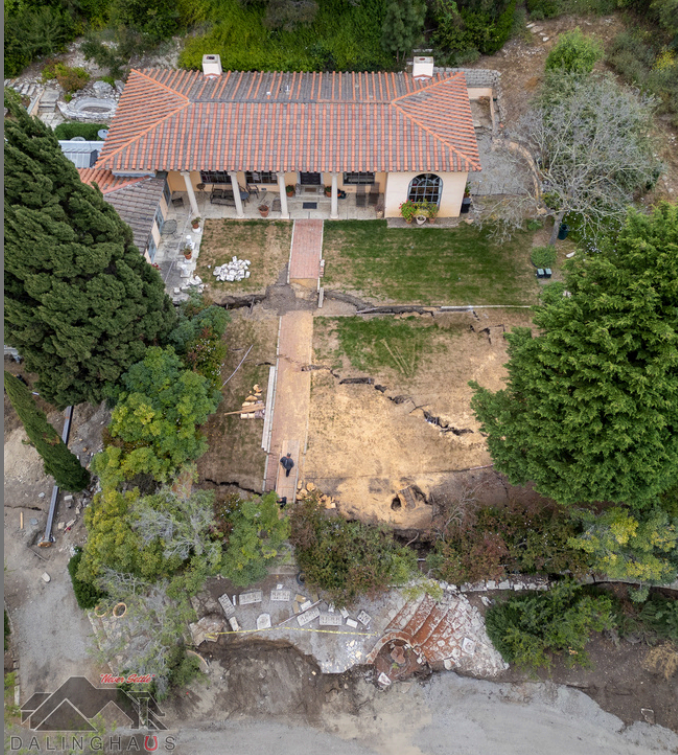
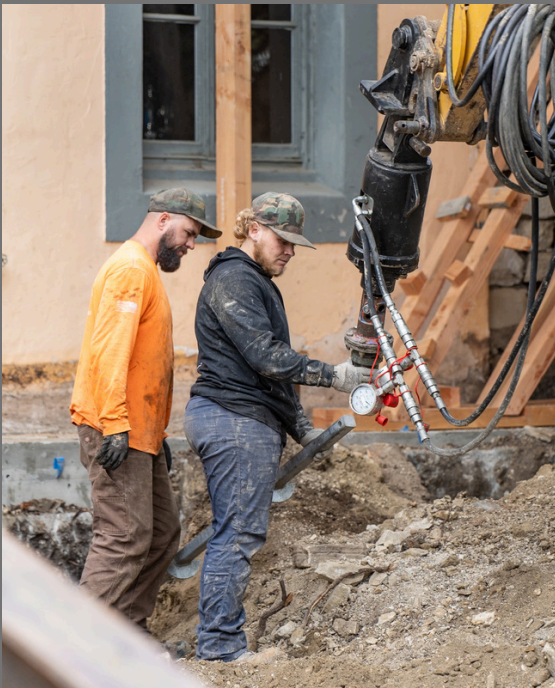
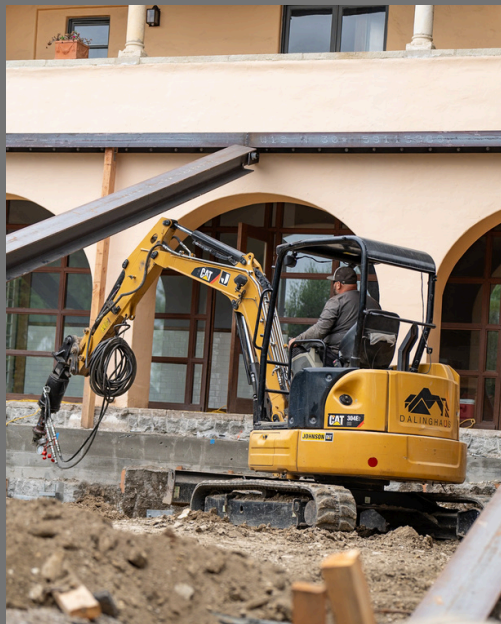
Previous engineering firms and contractors attempted to stabilize the structure with an unorthodox approach involving steel beams attached to small concrete pads.

However, these pads were shallow, continued to move, and required shims to be added every single day.

The steel beams were massive, and proved a hindrance to Dalinghaus's equipment. The whole entire hillside kept continuing to move and the roads were constantly sliding or being repaired.
