CASESTUDY

HELICAL TIEBACKS
STABILIZE LEANING
RETAINING WALL AT
HOA TENNIS COURTS

LEANING RETAINING WALL IN CORONA DEL MAR COMMUNITY SAVED WITH HELICALS

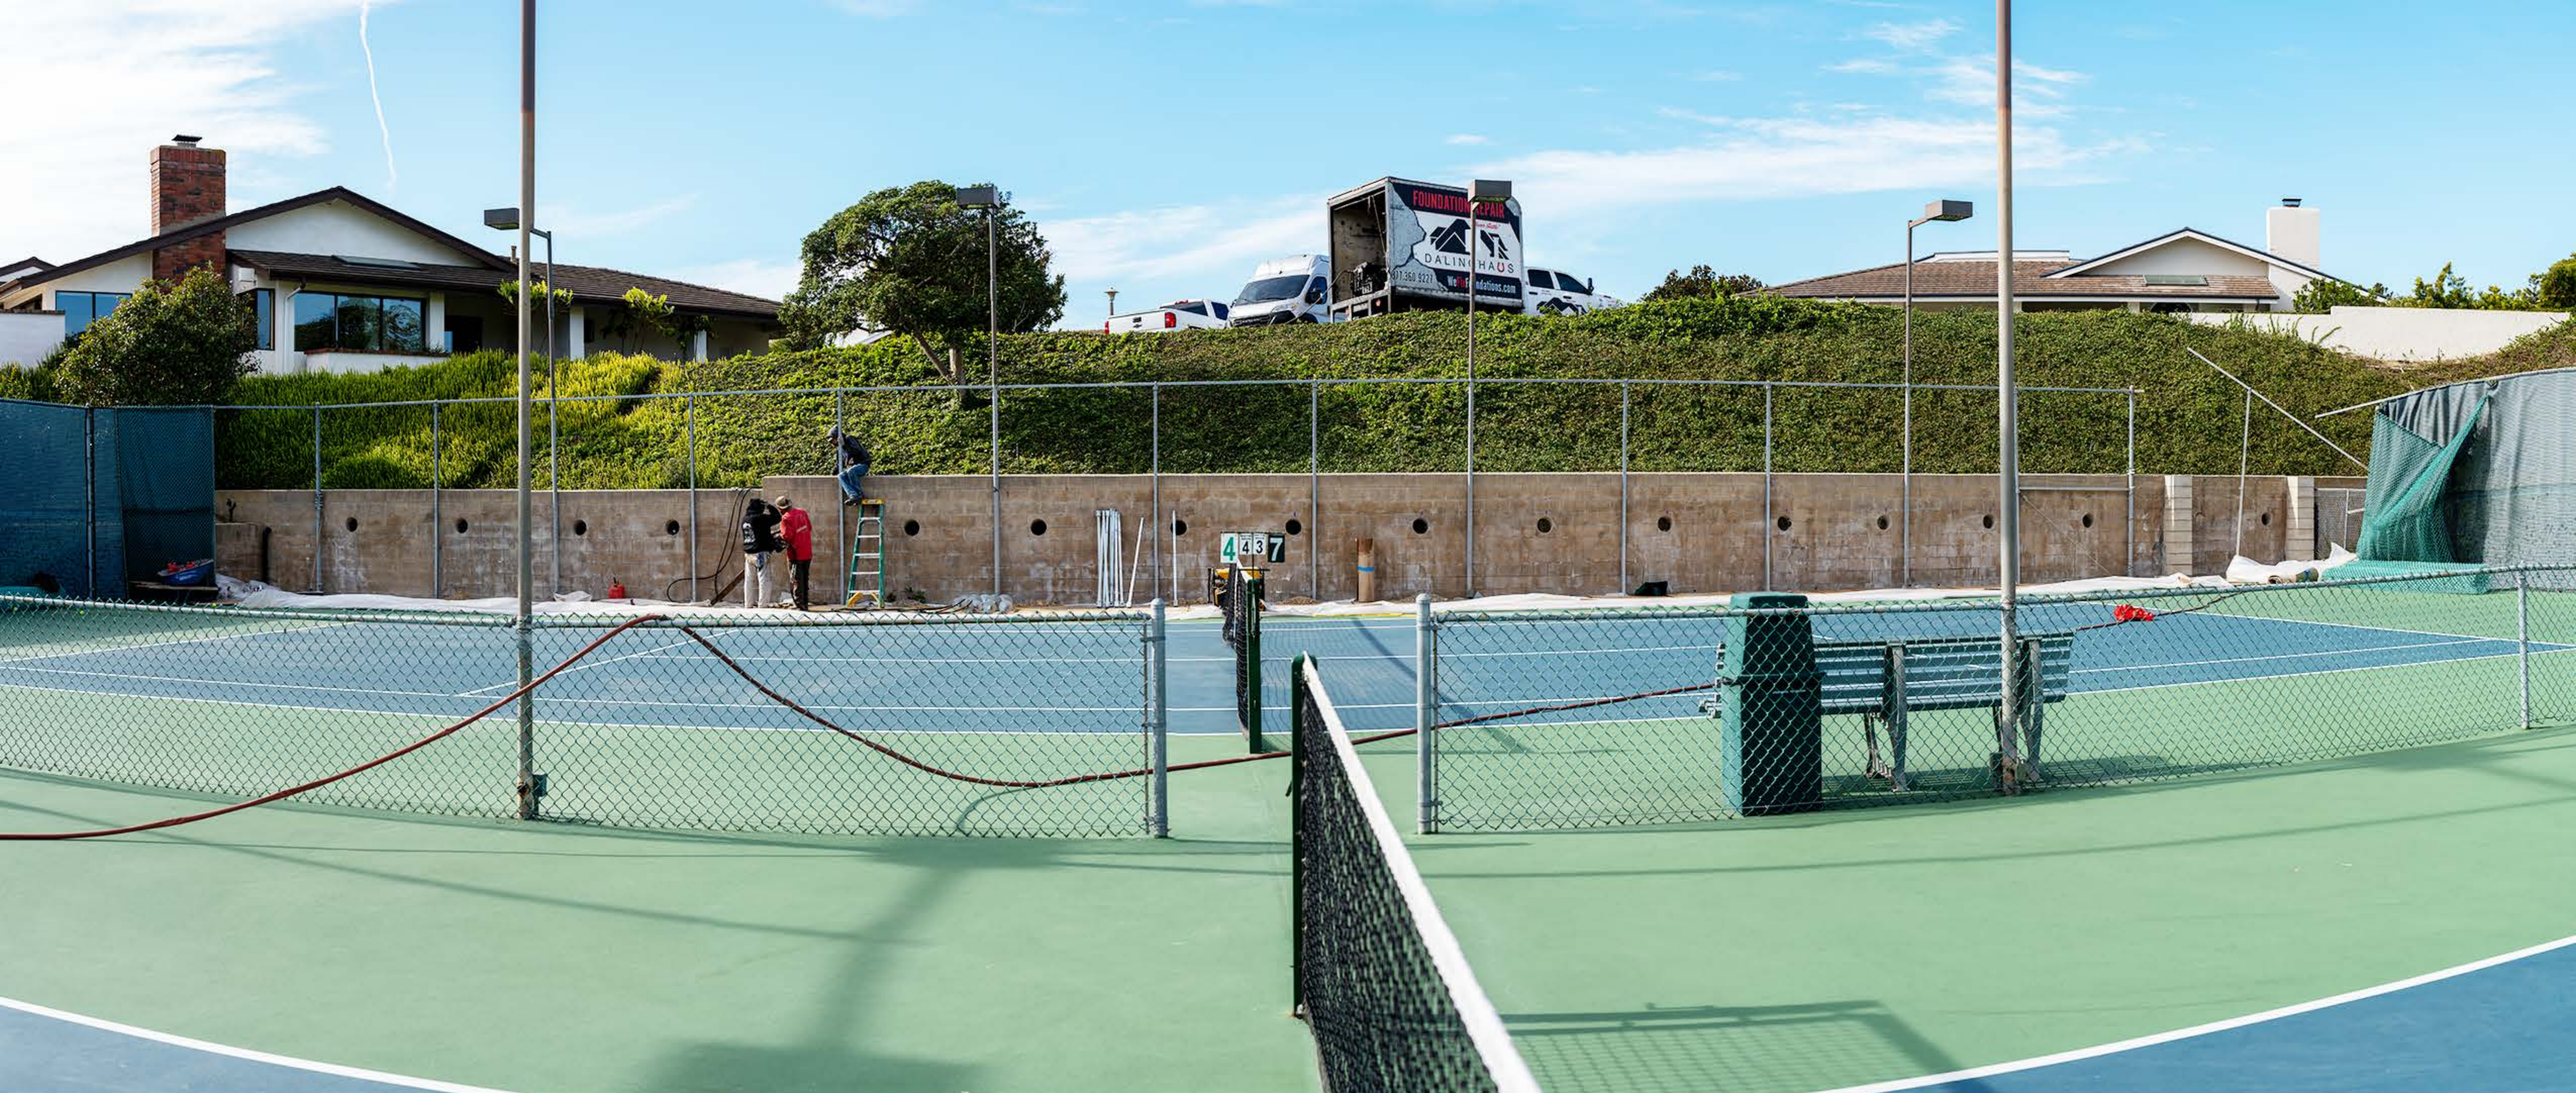
A photograph showing three construction workers at a site. One worker is perched on a ladder on the left, another in a red shirt is in the center pulling a yellow strap, and a third in a dark hoodie is on the right operating a large metal tool. They are working on a concrete retaining wall. In the background, there are tennis courts and a clear sky.

The crew marked out each of the pile locations before core drilling the locations and beginning their installations. They found they needed to hydraulically drive the piles about 22 feet on average in order to reach competent soils that would be able to support this wall for many decades. The installation process was relatively smooth and the crew had the project area cleaned up about a week after starting the project.

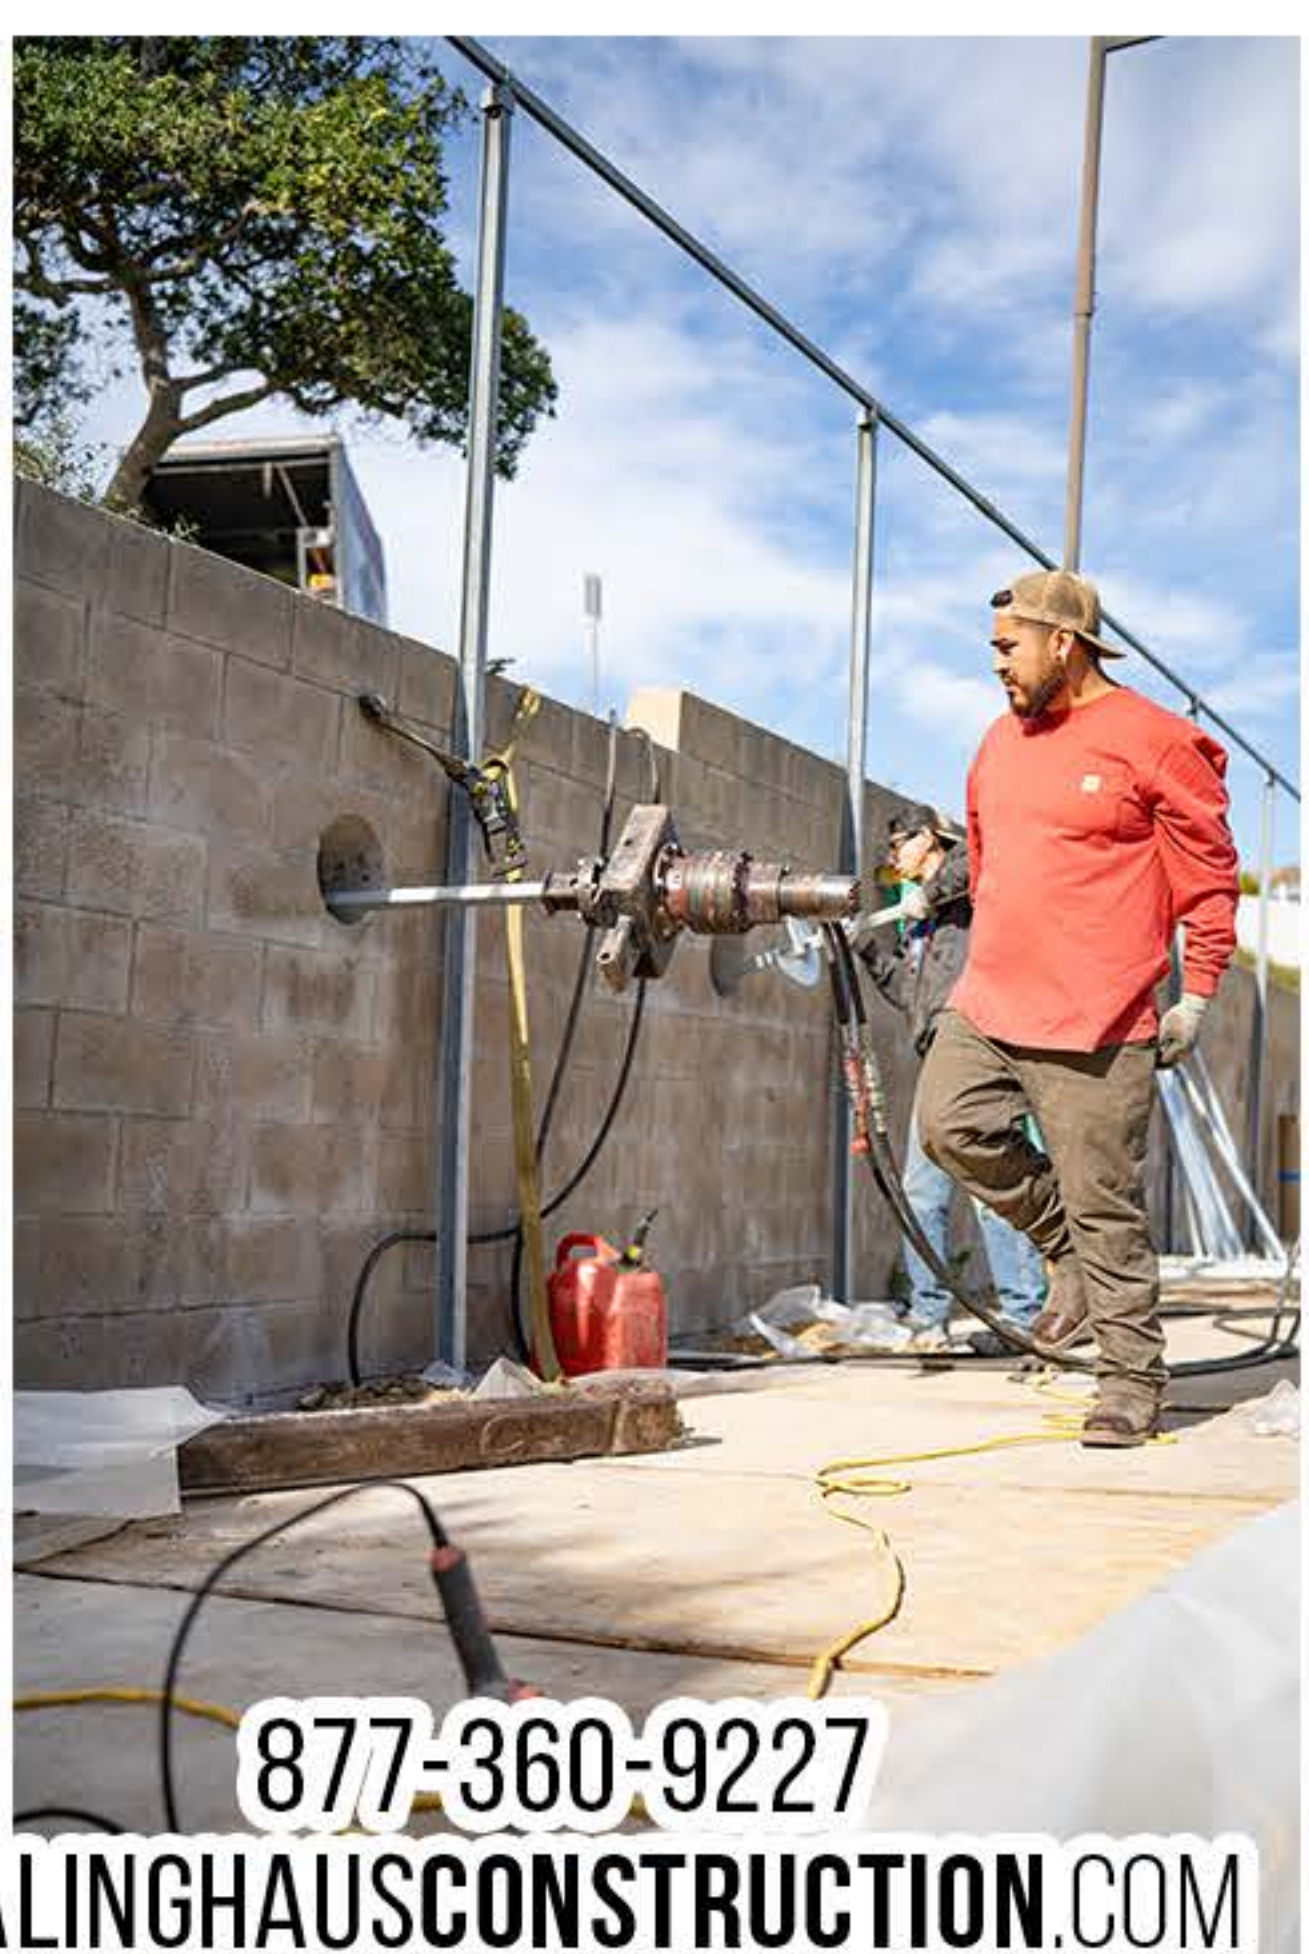
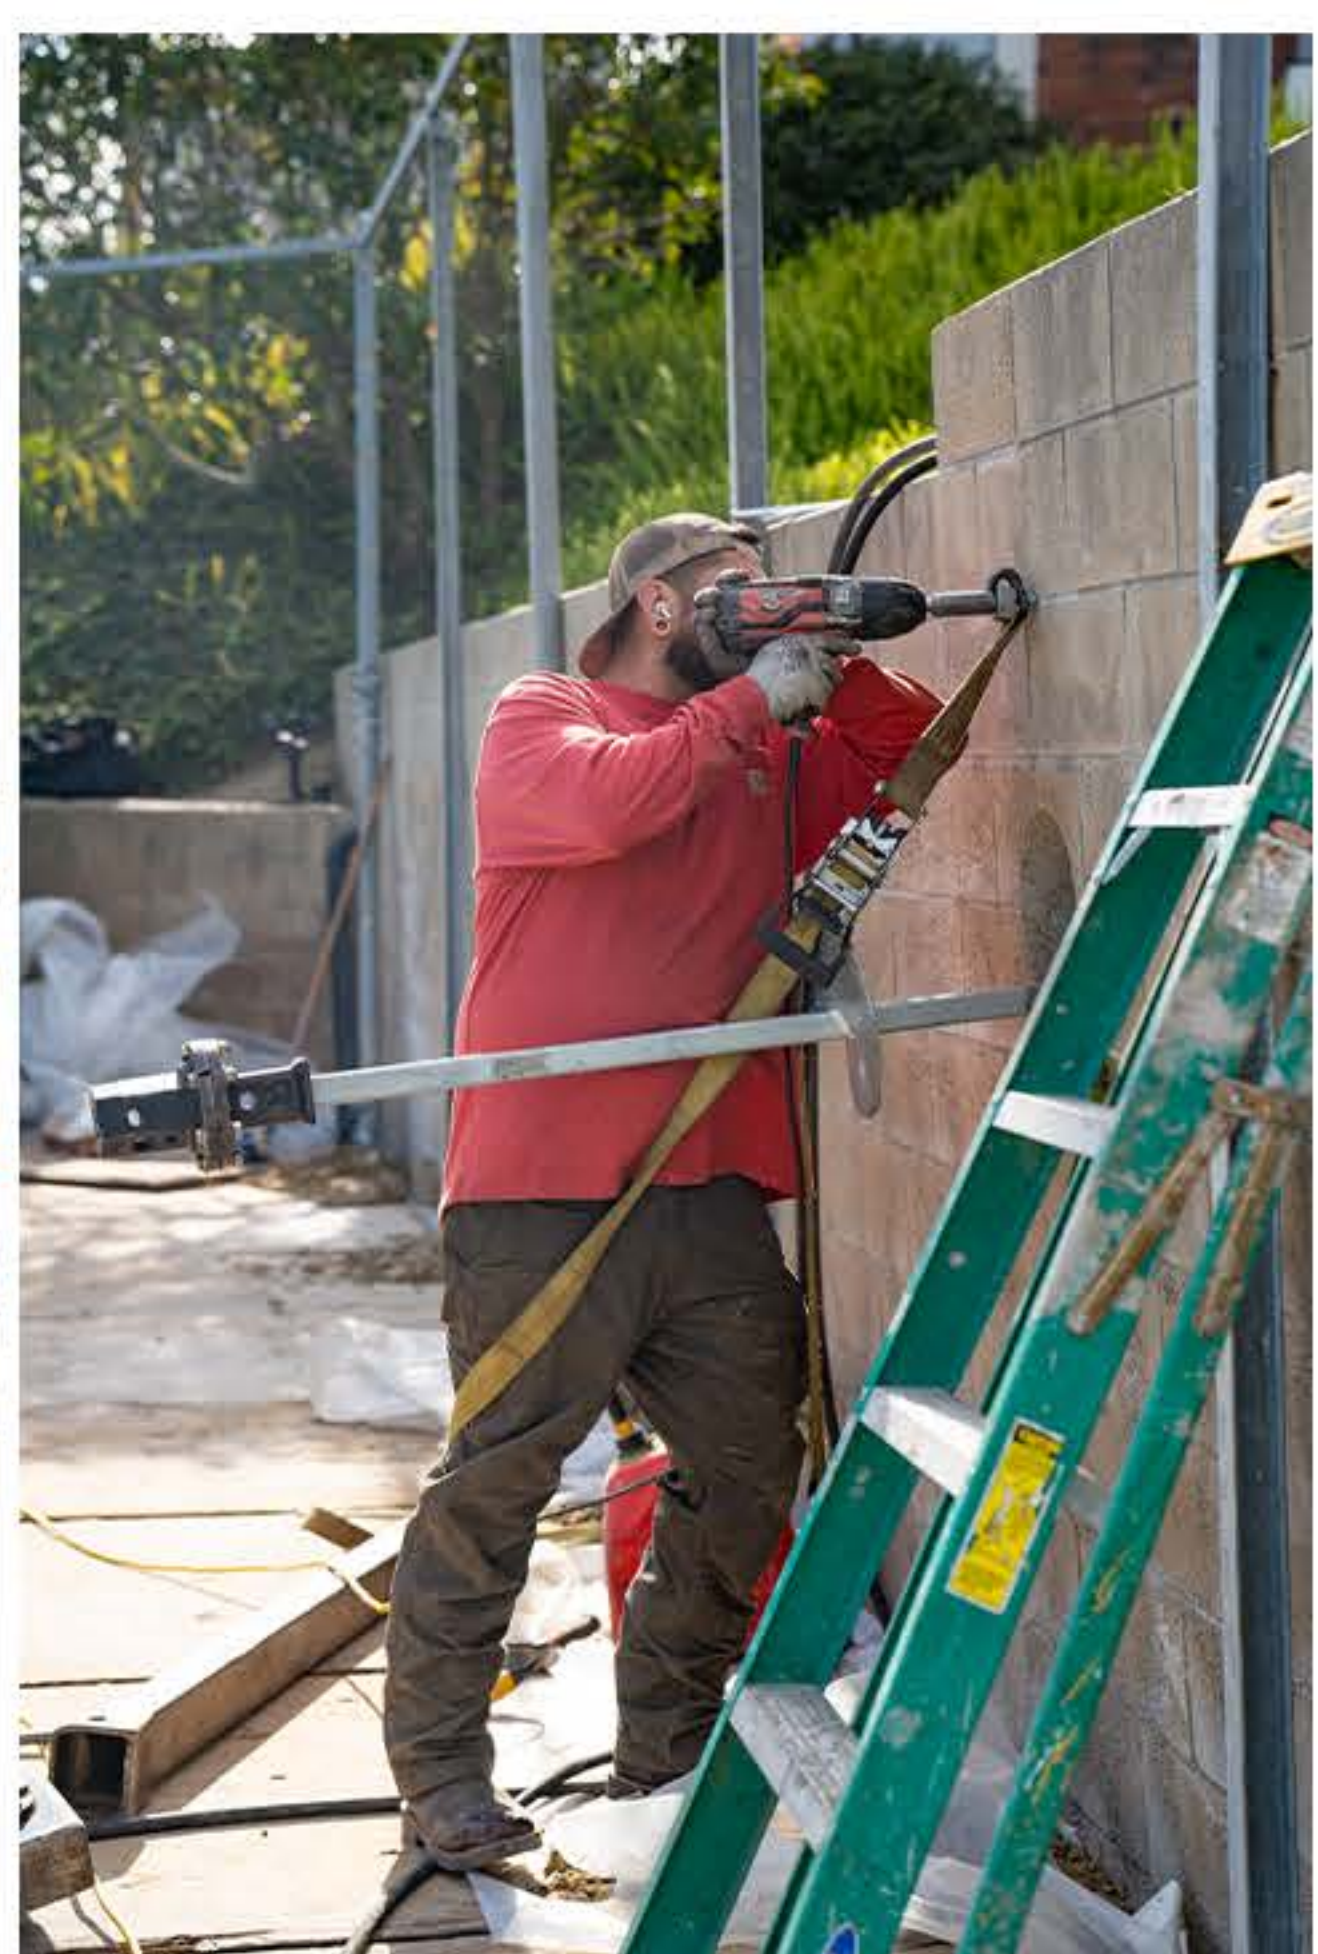
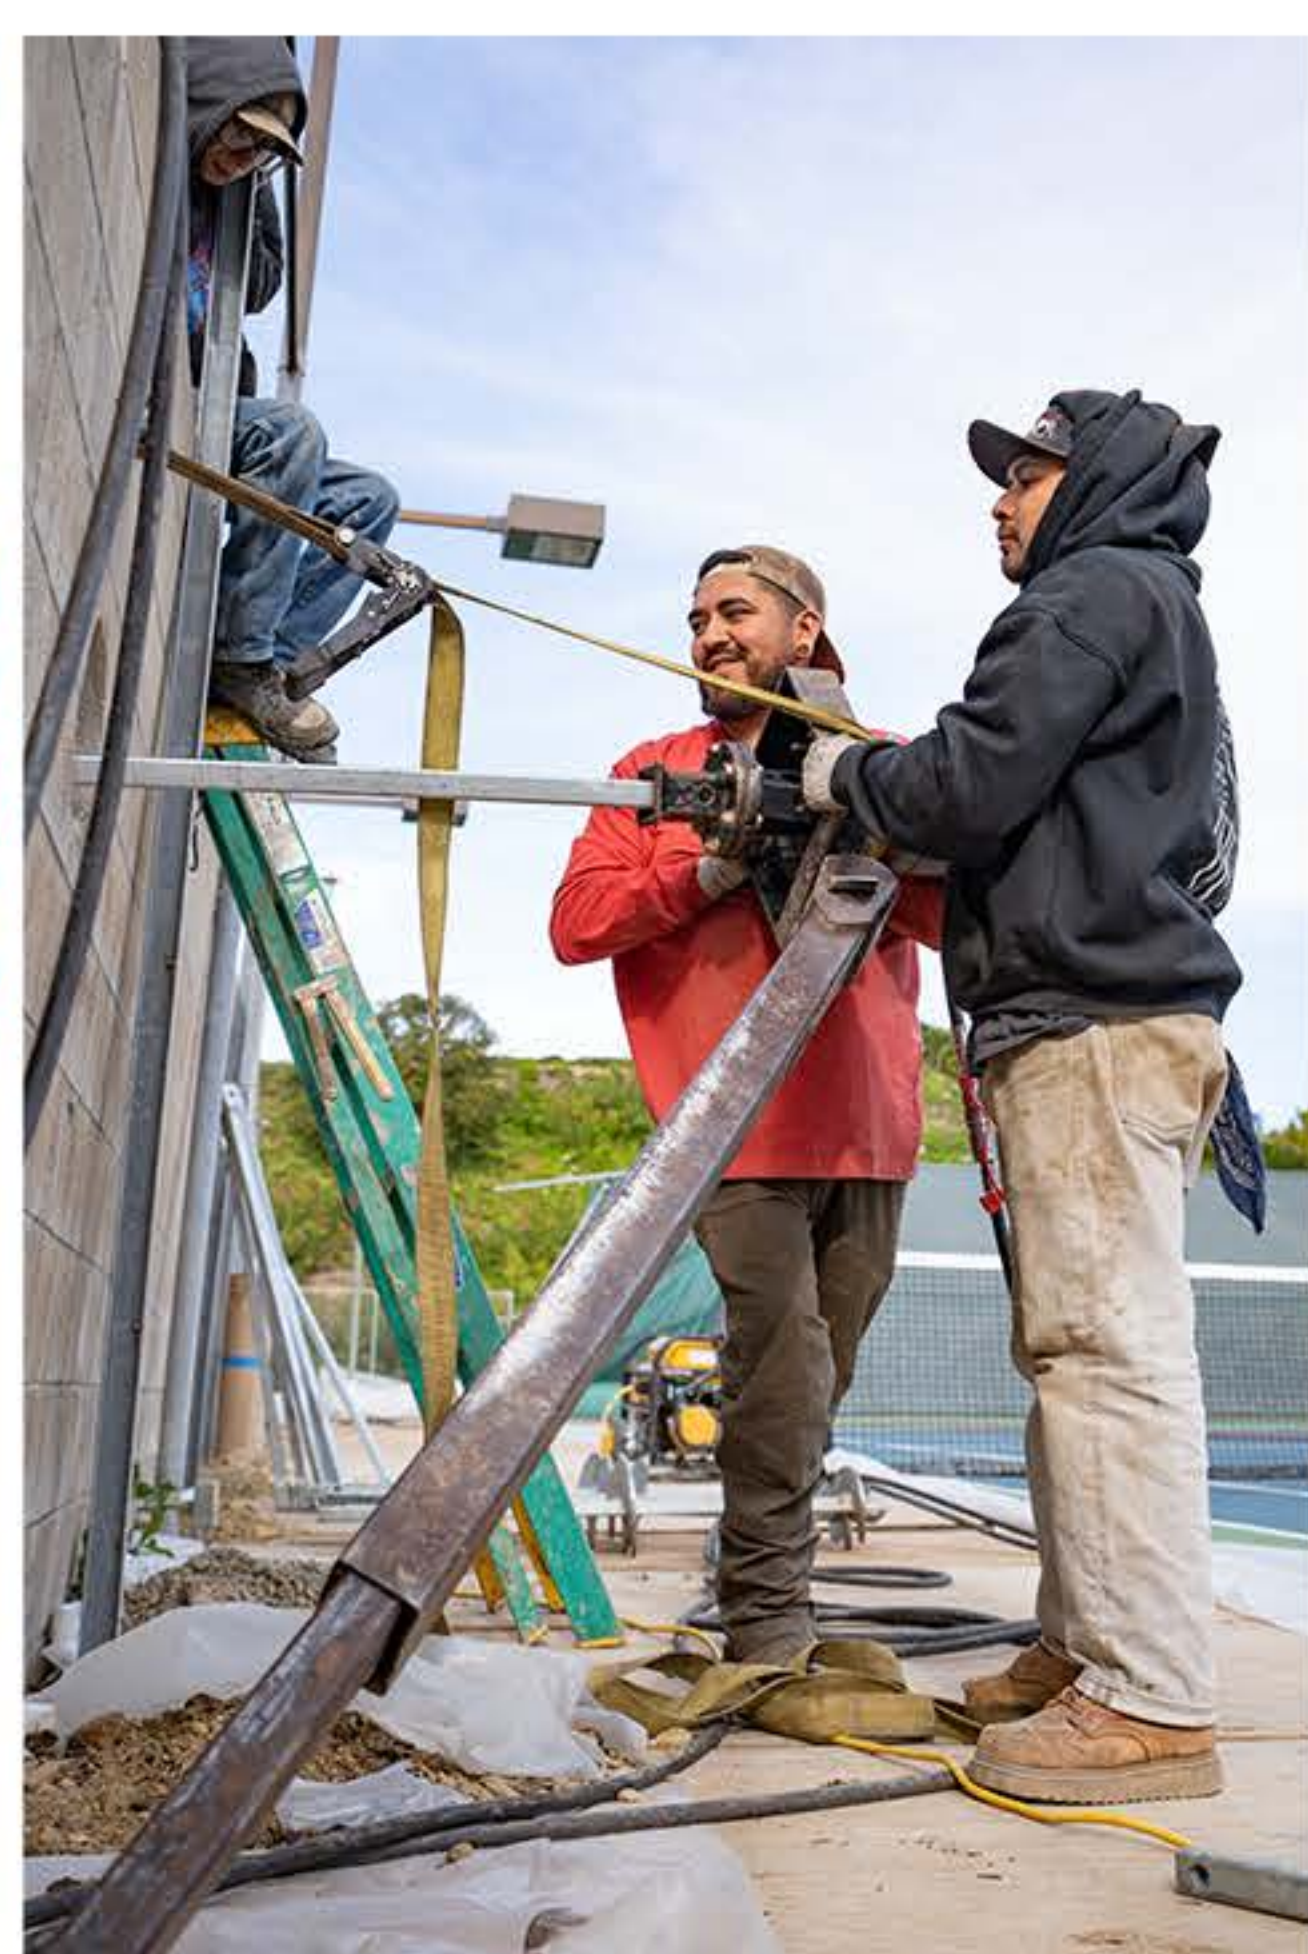
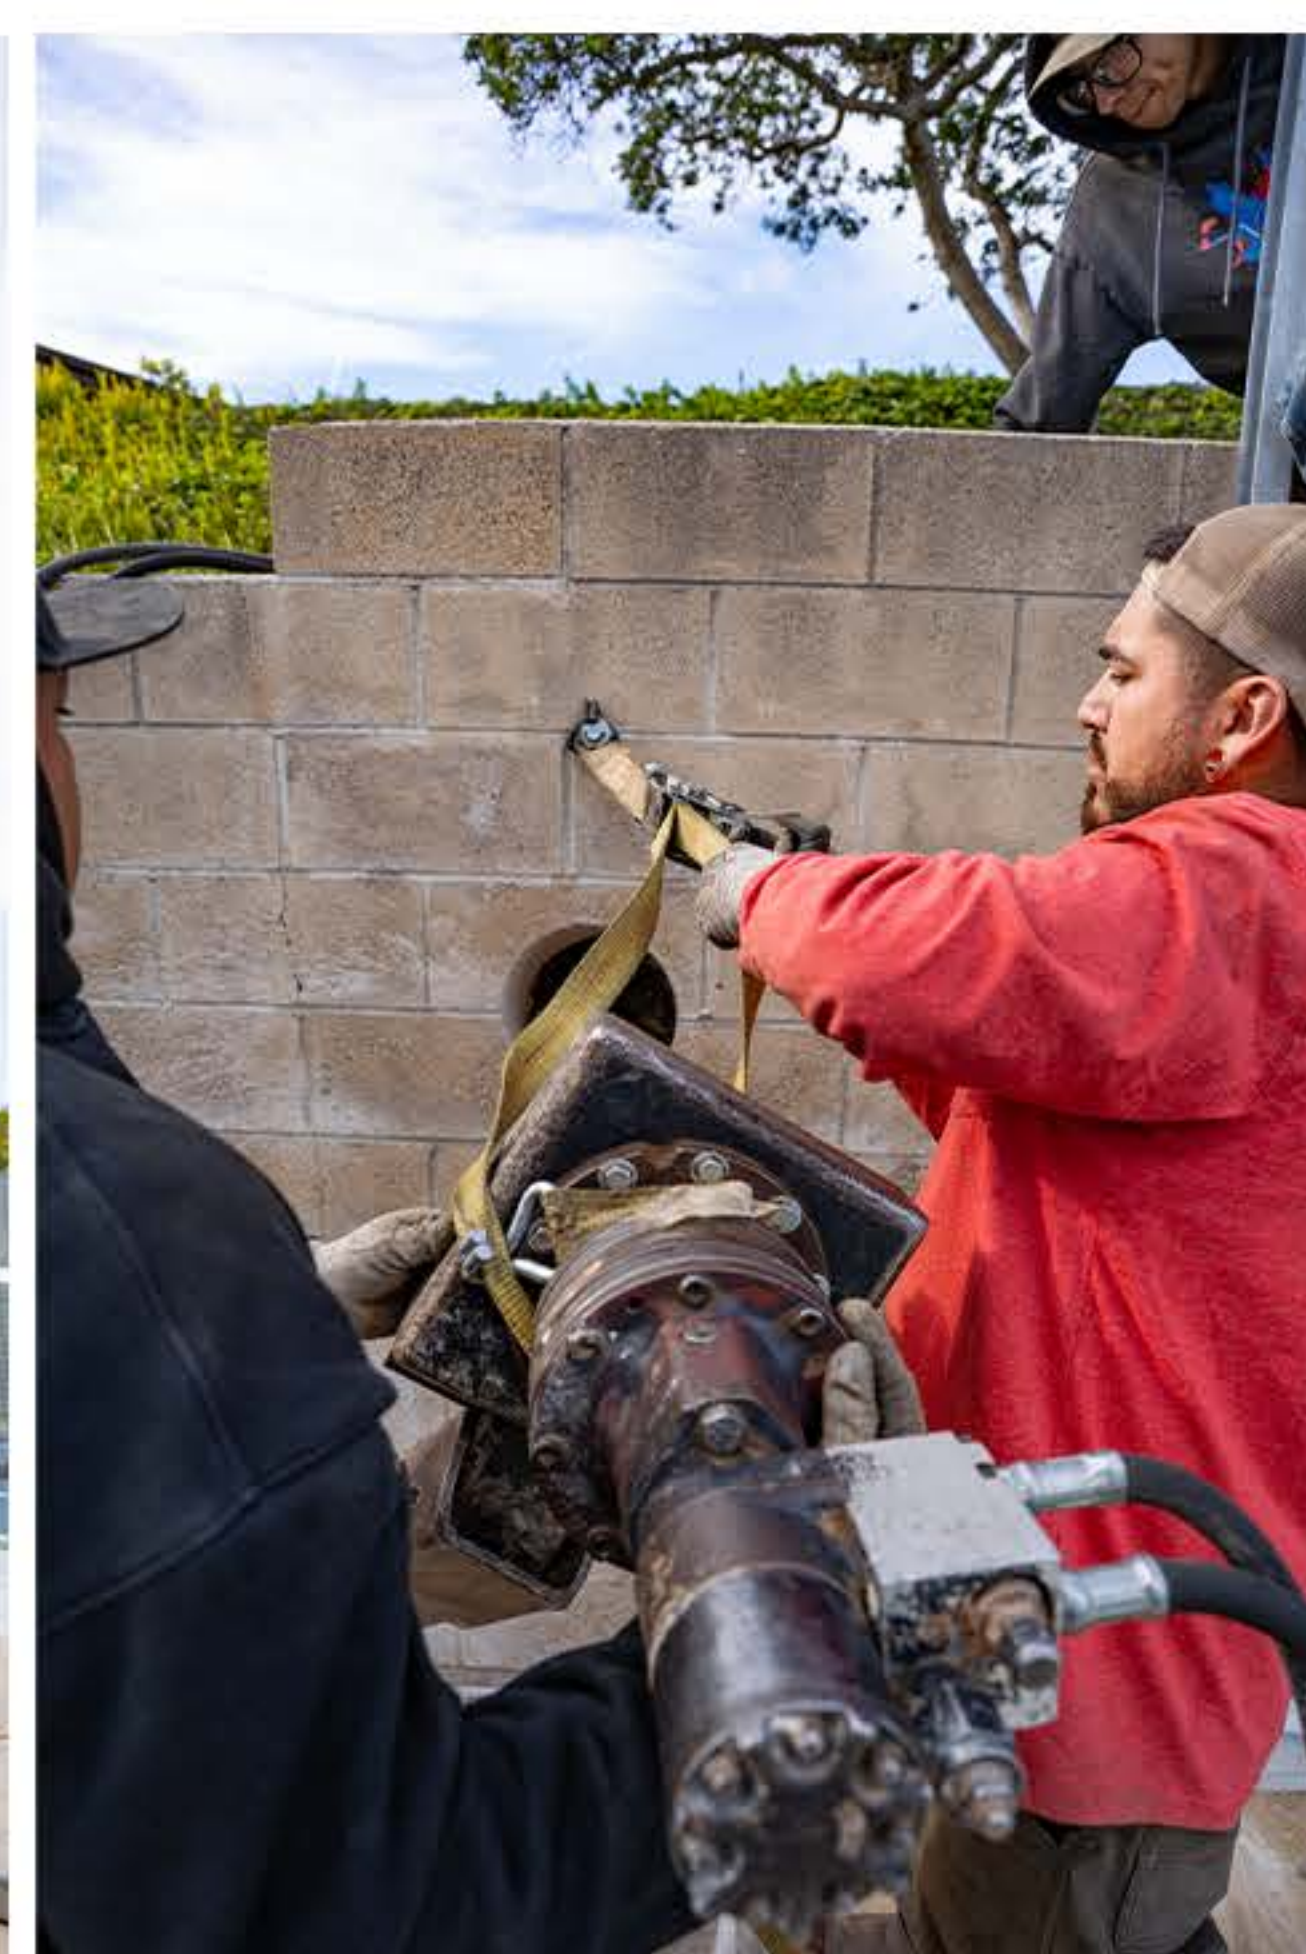
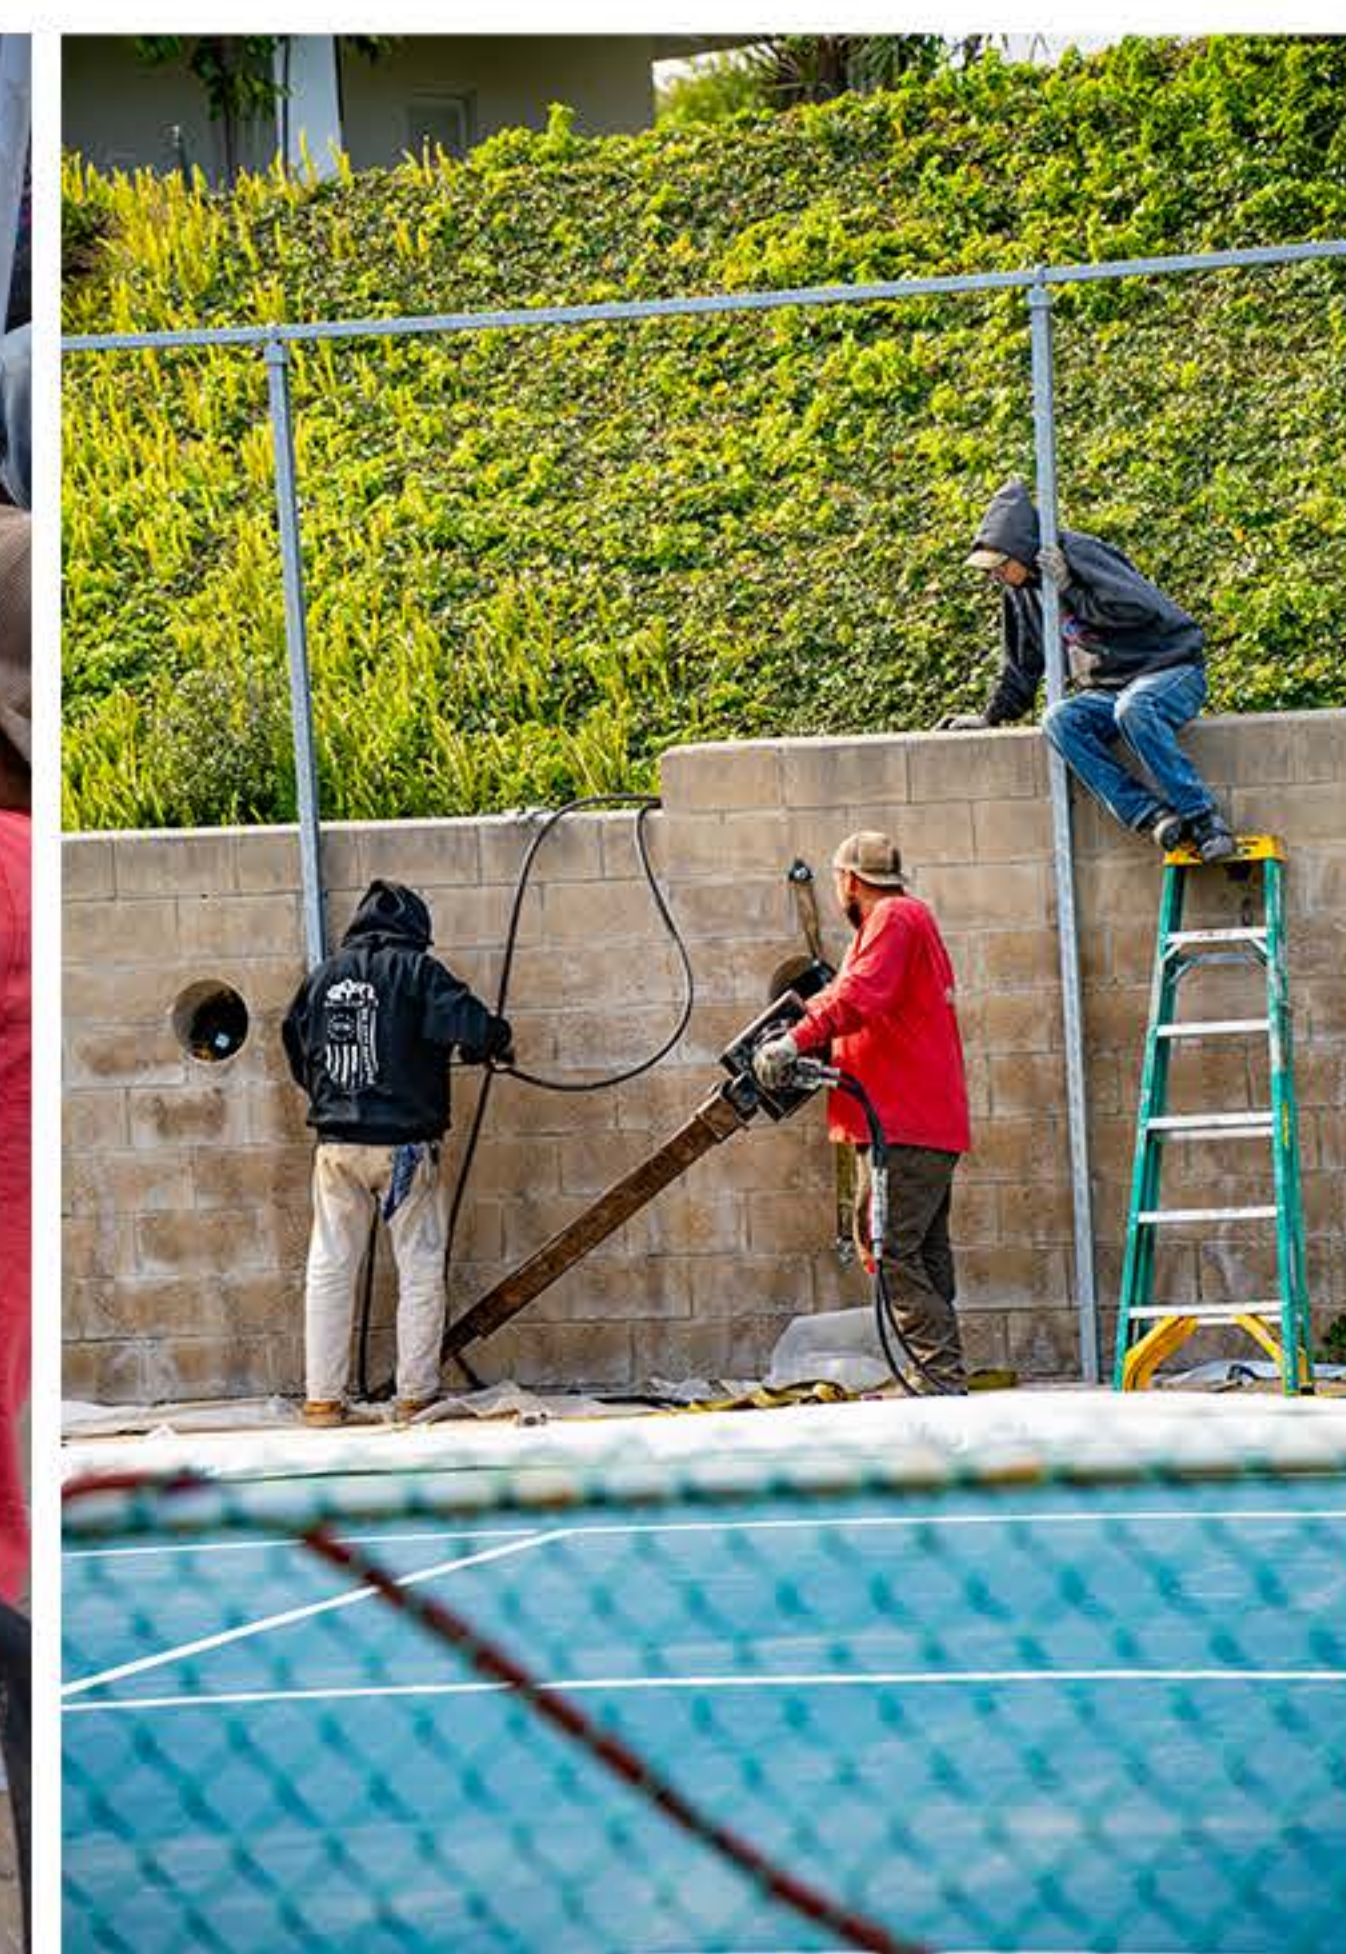
Brian Dalinghaus performed the initial inspection and found many cracks as well as several inches of deflection in multiple parts of the retaining wall. He designed a repair plan that would consist of core drilling through the wall before driving in the 18 helical tieback anchors that would stabilize this wall in place and prevent any future lean, roll, or deflection.
