# Structural Systems Repair Group (SSRG) Installing (34) Helical Piles at Condominium Complex in Miamisburg, OH

| <b>Project Name &amp; Location:</b> | Ashton Place Condominiums - Miamisburg, OH |
| <b>Project Type:</b> | Helical Pile Deep Foundation System |
| <b>Helical Pile Specifications:</b> | (34) 2.875" O.D. Round Shaft Helical Piles with 10', 12", 14" Helix Bearing Plates; 60 KIPS Ultimate Capacity; All Galvanized |

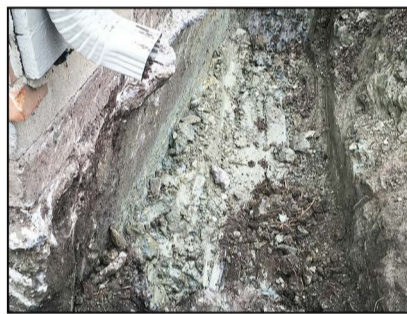
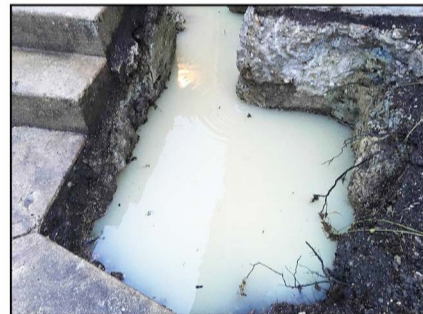
SSRG is installing (34) piles for stabilizing foundations at seven buildings with multiple units. Existing soils at the site consist of organic clay that resulted in settlement issues at these foundations. Helical piles were proposed as a stabilization solution for this project.

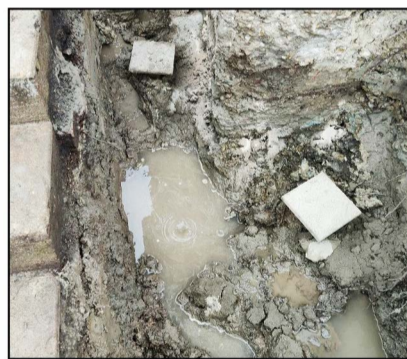
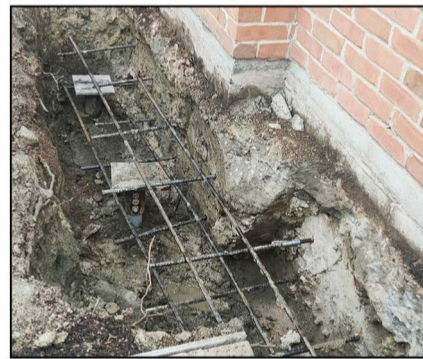
SSRG installed these piles in varying weather conditions with rain. New construction pile caps typically 8" x 8" size, used to connect the piles and new grade beam. Soil comprised of highly plastic clays overlying weathered shale and bedrock. Helical pile tip bearing on good strength shale or bedrock.
