Structural Systems Repair Group (SSRG) Installing (82) Helical Piles for Distillery Renovations in OTR Cincinnati

Project Name & Location:	OTR Stillhouse Distillery - Cincinnati, OH
Project Date:	May 2021
Project Type:	Helical Piles Deep Foundation System
Helical Pile Installation Contractor:	Structural Systems Repair Group, Cincinnati, OH
Structural Engineer:	JCA (Julie Cromwell Associates)
General Contractor:	Fedders Construction
Helical Pile Specifications:	(58) 2.875" OD helical piles with 12",14", 16",16", 18" helix bearing plates and (24) 3.5" OD helical piles with 12",14", 16",18", 18" helix bearing plates 40 Ton ultimate pile capacity
Soils & Embedment Depth:	Average Pile Depth 40 ft. Very loose sands with N-values between 1 and 10
Project Timeline:	3 Weeks
Helical Pile Manufacturer:	Helical Anchors, Inc. (MN)

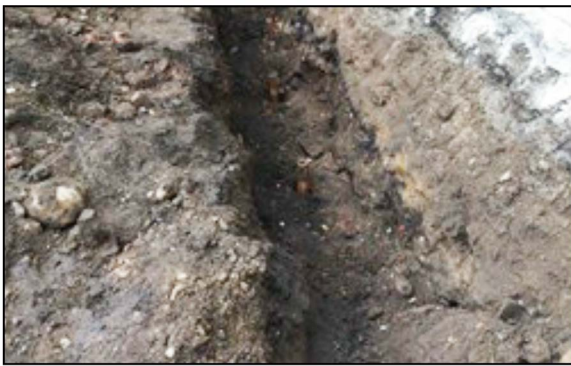
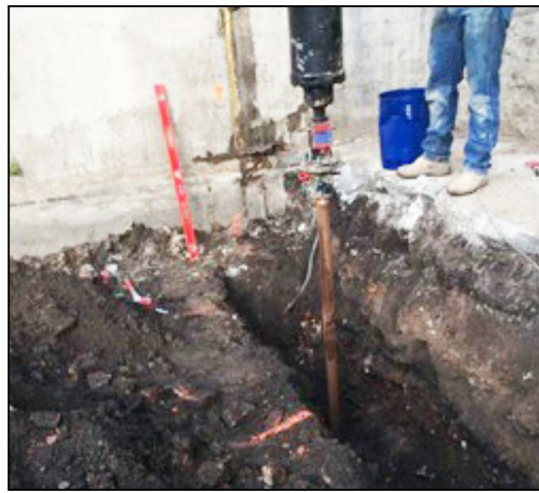
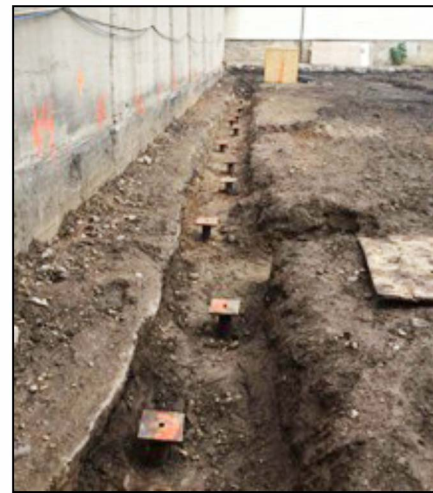
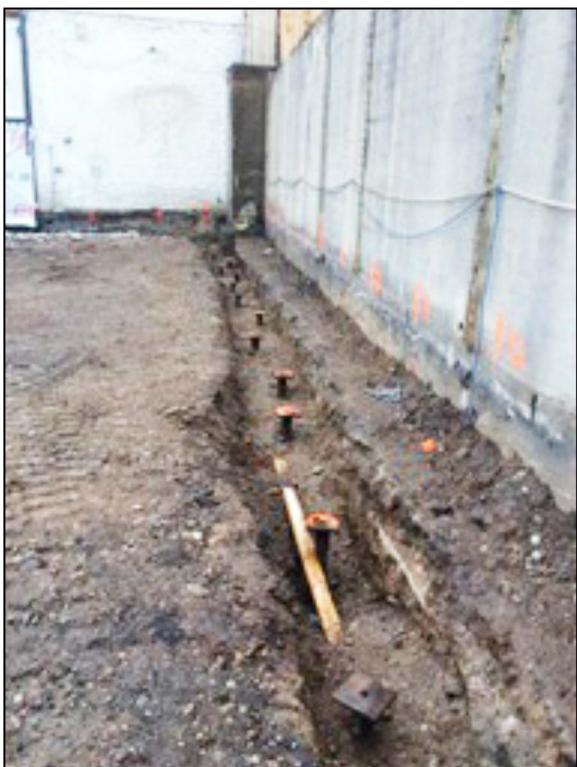
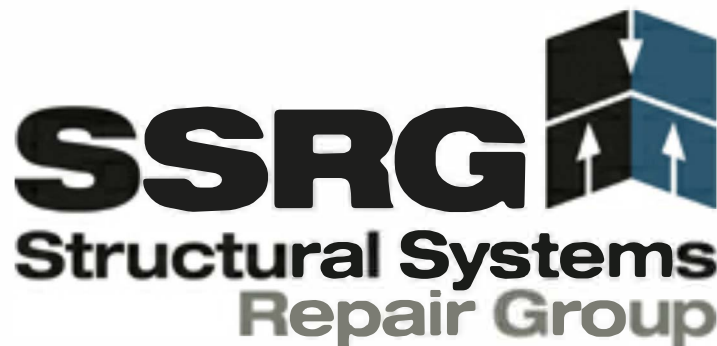
SSRG was contacted by Fedders Construction to propose a helical pile foundation system for new addition building due to the poor soils at project site. Helical piles with 5-helix plate configuration were proposed as an effective solution to achieve required capacities in this type of soil. (58) helical piles were installed for the new building addition and (24) helical piles for new canopy at the Distillery. SSRG installed few production test piles initially in April to assess the soil bearing conditions and potential obstructions onsite. Due to the canal that used to run adjacent to the jobsite years ago, there were concerns for soil bearing as there was considerable rubble fill. Torque monitoring results from the production test piles helped significantly in confirming the pile configuration needed to achieve the capacities.
